January 9th, 2025

MP09130

MP09130, MP09139, + MP09143
Maguire and University Apartments

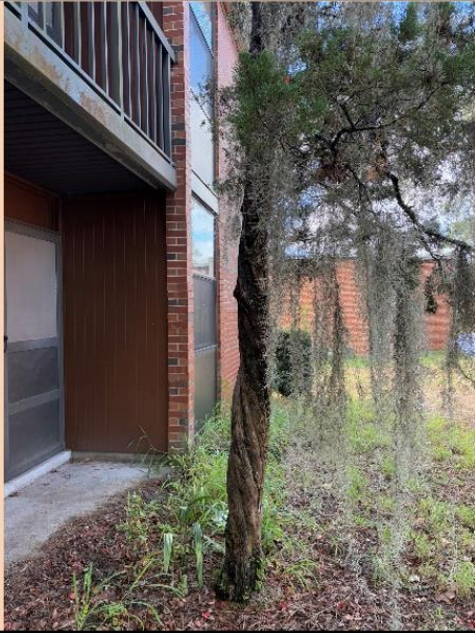
47	Red Cedar	7.3	09139	<p>-Recommended for removal -Tree is in <u>close proximity to building</u> being demolished</p>

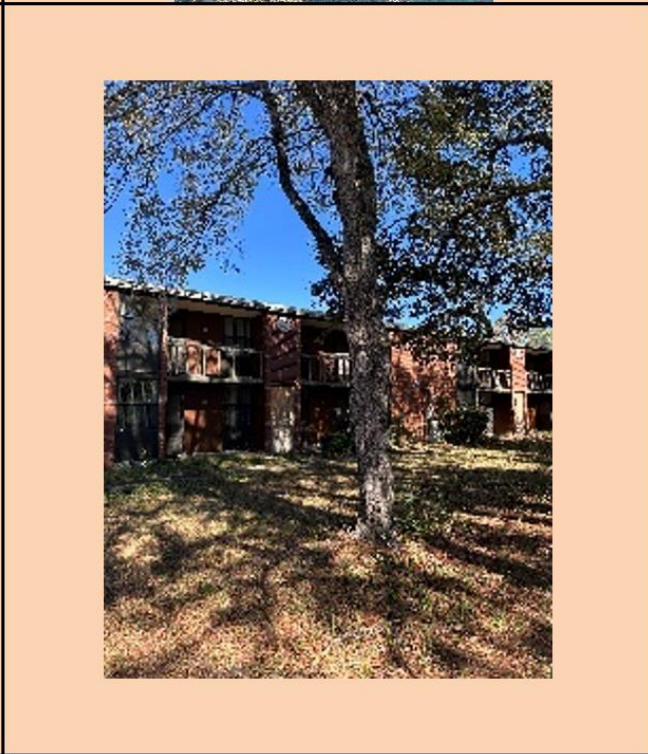
91	Elm	18.5	09139	-Recommended for removal -Co-dominant trunks above DBH
----	-----	------	-------	---

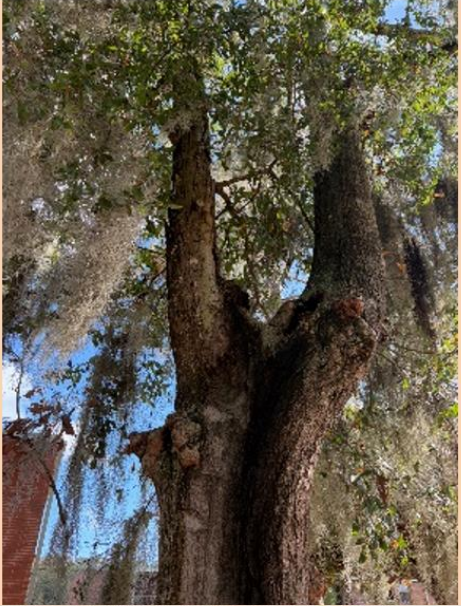
95	Laurel Oak	20.8	09139	<p>-Recommended for removal</p> <p>-Tree is in <u>close proximity to building</u> being demolished</p> <p>-<u>Tree is in poor condition</u></p>

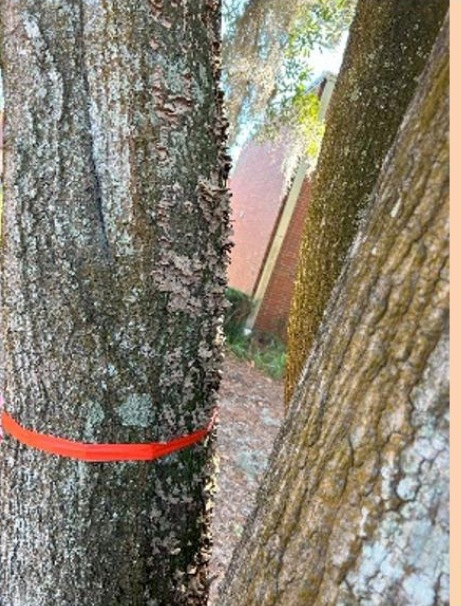
99	Laurel Oak	16.8 & 33.2	09139	<p>-Recommended for removal</p> <p>-<u>Tree is in poor condition</u> with obvious signs of decay and fungal growth along major trunk</p>

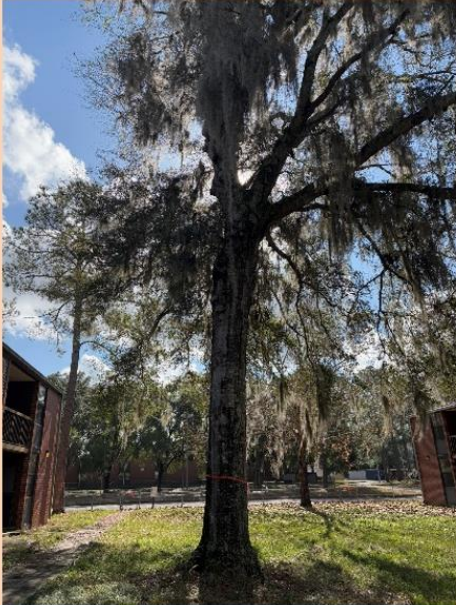
92	Laurel Oak	31.7	09143	-Recommended for removal -Tree is in poor condition

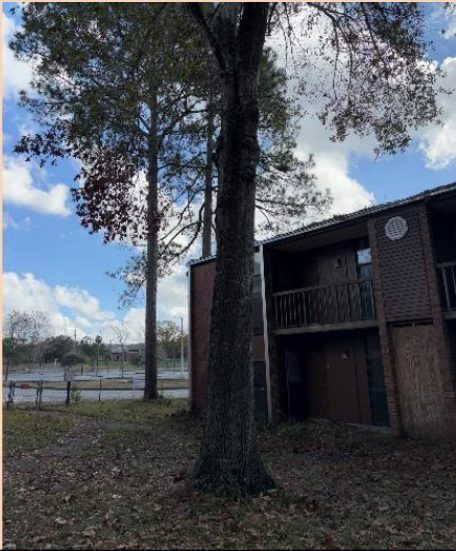
96	Laurel Oak	31	09143	-Recommended for removal -Tree is in close proximity to building being demolished -Tree is in poor condition

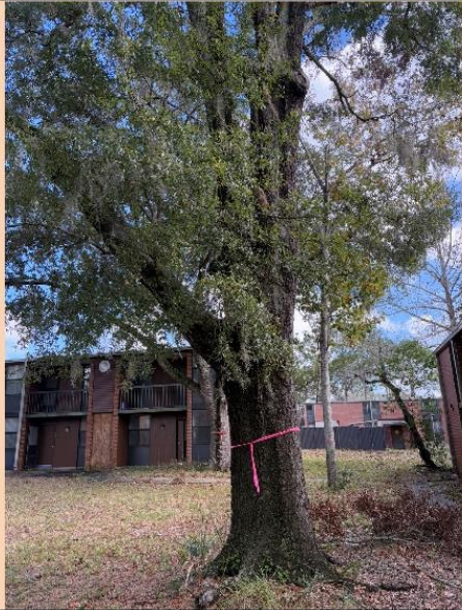
101	Laurel Oak	33	09143	-Recommended for removal -Tree is in poor condition

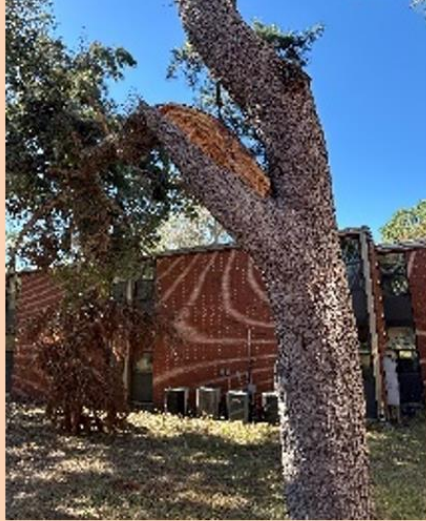
104	Short Leaf Pine	26.5	09143	-Recommended for removal -Tree has failure at major stem above DBH

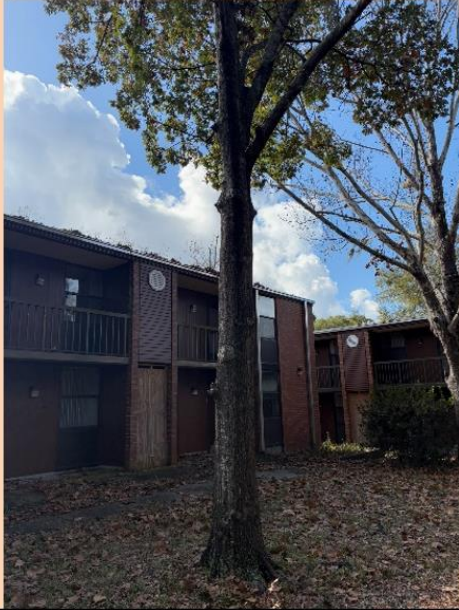
119	Shumard Oak	22.6	09143	-Recommended for removal -Tree is in poor condition

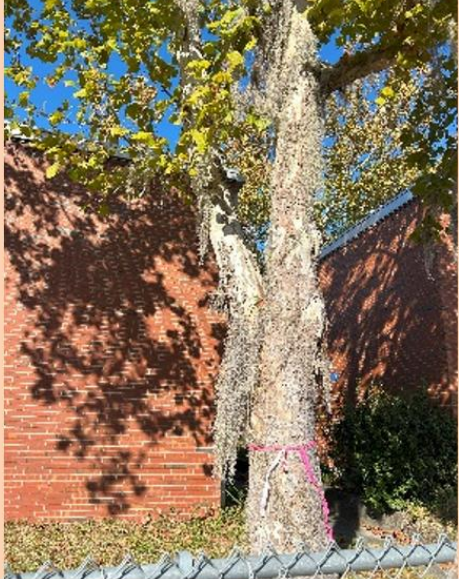
120	Sycamore	17	09143	-Recommended for removal -Co-Dominant branching -Tree is in close proximity to building to be demolished

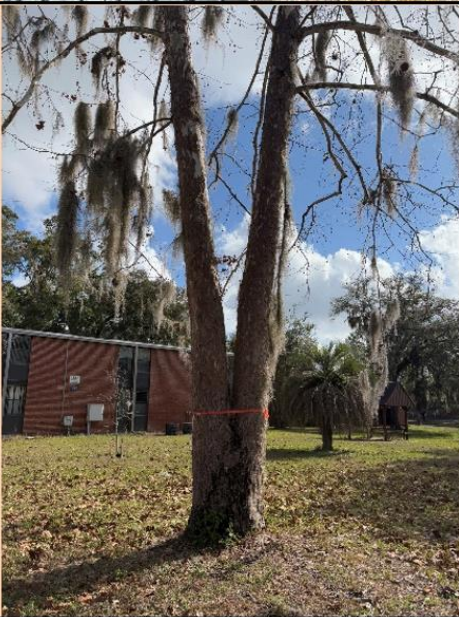
121	Sycamore	27	09143	-Recommended for removal -Co-Dominant branching

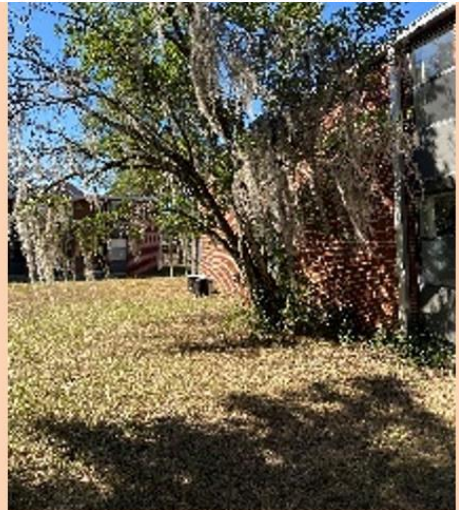
125	Cherry Laurel	11.5	09143	-Recommended for removal -Multi-trunk -Tree is in close proximity to building to be demolished

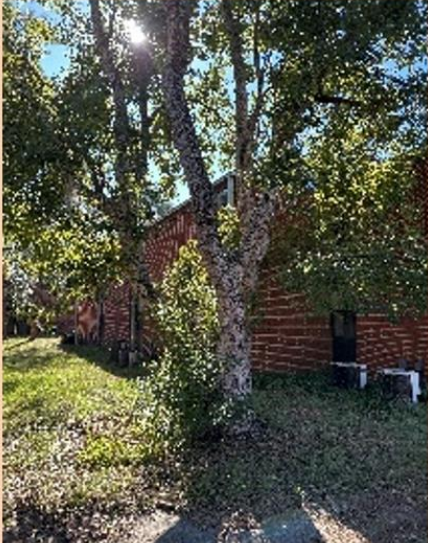
89	Camphor	34.5	09130	<p>-Invasive Species to be removed</p> <p>-Tree is in close proximity to building to be demolished</p>

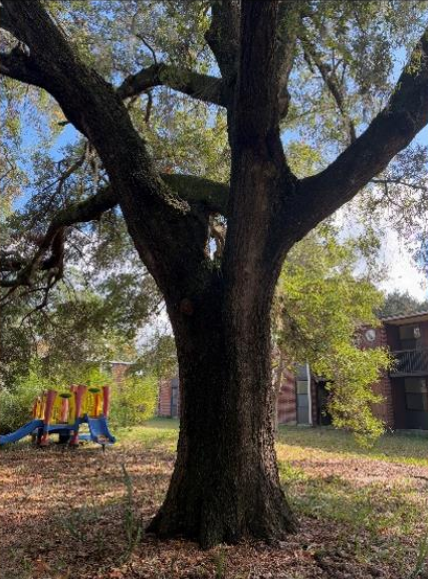
94	Laurel Oak	38.5	09130	<p>-Recommended for removal</p> <p>- Tree is in poor condition</p>

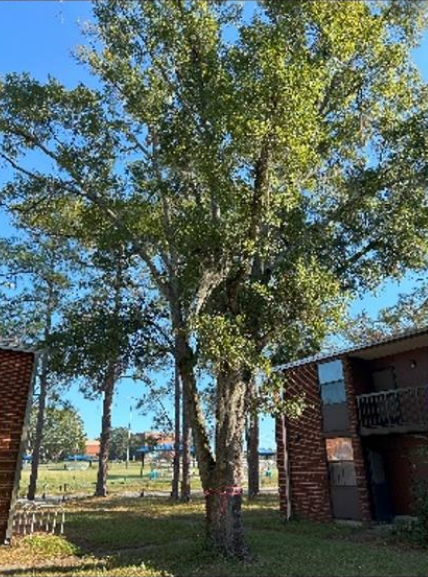
97	Laurel Oak	33.1	09130	<p>-Tree is in poor condition</p> <p>-Co-Dominant stems above DBH</p>

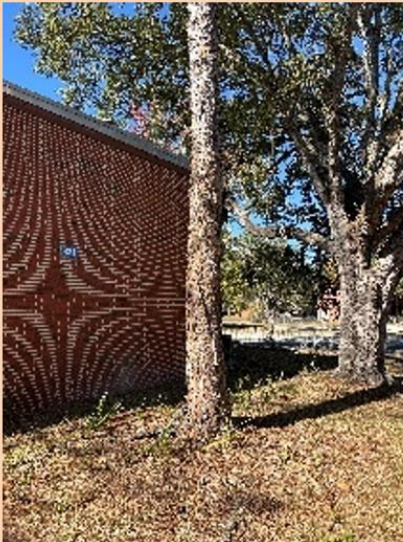
103	Loblolly Pine	26	09130	<p>-Recommended for removal</p> <p>-Tree is in close proximity to building to be demolished</p>

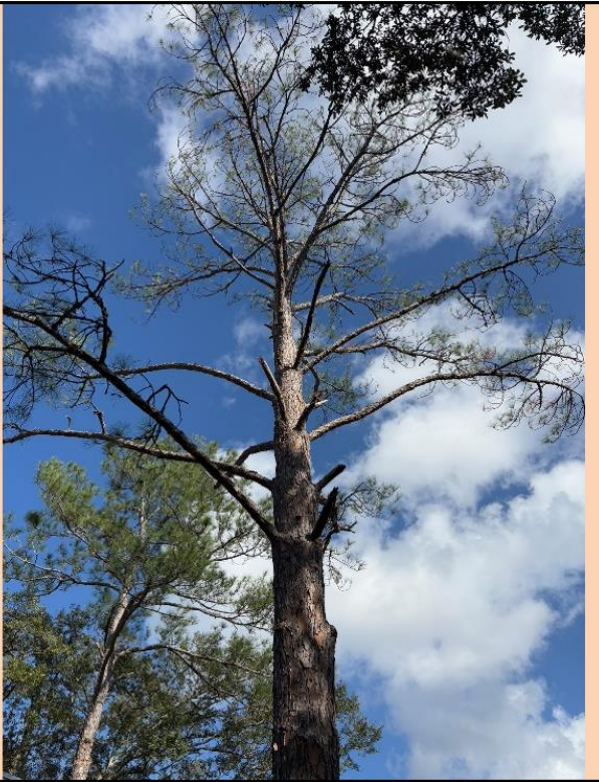
105	Short Leaf Pine	21	09130	-Recommended for removal -Tree is in poor condition
-----	-----------------	----	-------	--

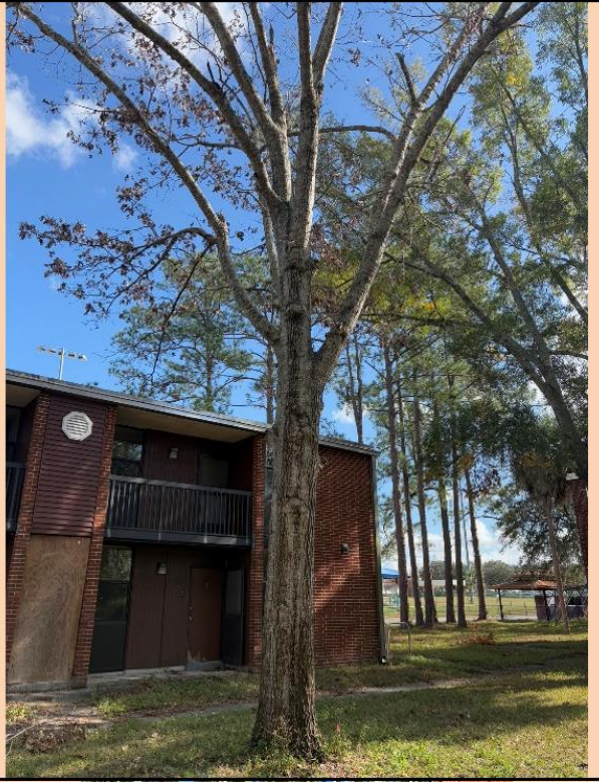
107	Shumard Oak	21.3	09130	-Recommended for removal -Tree is in poor condition
-----	-------------	------	-------	--

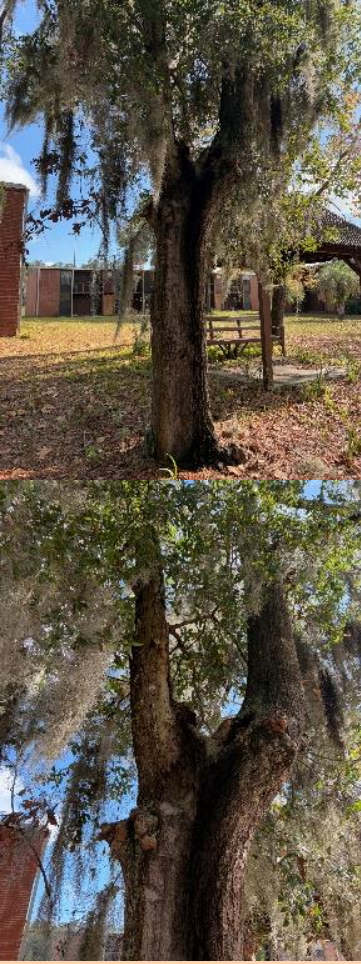
95	Laurel Oak	20.8	09139	<p>-Recommended for removal -Tree is in close proximity to building being demolished -Tree is in poor condition</p>

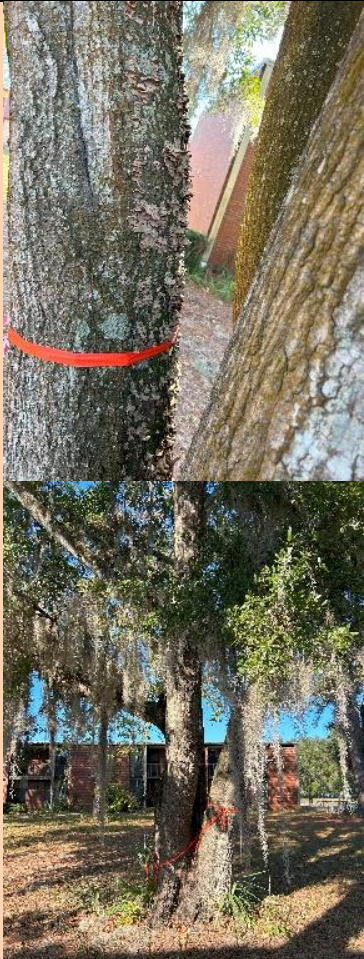
99	Laurel Oak	16.8 & 33.2	09139	<p>-Recommended for removal -Tree is in poor condition with obvious signs of decay and fungal growth along major trunk</p>

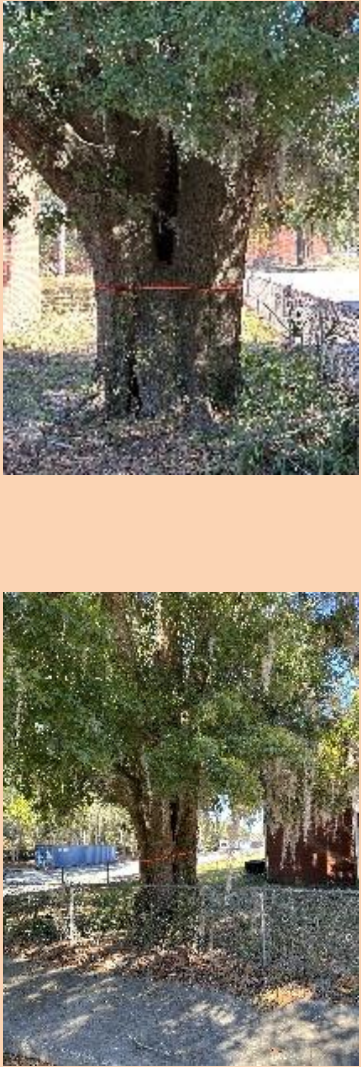
Tag #	Species	DBH	MP#	Arborist Notes/ Recommendation	Photo (if available)
100	Laurel Oak	53	09143	<p>-Recommended for removal</p> <p>-Tree is in poor condition</p> <p>-Tree has signs of decay within trunk and cavity at base of trunk</p>

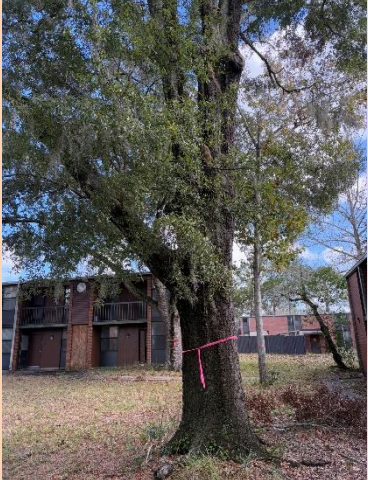
101	Laurel Oak	33	09143	<p>-Recommended for removal</p> <p>-Tree is in poor condition</p>

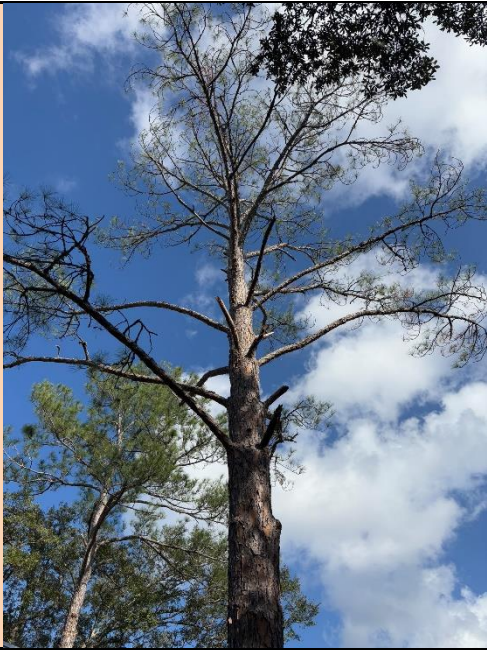
Tag #	Species	DBH	MP#	Arborist Notes/ Recommendation	Photo (if available)
105	Short Leaf Pine	21	09130	<ul style="list-style-type: none"> -Recommended for removal -Tree is in poor condition

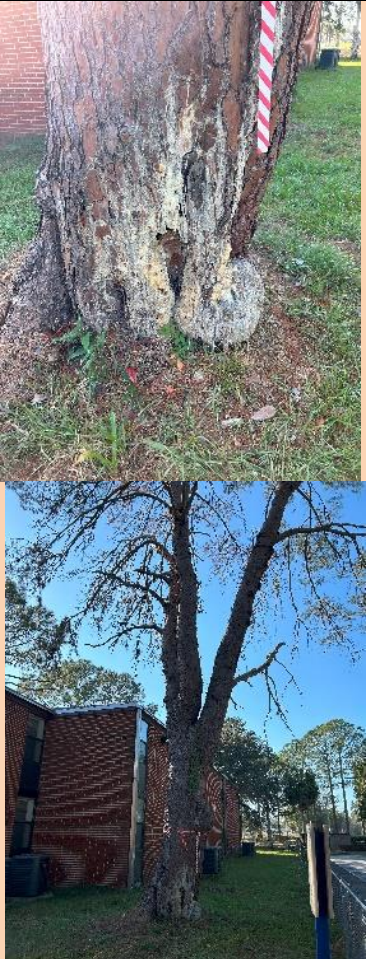
106	Short Leaf Pine	38.6	09130	<ul style="list-style-type: none"> -Recommended for removal -Tree is in poor condition -Co-dominant stems above DBH -Tree is within 10' of building to be demolished

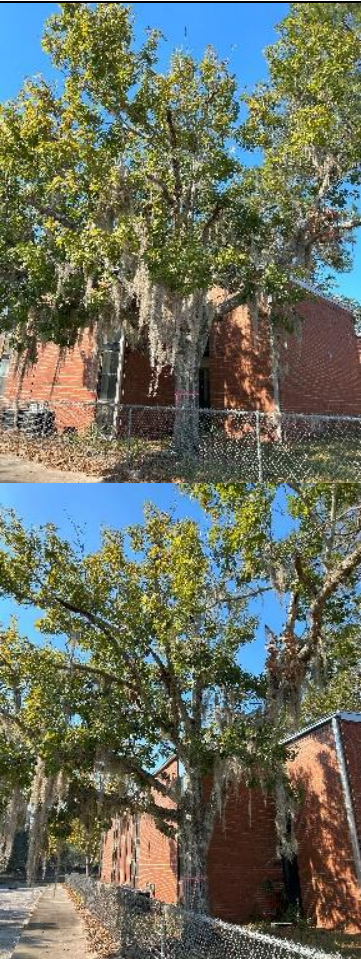
Tag #	Species	DBH	MP#	Arborist Notes/ Recommendation	Photo (if available)
118	Shumard Oak	22	09143	<ul style="list-style-type: none"> -Recommended for removal -Tree is poor condition -Tree is <8' from building to be demolished

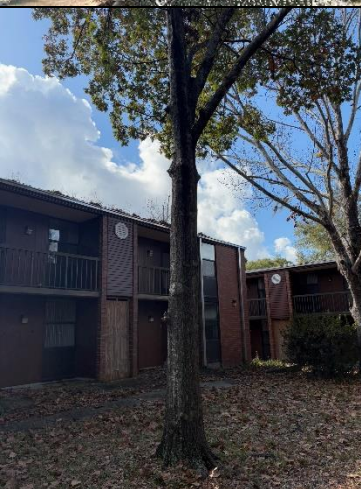
119	Shumard Oak	22.6	09143	<ul style="list-style-type: none"> -Recommended for removal -Tree is in poor condition

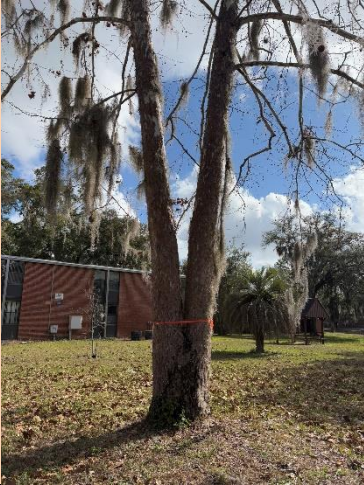
121	Sycamore	27	09143	-Recommended for removal -Co-Dominant branching

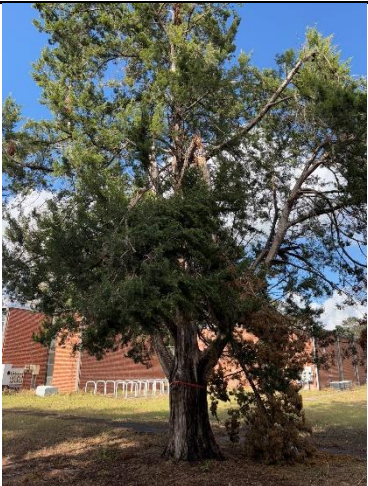
Tag #	Species	DBH	MP#	Arborist Notes/ Recommendation	Photo (if available)
272	Red Cedar	20.6	09143		
273	Red Cedar	32.2	09143	-Tree has structural damage to the canopy -Tree will require pruning for preservation
