**7.**  
**CONSERVATION**  
**DATA & ANALYSIS**

## **I. Introduction**

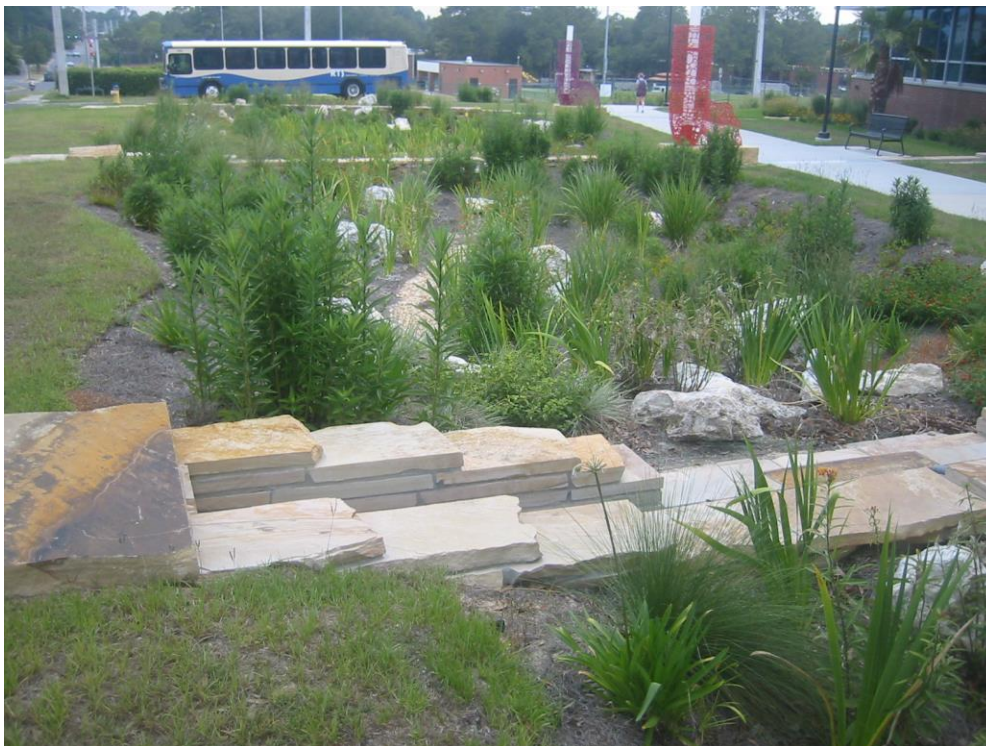
This example illustrates a bio-retention (rain garden) stormwater treatment in front of the Southwest Recreation Center.

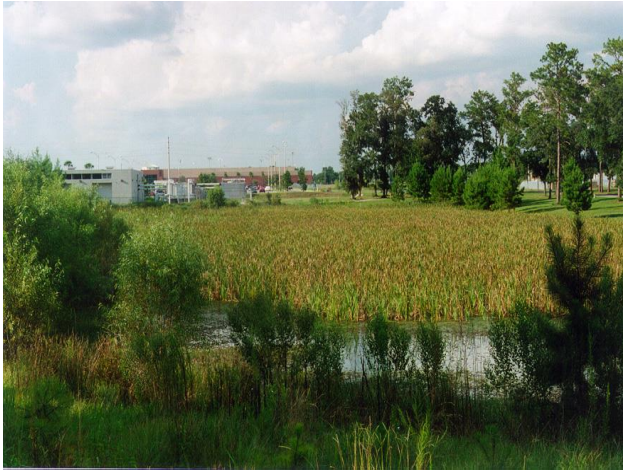
Pre-SEEP (looking north) – Cattail dominated

Another approach that uses the traditional stormwater pond design with an ecological design twist is a large scale bio-retention area, which is a BMP that should be considered in developing areas of campus. This approach to stormwater retention can be found currently at the Stormwater Ecological Enhancement Project (SEEP), adjacent to the Performing Arts parking lot and the Natural Areas Teaching Lab (NATL) Conservation Area. The retention pond was originally constructed in 1988 as a typical wet retention pond with a flat bottom and no attention paid to plant species diversity. In 1995, an initiative to redesign the basin into a more ecologically sensitive manor that befitted its placement next to the NATL was initiated. As articulated by its designers, the primary goal of the SEEP was to increase the diversity of flooding depths and frequency of flooding that will occur, since this is the primary factor regulating species composition in a wetland. To do this, two depressions (one 4-feet, the other 5-foot deep), were dug at the southeastern end of the pond providing a deep, open-water habitat. At the north end a low berm was constructed to temporarily impound 80% of the entering stormwater. This forebay provides the first phase of treatment and was planted with species known to take up heavy metals and remove nutrients. Water from the forebay is then slowly released, first flowing through an area planted to resemble a bottom-land hardwood swamp, moving into a shallow freshwater marsh and then entering the deep-water ponds. The basin was planted with species that resemble those found in wetlands of North Central Florida.

The expected benefits of this type of retention are species diversity, wildlife habitat, aesthetics, water quality, and research potential. All of these benefits have been shown to have merit at the SEEP, however one issue remains that has not been adequately studied. This issue is the potential effects that these ponds have on wildlife, and particularly federally listed species. Since stormwater ponds are designed to treat the noxious constituents found in run-off, they are laden with metals, pesticides and fertilizers all of which can prove harmful to wildlife. The main species of concern that use ponds for foraging are wading birds, such as the federally listed Wood Stork. At present little research has been conducted on what the long-term impacts are on these species from utilizing stormwater detention, roadside swales, and ecologically enhanced ponds. Arguments can be made that these species will utilize wet retention ponds regardless of whether they have

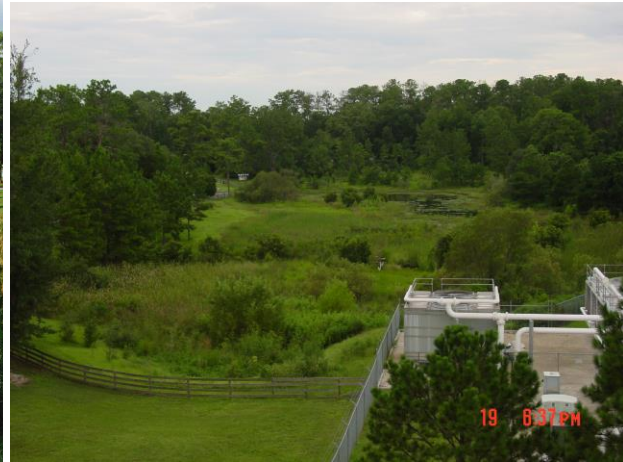
SEEP (looking south) – Variety of plant species

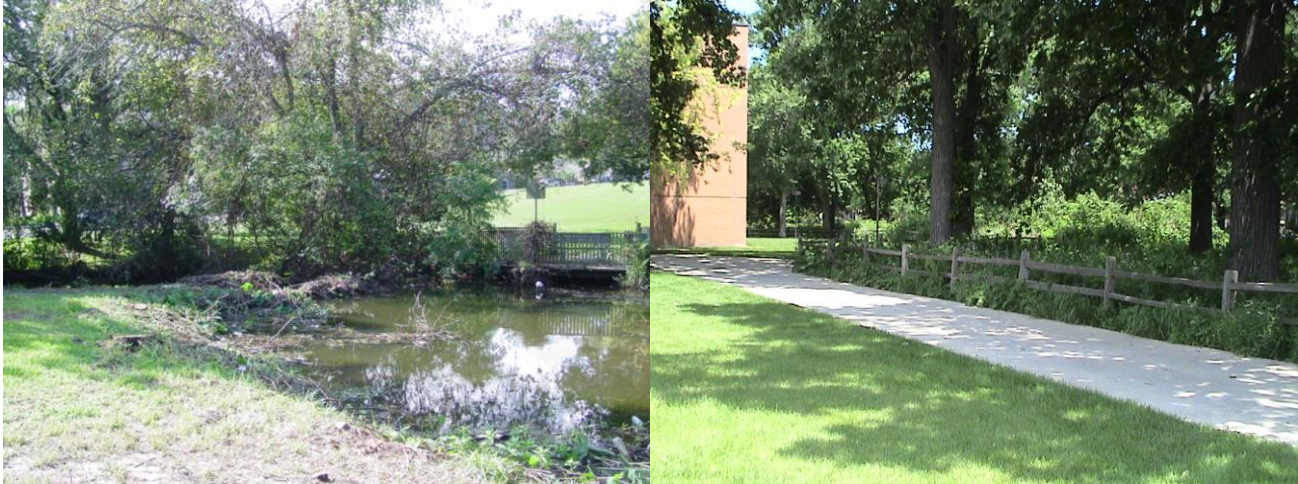
Mowed to the water's edge

Fenced off natural area – no mow area

Throughout campus, many areas have been traditionally mowed to give a neat and orderly appearance. While this has been the traditional approach, there are some areas where mowing is not necessary and by eliminating some of these areas, the University may save time, money, and energy while enhancing wildlife habitat. In fact, quite often the use of infrequent mowing, decorative fencing and planting of wildflowers can be done in such a way that it both enhances habitat and is aesthetically pleasing. Additionally, in some areas a less frequent mow schedule versus an all out ban on mowing may be more appropriate. As with all operational decisions there are a number of factors that must be considered, before deciding which areas are appropriate for non-traditional approaches. The balance between aesthetics (form) and function will always have to be determined on a case-by-case basis. Public education can improve the acceptance of strategic no-mow areas by explaining the benefits of this approach and recognizing the areas as wildlife habitats
