Reitz Union Lawn / Inner Road Improvements

Project No. UF-644, UF-644A and UF-644B

LVL Committee Meeting

October 5, 2023

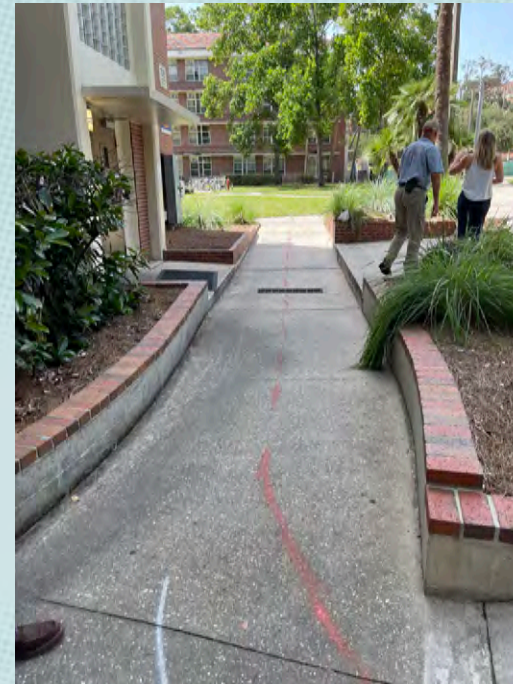
2 Sabal palmetto (est. 30' c.t.) and European Fan Palm

Discussion regarding construction impacts on drainage, planters, two Sabal Palms and a European Fan Palm.

Construct utilities as planned. Reconstruct sidewalk, drainage and planters in their original configuration. Turn Sabal Palms and European Fan Palm over to UF Grounds for planting elsewhere on campus. Plant 2 new Sabal Palms after reconstruction is complete.

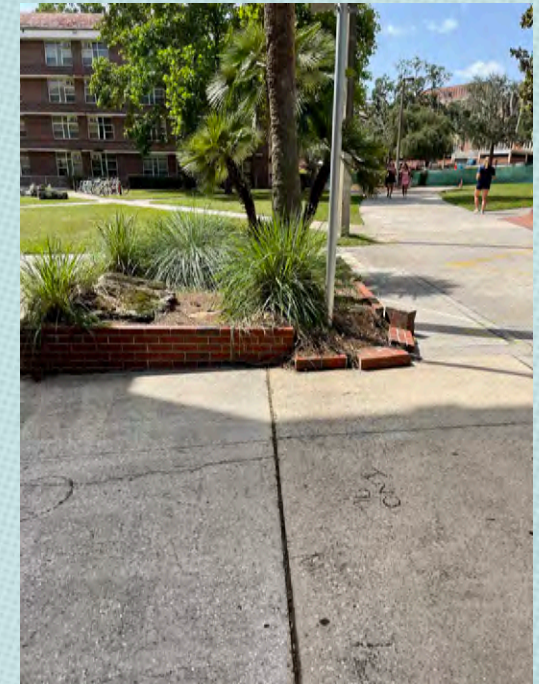
Walk and Drain Inlet at Reid Hall

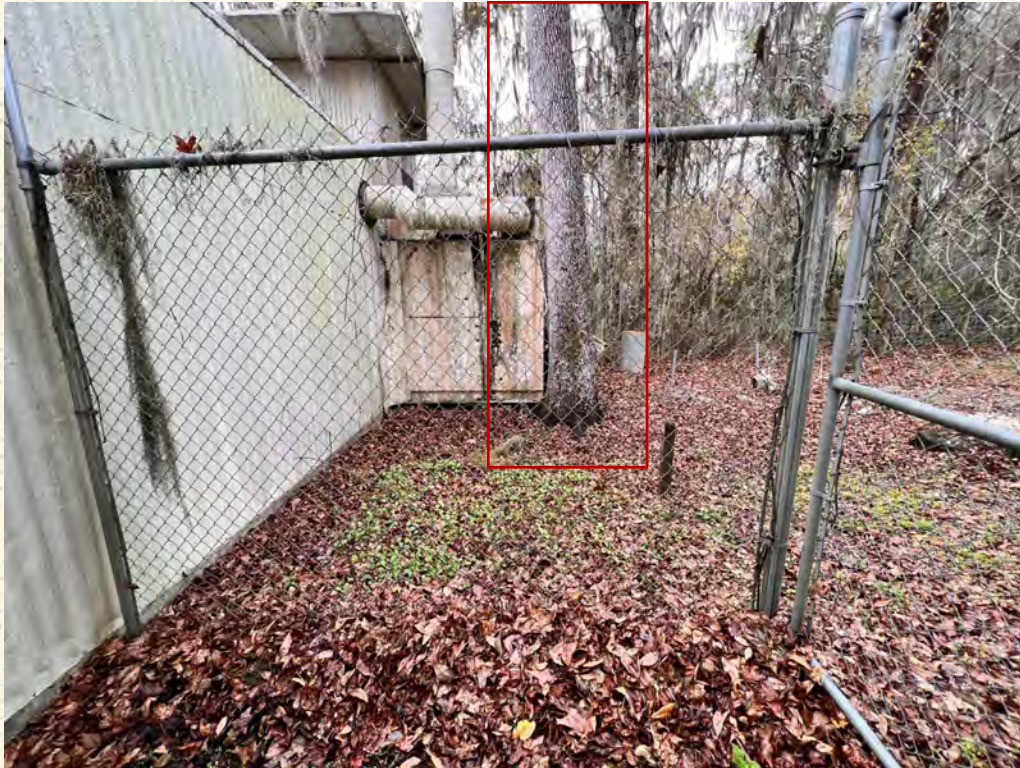
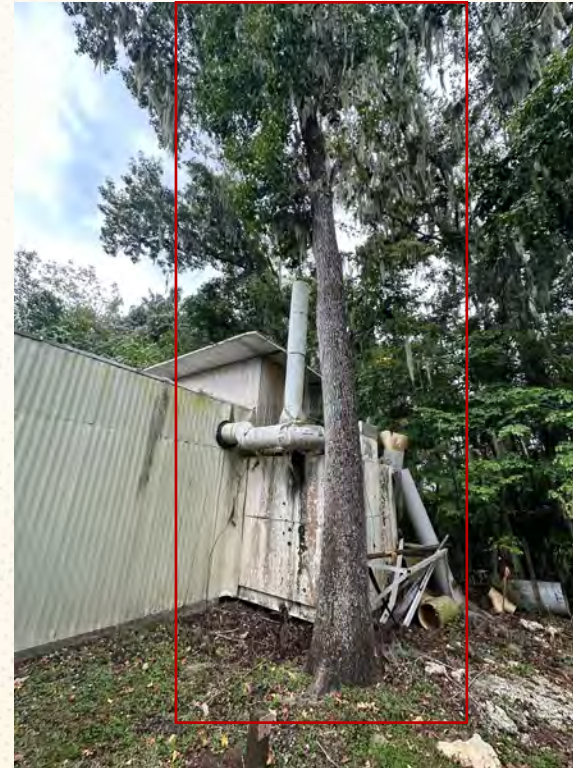
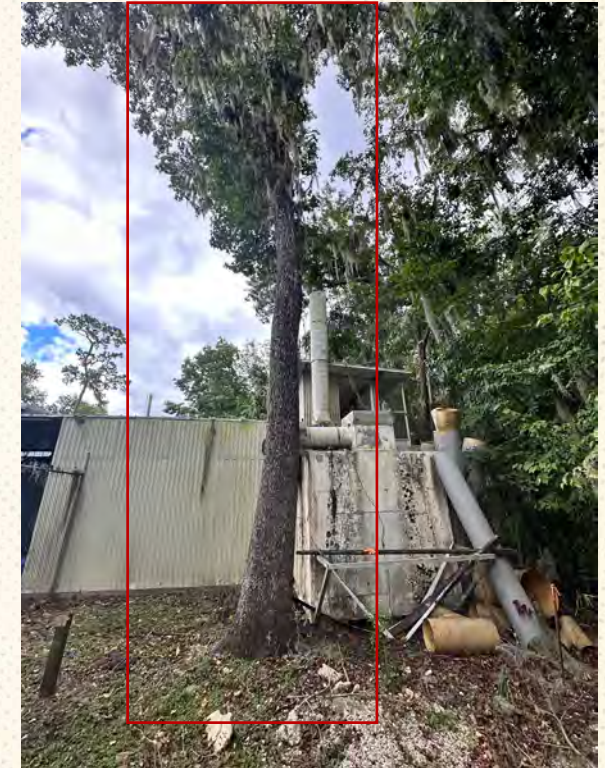
Tree Impacts

- Provide locations, summaries, photos and justifications for the proposed trees for removal. Be sure to provide species, current health of the tree and dbh. **1 tree to be removed on the SW corner between building 771 and 226, water oak, poor condition, +/- 13"**
- **No other trees to be impacted.**

Why is this the best option? **The current tree is in poor health and in a location that is causing the existing canopy to become unserviceable and a hazard.**

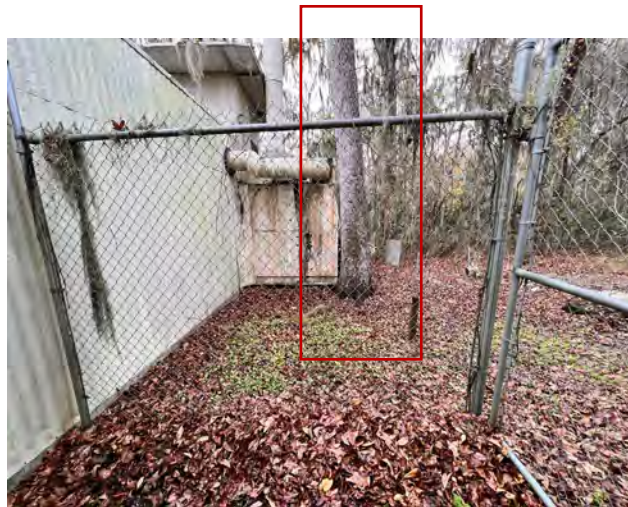
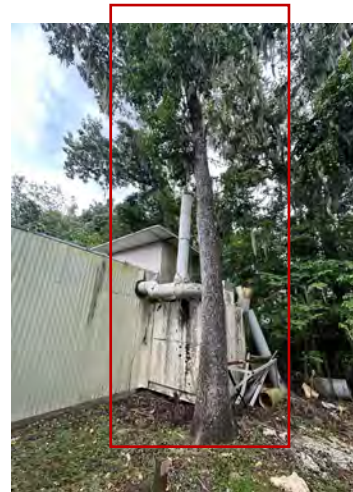
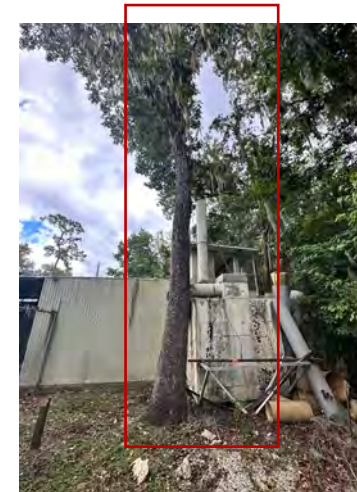
Tree Impact Summary

Will these trees be replaced on site, off site, or will the project pay into the [tree mitigation fund](#)? **The project will pay into the tree mitigation fund.**

Tree #	Species	DBH	Health	Photo
1	Water Oak	+/- 13"	Poor	1

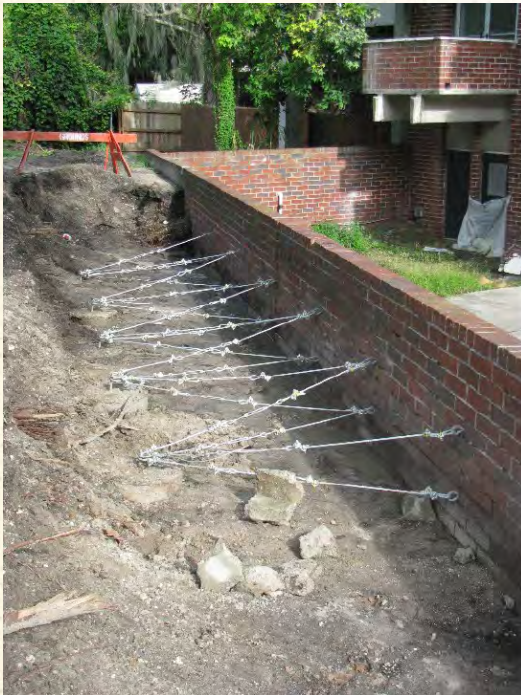
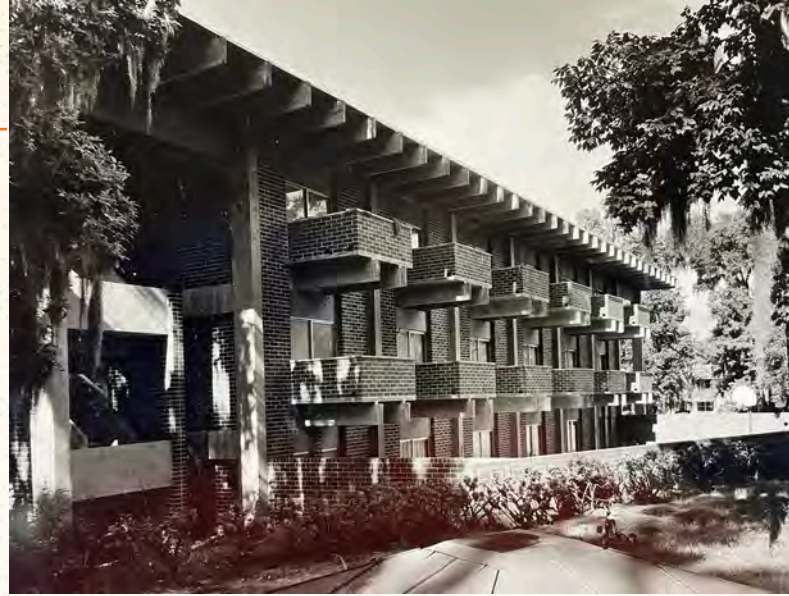
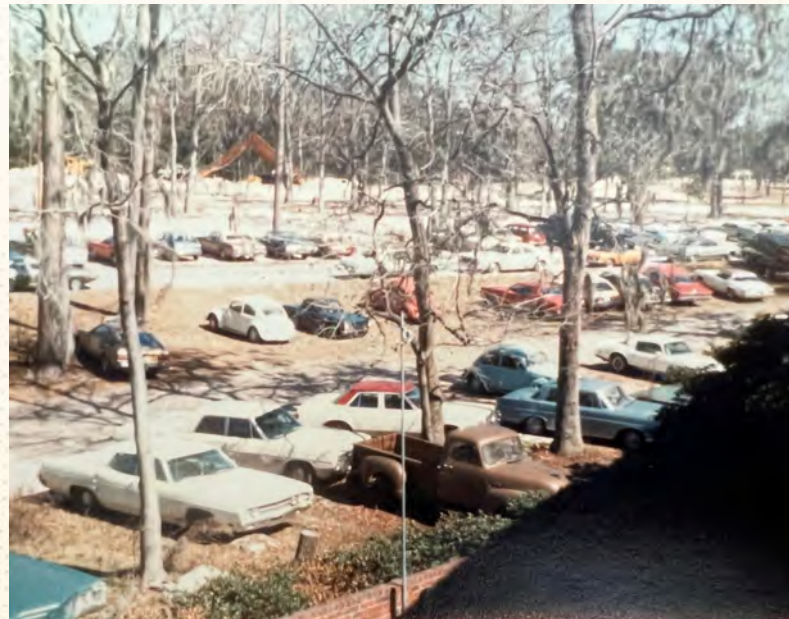
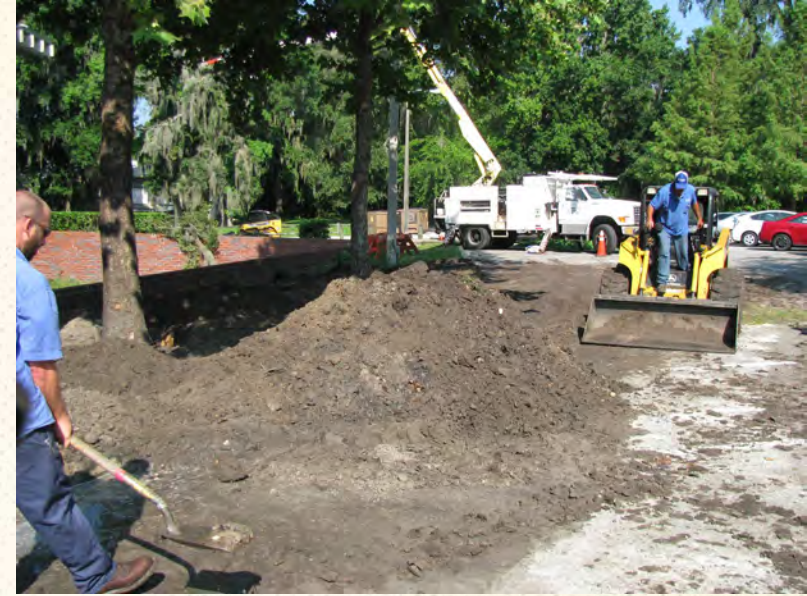
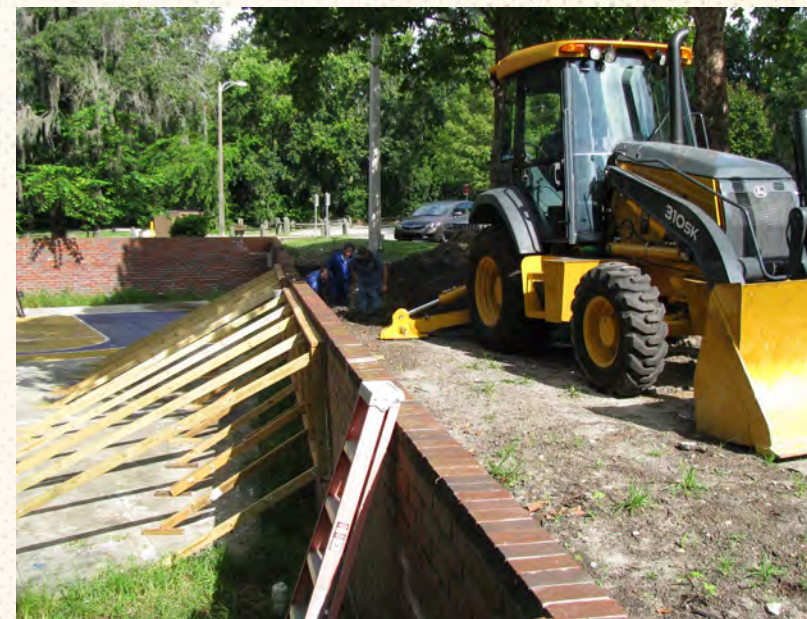
Tree Impact Summary

Root base of existing trees continue to put pressure against applicants existing privacy wall. West side of the tree's root base was constricted by the wall; however, the west side of the trees canopy extends over the applicant's property by 20 feet or greater.

Tree #	Species	DBH	Health
#1	Sycamore	18 inches	Good
#2	Sycamore	18 inches	Good

The 2 trees are somewhat mature 24' and 18' DBH and will grow considerably larger in size. Branches are already over the courtyard area dropping leaves and fruit providing continuous debris which clogs the sump. Roots are pushing on the wall which had been reinforced to avoid buckling, this will continue. Root pruning is possible but is costly and does not address the limbs above the courtyard. This would be at best a temporary solution.
