DRAFT - Lake Alice Watershed Management Plan

Prepared for
University of Florida

April 2024

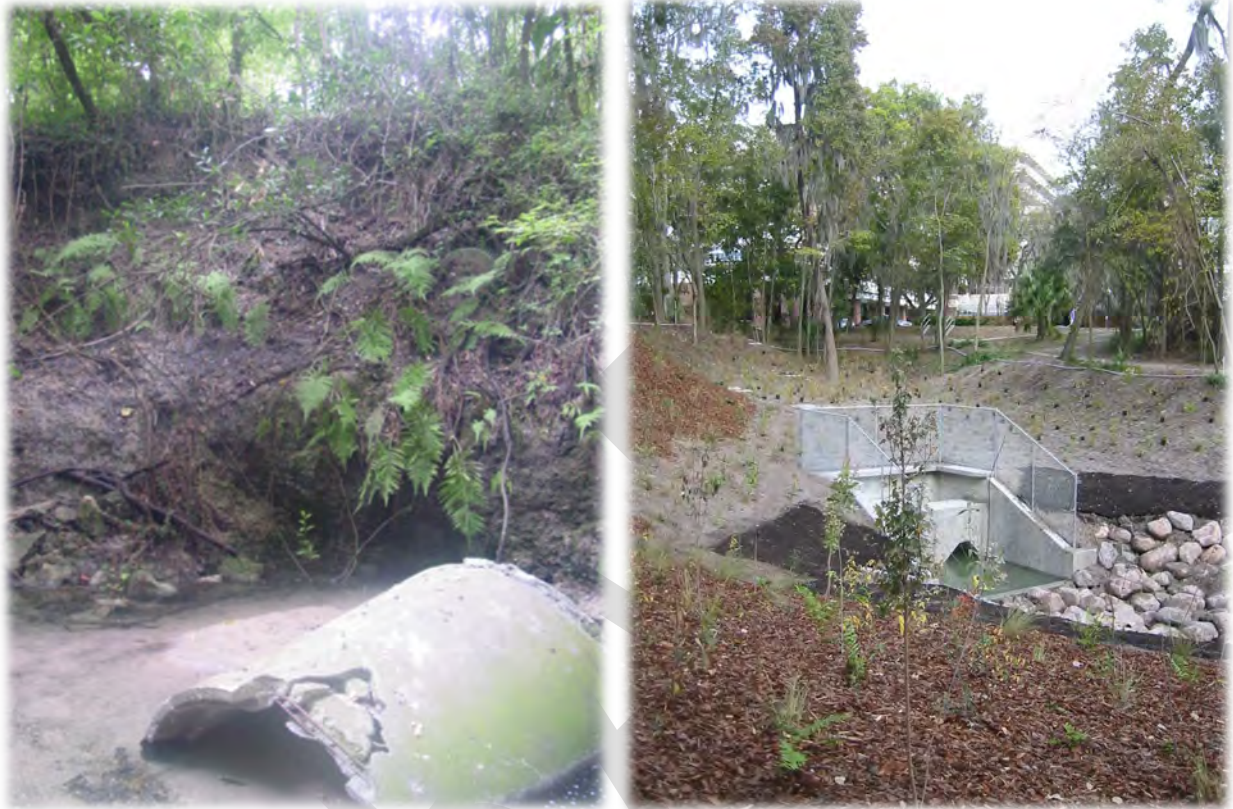
Figure 4. Reitz Ravine Repair and Stabilization Before and After

Projects identified as critical projects are needed to address failing infrastructure and life safety issues. All of the critical projects address extreme channel erosion. The University has successively completed similar repair projects in the past at Reitz Union Ravine, as shown in Figure 4, and at Diamond Creek. Critical projects were identified based on feedback from the Project Team and verified with site visits. This section discusses the problems at each location and the proposed approach to fix these areas including recommended next steps. Identified critical projects were:

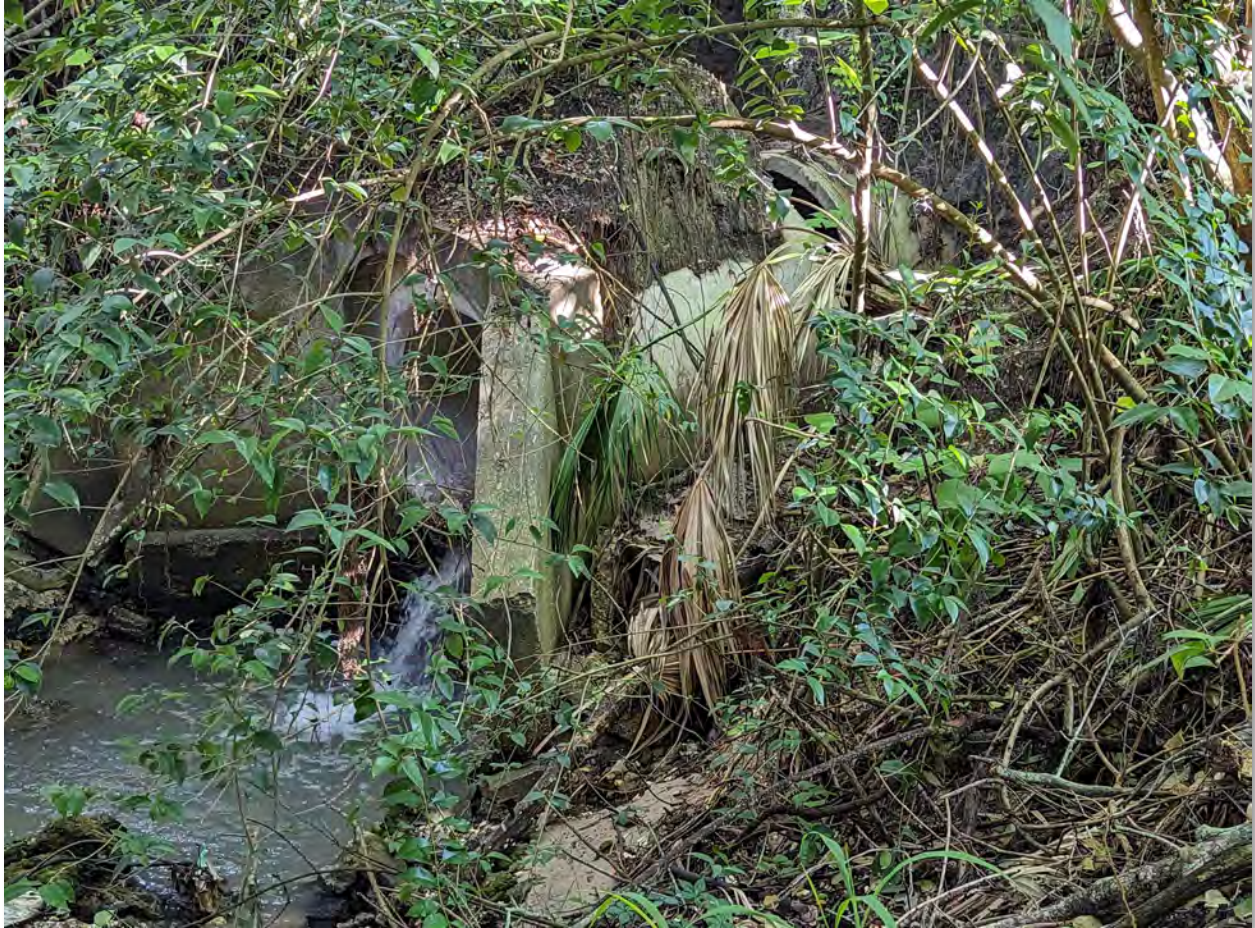
Figure 5. Jennings Creek Headwall Separation

Jennings Creek is one of the primary creeks on campus that conveys stormwater to Lake Alice. The creek begins at Yulee Pit, located just west of SW 13th Street, and flows through a 48" pipe under Museum Road, northwest of Beaty Towers. At the downstream end of the pipe under Museum Road, the headwall that supports the pipe has collapsed and created a separation in the last joint of the pipe (Figure 5). This collapse is due to the volume and velocity of stormwater moving through this pipe which falls on an unprotected creek bed and has caused the erosion of material that previously supported the headwall. During a site inspection on July 5, 2023, the pipe was evaluated using a remotely-operated camera. At that time, it was determined that no additional pipe joints were separated. Upon inspection of the channel further downstream, a failed weir stretches across the creek. This feature appears to have historically backed water up creating a pool that would have absorbed the energy coming through the Jennings Creek pipe. This weir appears to have failed due to water eroding around the weir, which resulted in bank instability and the loss of trees along the channel edge. The loss of this pool subsequently resulted in the erosion of material supporting the headwall and the current condition of the headwall.

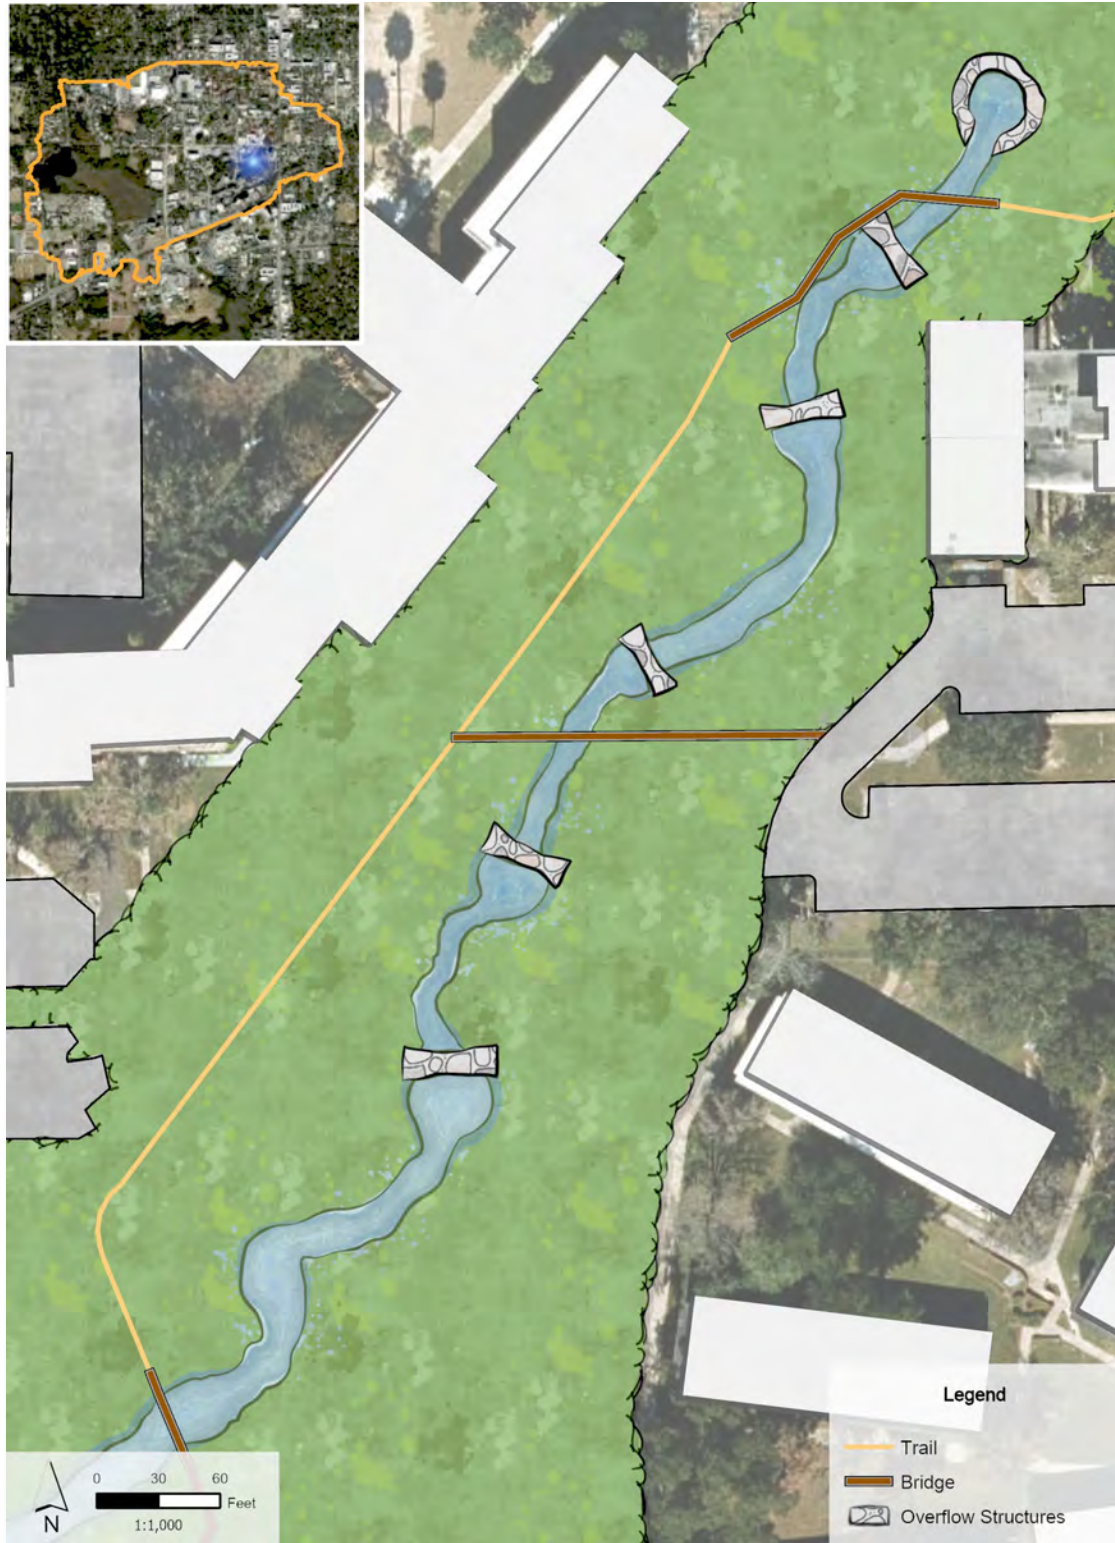
Figure 6. Jennings Creek Headwall and Step-Pool Improvements

The proposed project in this area consists of a series of step-pools with a new headwall installed on the Jennings Creek pipe. The conceptual design performs two necessary functions. The headwall replacement is necessary to allow flow through the pipe without additional upstream failure that might affect the integrity of the pipe and Museum Road. Pairing this replacement with the step-pool design will allow for energy dissipation on the downstream end of this pipe to protect the headwall and downstream channel. Rather than the rock and concrete weir that existed downstream on Jennings Creek previously, this project proposes to use sheetpile overflow structures installed perpendicular to the direction of flow and beyond the edge of channel to ensure that flows will not erode around or underneath the wall. The sheetpile will be topped with cemented stone to improve aesthetics in the installed system. The existing steep creek banks, depending on location, will be either laid back (slope decreased) or will have gabion baskets to retain the slope and to ensure bank stability. In both cases naturalized native planting will be used to increase habitat value, enhance slope stability, and improve aesthetics. The conceptual layout for this feature is shown in Figure 6. The figure includes the conceptual layout for the trails as shown in the Campus Trails Master Plan. The northern-most trail may need to be revised to ensure the trail supports do not increase scour at the toe of the west creek bank.

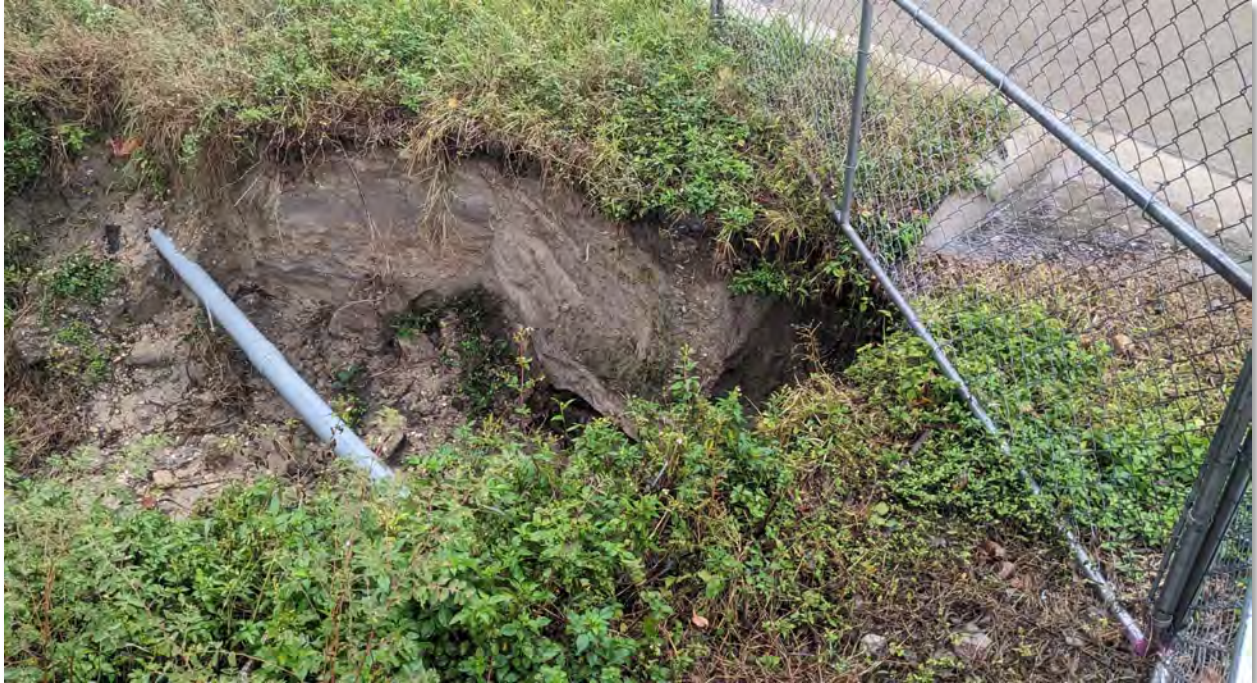
Figure 7. Keys Complex Erosion

Of the 15 pipes known pipes that enter Graham woods, all of them terminate upslope of the channel, and nearly all of them terminate outside of the jurisdictional wetland. This configuration has resulted in substantial erosion and bank instability on the perimeter of Graham Woods. At the northwest corner of Graham Woods, stormwater that bypasses inlets along Stadium Road is directed through a curb cut along the Keys Complex maintenance drive and into a vegetated area along Graham Woods. With the construction of the Heavener Football Complex and Student Health Care Center north of Stadium Road, additional stormwater was routed to this location which has resulted in an erosive channel forming along this surface drainage feature. Following initial channel formation, subsequent storms have contributed to additional erosion resulting in a vertical-walled channel approximately six feet deep that extended all the way back to the Keys Complex Drive (Figure 7). This feature exposed a communications conduit and was beginning to undermine the curb cut. Facilities Services used aggregate to form a temporary repair to reduce the potential for additional damage near the driveway.

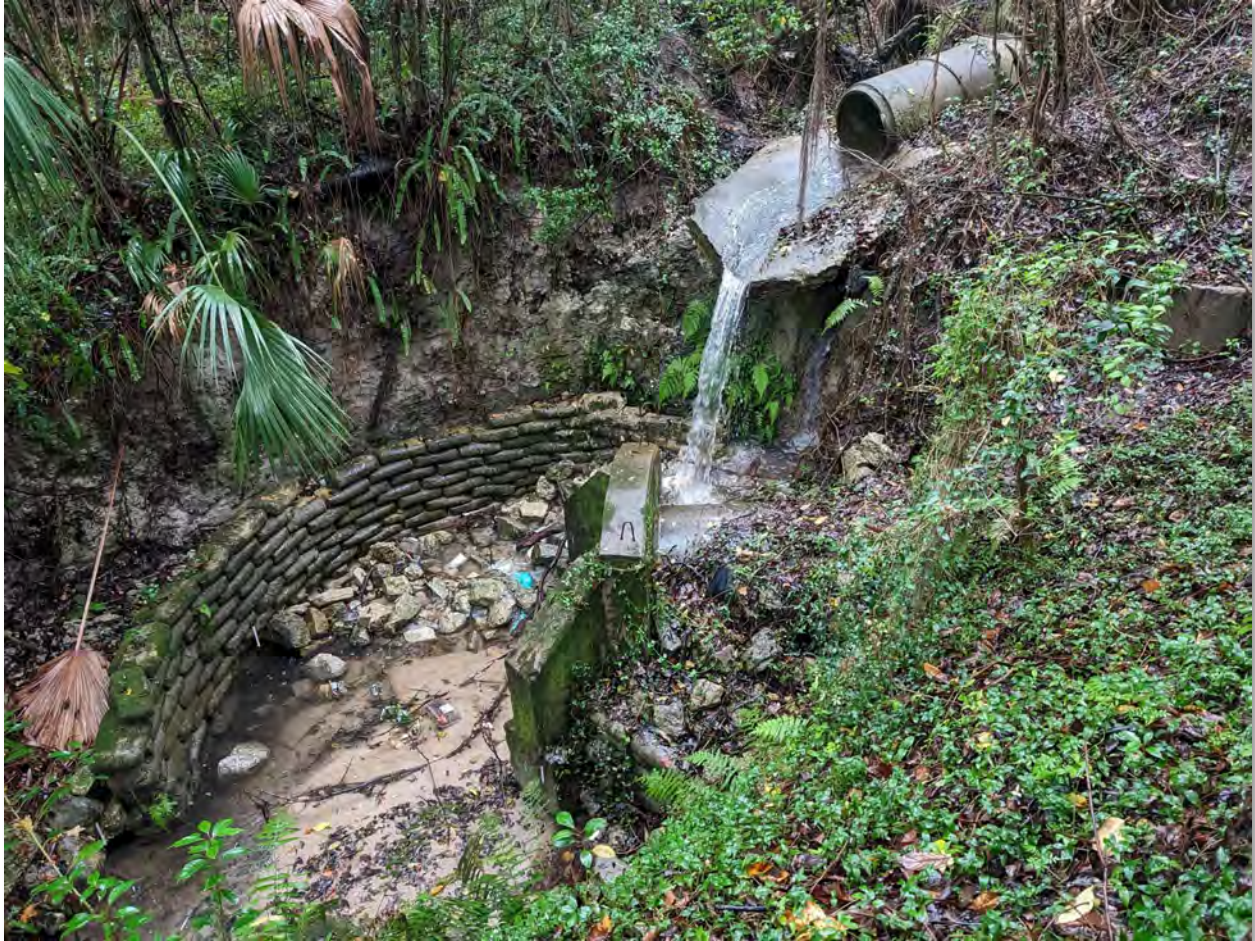
Figure 8. Graham Woods Erosion and Pipe Outlets

The resulting channel continues into Graham Woods and has resulted in the loss of soil supporting large trees within the Conservation Area and caused their collapse. The termination of this erosive feature is a deep stormwater feature with a sand-cement riprap wall and two additional pipe outlets (Figure 8). At this location the higher elevation pipe outlet is collapsing into the deep feature and there are apparent bank stability issues due to the near vertical sides of the stormwater feature. While temporary fencing has been installed to reduce access, the fence has been repeatedly damaged by people to allow access.

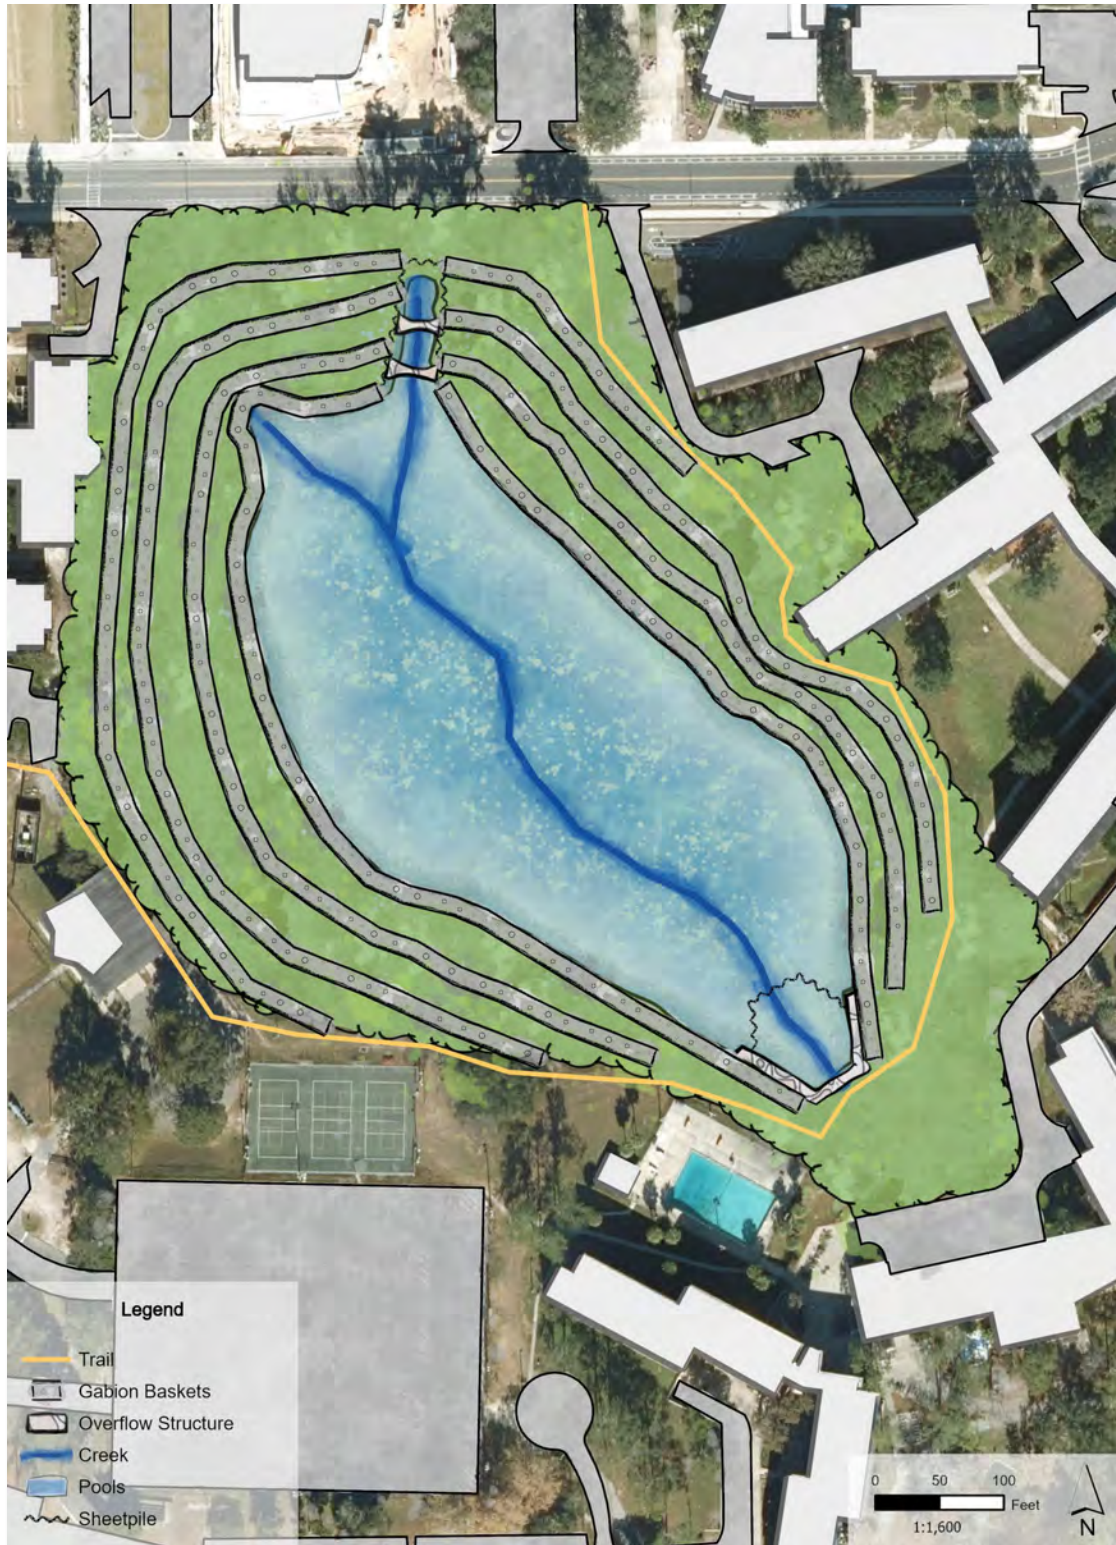
Figure 9. Graham Woods Stabilization and Stormwater Basin

The proposed project in this area includes construction of one or more grade control structures in the bottom channel. Concrete structures, such as baffled end walls and riprap aprons will provide energy dissipation for stormwater inflows and will provide erosion protection for the various stormwater pipes that currently discharge into Graham Woods. To reduce erosion along the edges of Graham Woods, the side slopes will be recontoured and strategically hardened with gabion baskets, stormwater pipes will be extended with inverts lowered to enter the bottom of Graham Woods, and native vegetation will be installed to secure soils. Native plantings will also be used to restore habitat value and to improve aesthetics and recreational opportunities. To address upstream stormwater inflows, inlets along Stadium Road will be milled to capture flow more effectively, and a new stormwater inlet and pipe will be considered along the Keys Complex driveway to route flows into one of the existing stormwater inflow pipes rather than overland. Ideally the proposed project will also re-route the stormwater conveyance around, rather than under Graham Hall. The proposed concept for Graham Woods is shown in Figure 9.

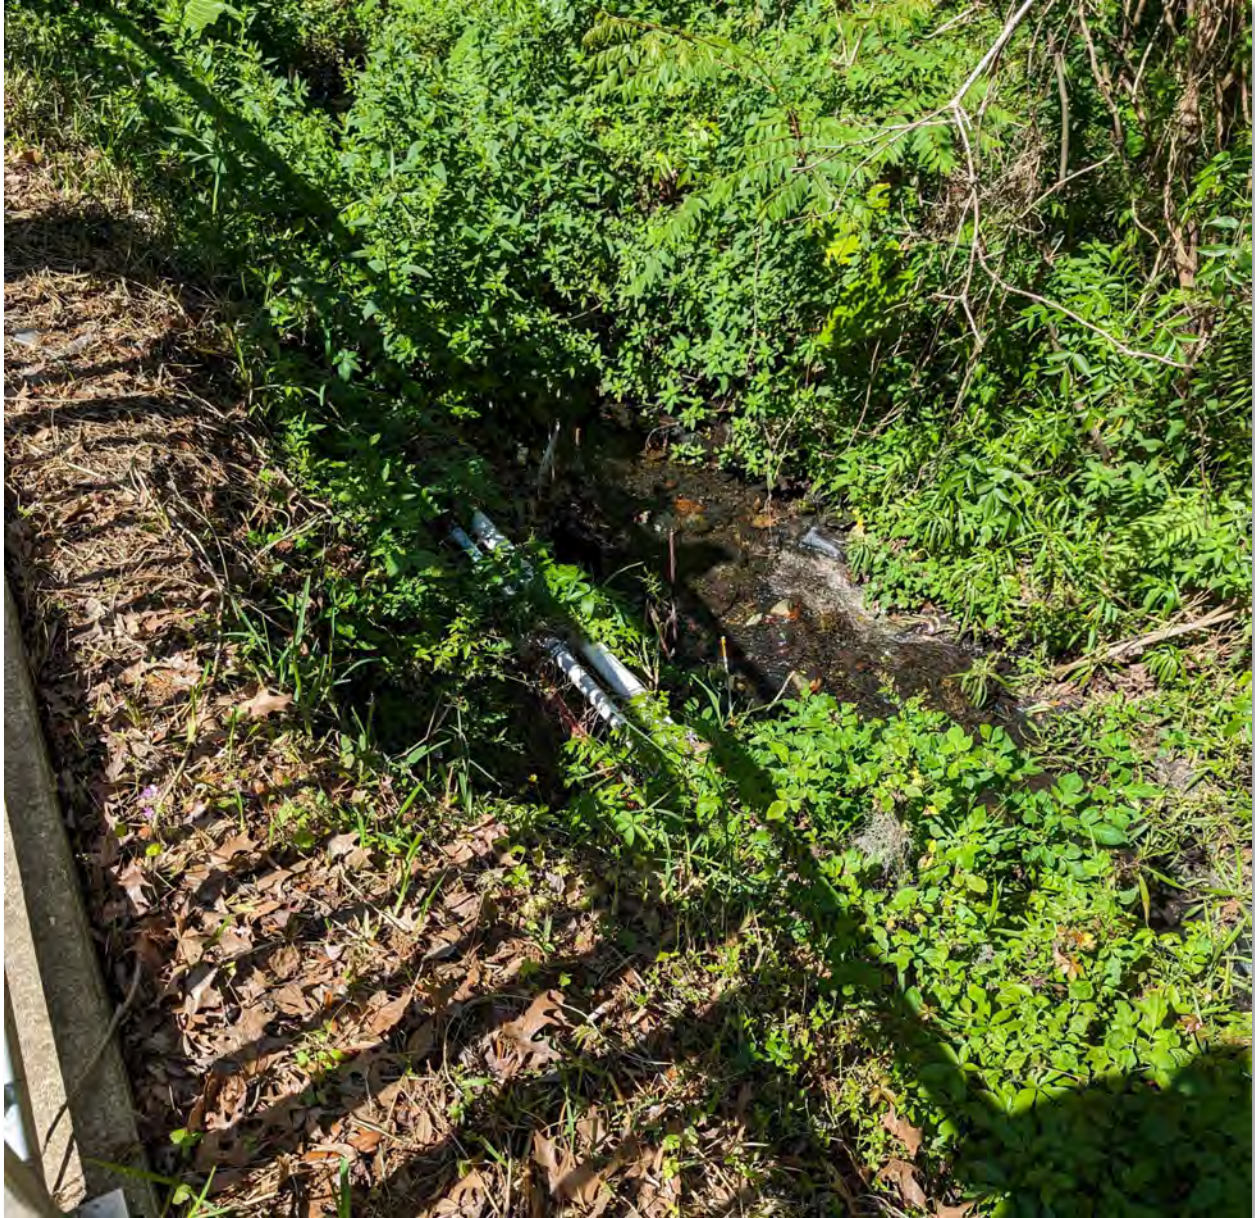
Figure 10. Lake Alice Creek Along McKnight Brain Institute Sidewalk

The McKnight Brain Institute is located downstream of the confluence of Jennings and Diamond Creeks. In this location the sidewalk was constructed into the wetland that buffered the creek channel. The earthen embankment next to the sidewalk was constructed at a steep bank and included utilities between the sidewalk and the creek. The creek has eroded the toe of slope due to sheer stress, and changes in the flow characteristics of the system. This has resulted in flows being directed toward the edge of the sidewalk which has exposed utility conduits (Figure 10). This erosion risks undermining the existing sidewalk, and if it migrates further, a road and loading dock may be impacted.

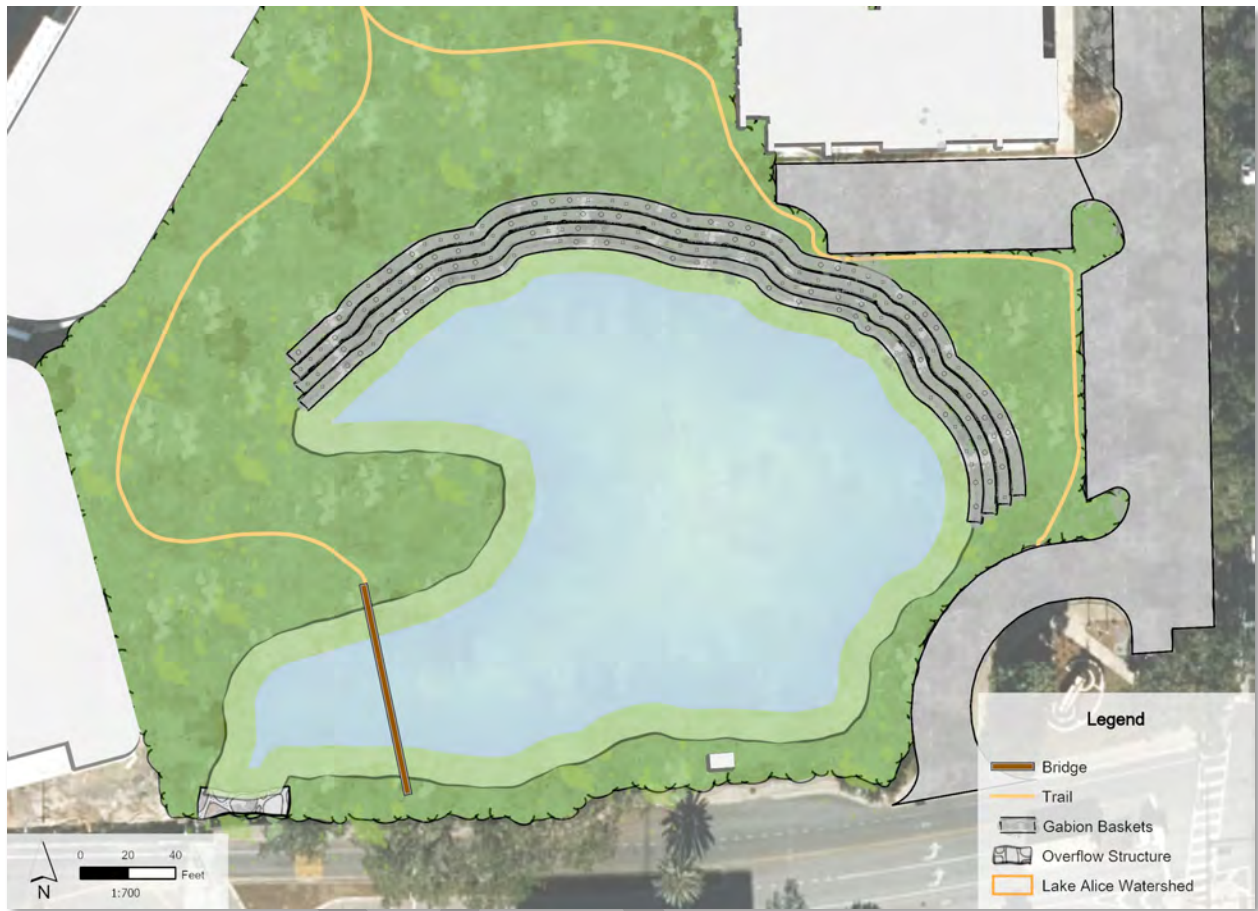
Figure 12. Yulee Stormwater Park

The recommended project at this location is a stormwater park that includes an open-water feature, fountain/aerator, littoral fringe, stabilized slopes, and human use features. Development of this feature will serve four primary purposes: increasing storage in the headwaters of Jennings Creek, dissipating energy associated with new multi-story development, improving water quality, and creating an inviting and accessible gateway to UF. This feature was conceptualized as a stormwater amphitheater with slopes stabilized and landscaped to provide a functional outdoor space for recreation, relaxation, and outdoor learning. Trails would be developed to connect adjacent buildings efficiently, but with overlooks of the park-like setting. The concept developed for this location is shown in Figure 12.

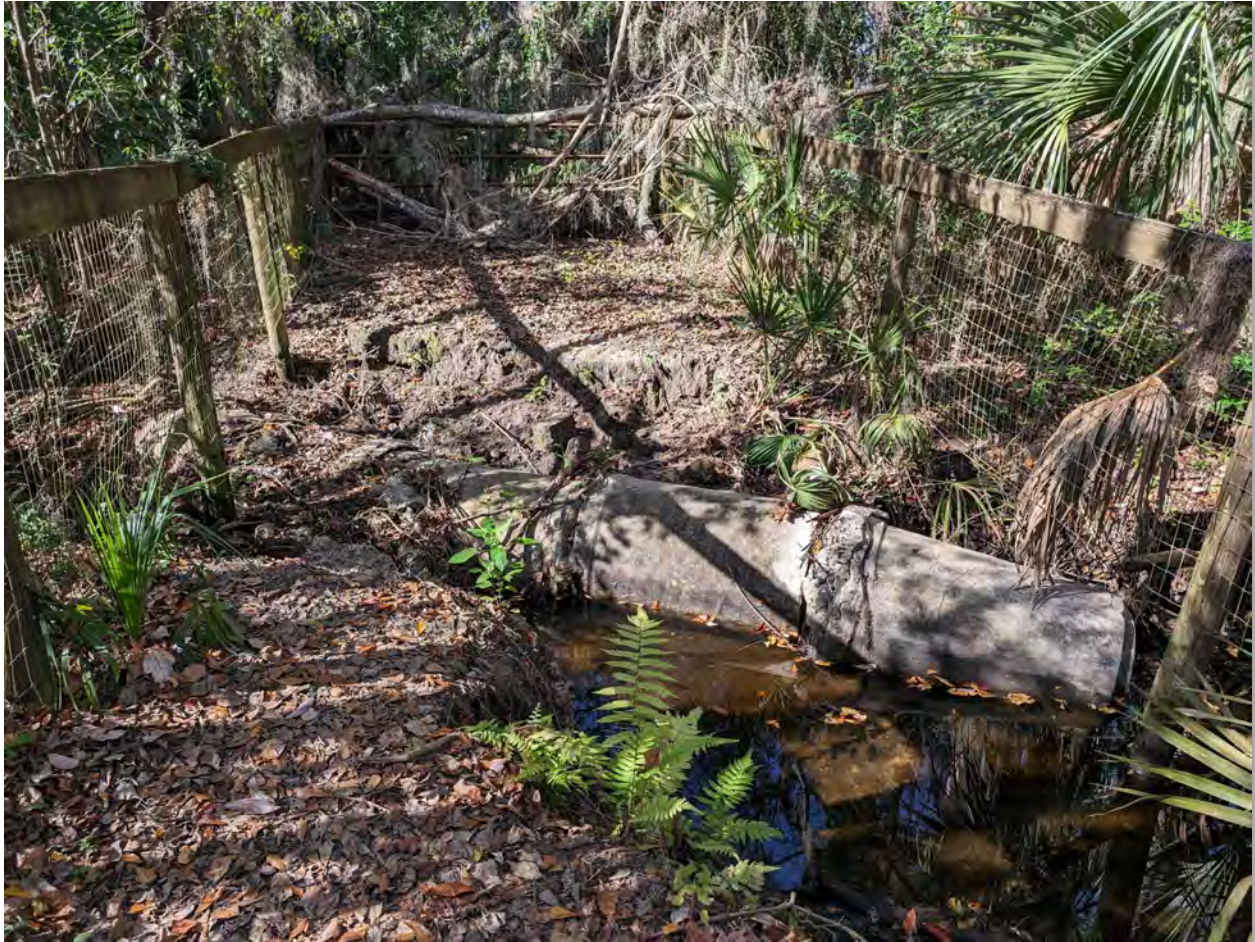
Figure 13. Washed-Out Dirt Road in Lake Alice South Conservation Area

The proposed project in this area is installation of a trash trap downstream of Archer Road and an expansion of the wetland to include upland and grassed areas downstream of a former culvert and road crossing that has eroded and failed (Figure 13). Installation of a trash trap will provide capture of much of the trash that currently migrates to Lake Alice and will facilitate efficient collection and disposal of the accumulated material. Given that this trash is generated from Archer Road, discussions should be initiated with FDOT to install and maintain this system. Repair of the existing creek crossing and expansion of the

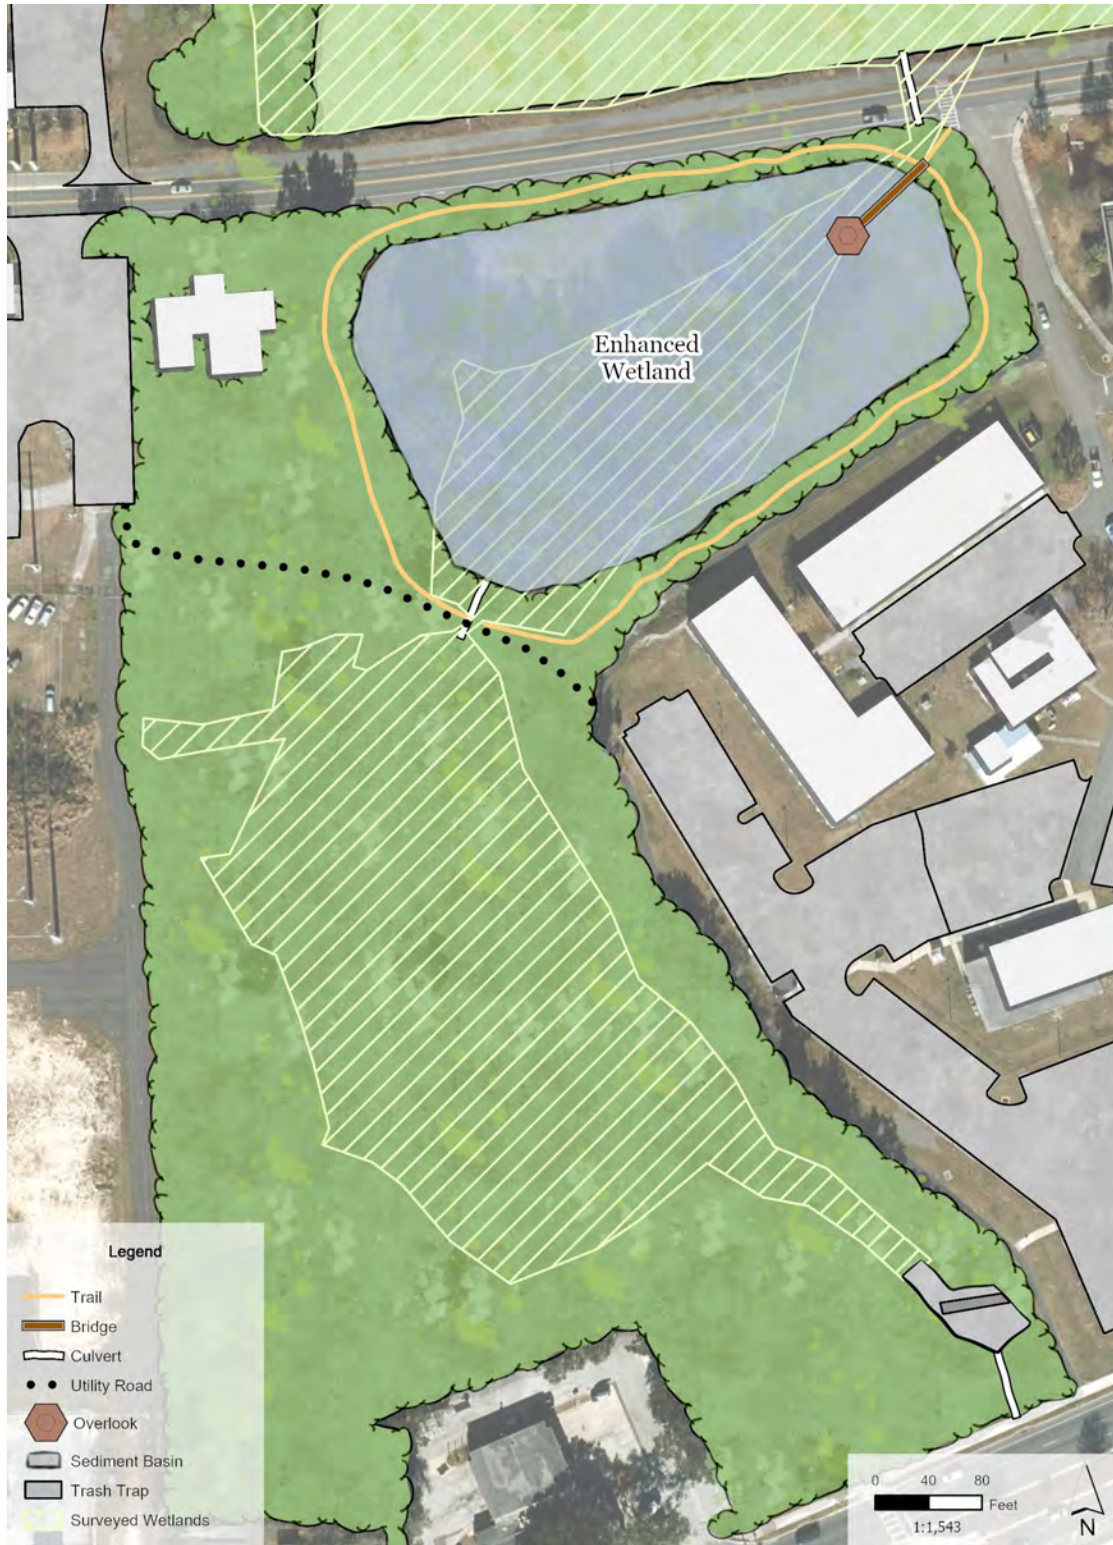
Figure 14. Lake Alice South Stormwater Wetland

wetland will provide several benefits to the watershed and Lake Alice. These include improved water quality, increased stormwater storage, and creation of a passive use wetland park and recreational amenity in the southern portion of campus. The proposed layout in this location is shown in Figure 14.

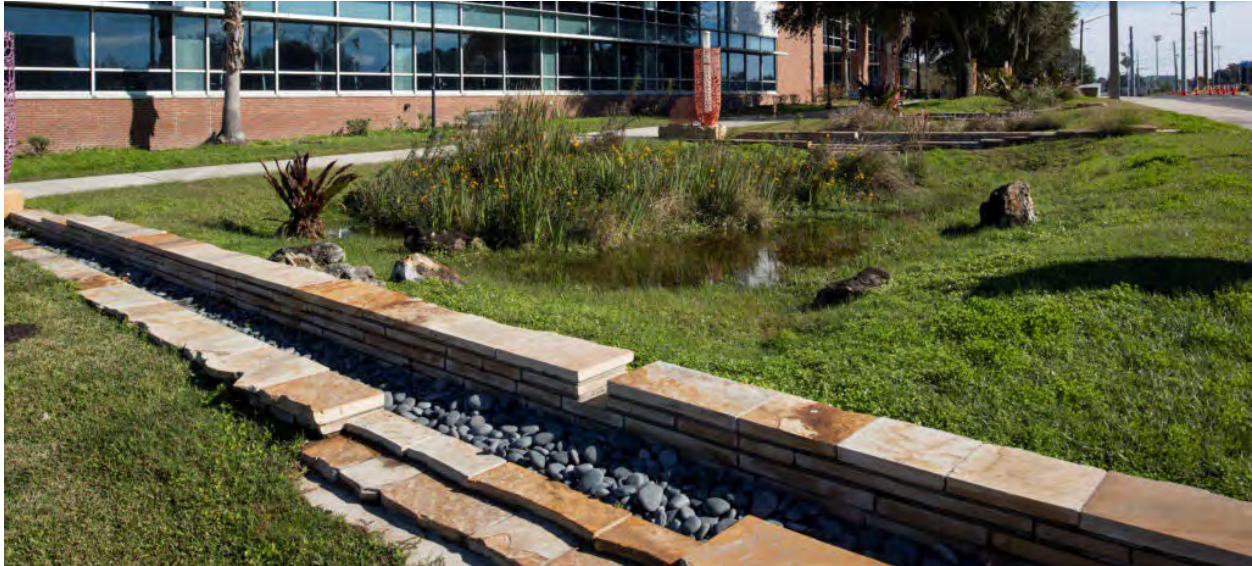
Figure 15. UF Southwest Recreation Center Rain Garden (The Nature Conservancy, n.d.)

The University of Florida is a highly developed campus that includes buildings and infrastructure constructed over more than 100 years. Because of the high intensity of development on campus, opportunities for implementing large stormwater projects are limited to either natural areas, un-built areas of campus, or within the footprint of structures that are to be demolished. Despite the lack of opportunities for developing large projects there are numerous opportunities to install smaller, low impact development (LID)/green stormwater infrastructure (GSI) projects on campus. These features offer the opportunity for dispersed stormwater management that can be implemented to provide treatment, reduce runoff volumes, and reduce peak flows. The University had a LID manual developed in 2010 (Causseaux, Hewett & Walpole, Inc., 2010). This manual offers recommendations on a wide variety of LID opportunities and recommendations on implementing these features on campus.

Available forms of LID/GSI that would be optimal for developed areas of campus include bioretention, rain gardens, vegetated swales, curb cuts with recessed median storage, and permeable pavement. The Southwest Recreation Center has a rain garden, as shown in Figure 14. Many of these practices can be incorporated in the existing landscape through minor changes to grade, slopes, and small structural modifications. As an example, the surface parking lot at the O'Connell Center currently includes vegetated swales and curb cuts. However, the structures that convey this water into the stormwater network are at or near grade, meaning that minimal water is stored in these features before discharge. By modifying these structures to increase the grate elevation with incorporation of a lower elevation orifice these features could be designed to provide storage while still draining back to the bottom of the swale within 48-72 hours. Another opportunity available in many locations on campus are vegetated landscaped beds that are often bordered by brick edging or seat-walls. These areas could be re-designed to have grades lowered with curb cuts to allow for water to enter these areas during storms with water either infiltrating or being under-drained into the stormwater network in a more controlled fashion.
