# Attachment A – Lake Alice Watershed – History and Literature Review

Prepared for  
University of Florida

August 2024

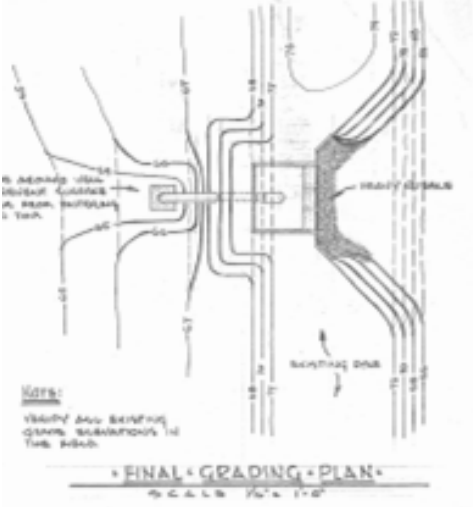
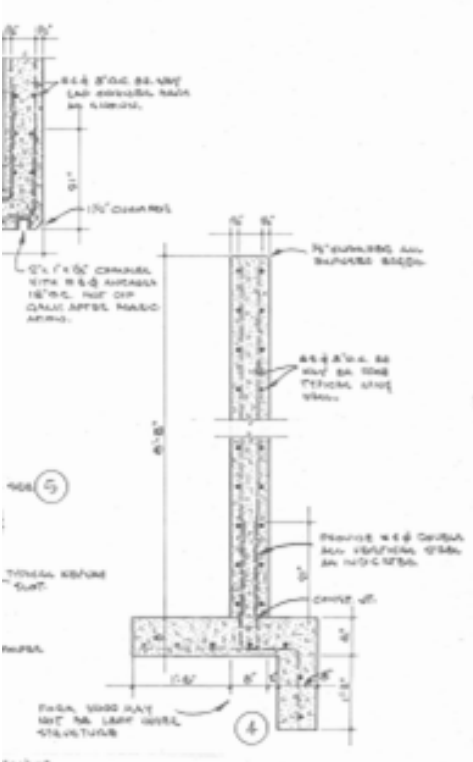
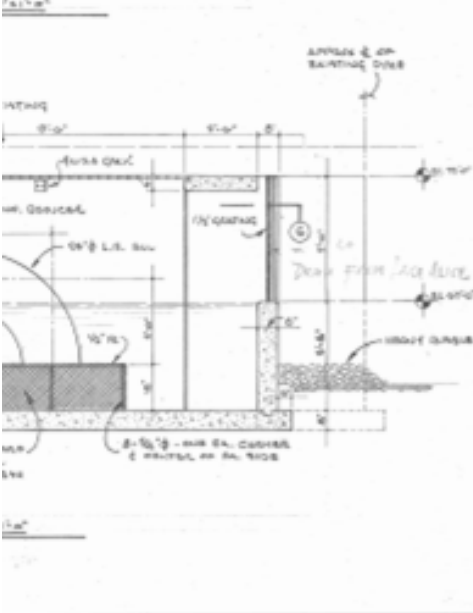
PLANS & DETAILS		
LAKE ALICE RECHARGE WELLS		
UNIVERSITY OF FLORIDA GAINESVILLE, FLORIDA		
DESIGNED BY GUY C. FULTON, A. I. A.	CHECKED BY JEFFERSON M. HARTON, A. I. A.	JOB NO. 470
DATE JAN 2, 1959	DATE JAN 5, 1959	SHEET NO. 1
GUY C. FULTON, A. I. A. ARCHITECT TO THE BOARD OF CONTROL BUILDING 'F' UNIVERSITY OF FLORIDA GAINESVILLE FLORIDA		
JEFFERSON M. HARTON, A. I. A. CONSULTANT TO THE UNIVERSITY OF FLORIDA

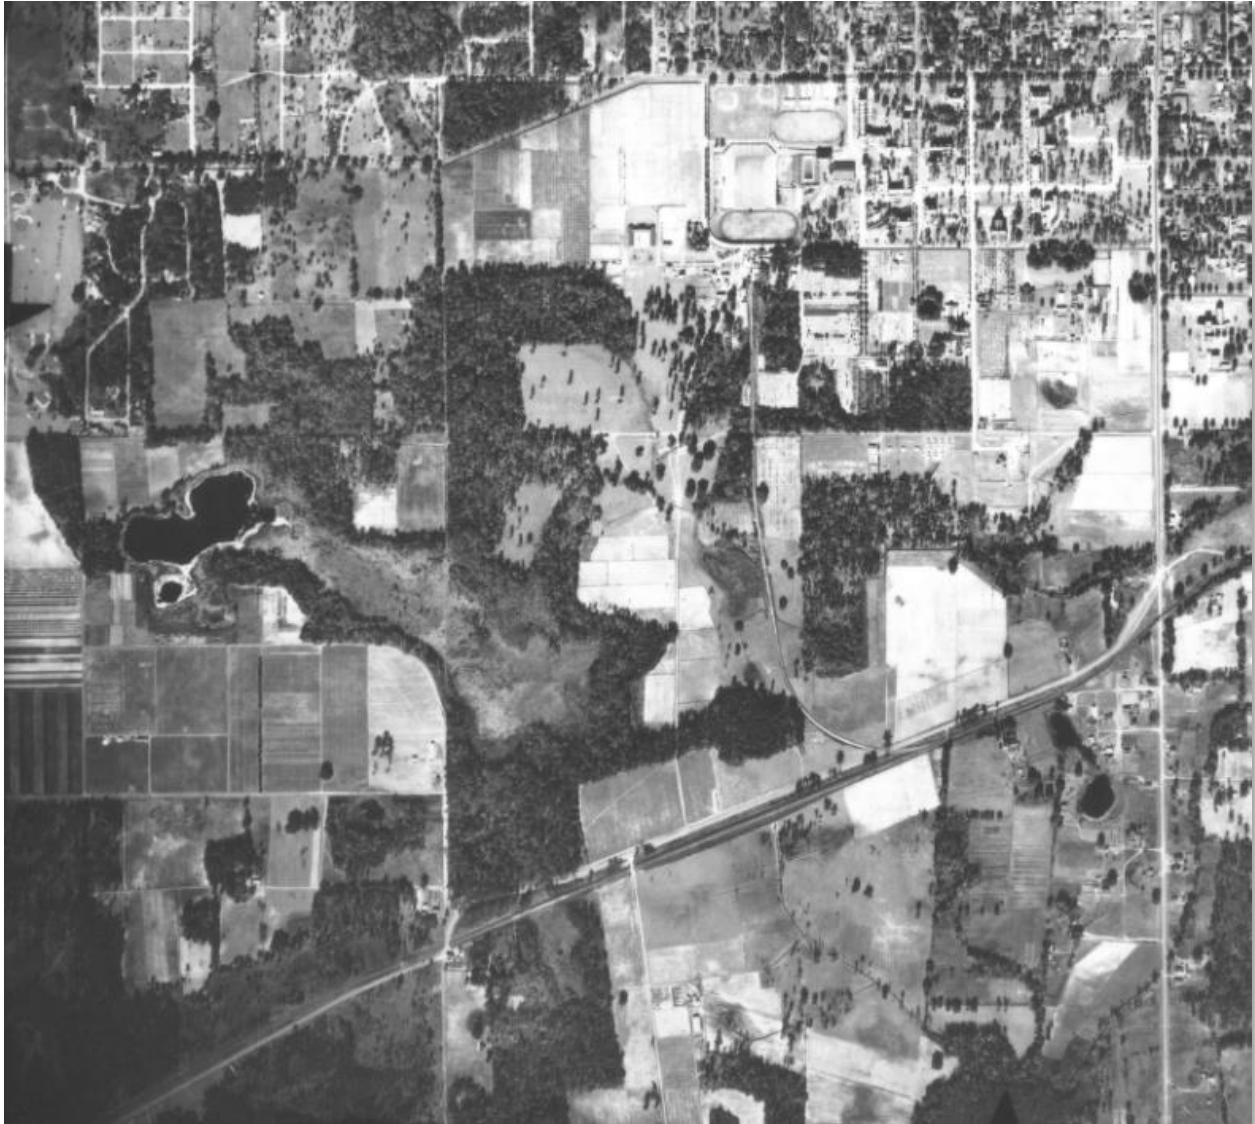
**Figure 3. 1938 Aerial Image**

The earliest aerial imagery digitally available from the UF map library is from 1938 (Figure 3). The imagery shows some things that look familiar, like the roads that bound UF: SW 34<sup>th</sup> Street, SW 2<sup>nd</sup> Avenue, University Avenue, NW 13<sup>th</sup> Street, and Acher Road. The “old” part of campus near University Avenue & SW 13<sup>th</sup> Street is clearly visible. The roads that will become Museum Road, Stadium Road, and Newell Drive are also visible as are McCarty Woods, Bartram-Carr Woods, Harmonic Woods and Graham Woods. The narrow, wooded stream corridors for Jennings Creek and Diamond Creek are visible. At the north end of Jennings Creek are two wetlands that have ditches cut through them to drain to Jennings Creek. The first of these is Yulee Pit and the second appears to have been in the footprint of the current Honors Village and Broward Hall.

Lake Alice appears as a small, 9.5-acre, open water lake with a larger wetland complex to the east. There is also a well-defined round sinkhole with open water to the south, and a second, less-open sinkhole to the southeast of the first sinkhole. The south side of the wetlands is bounded by a dense stand of trees.

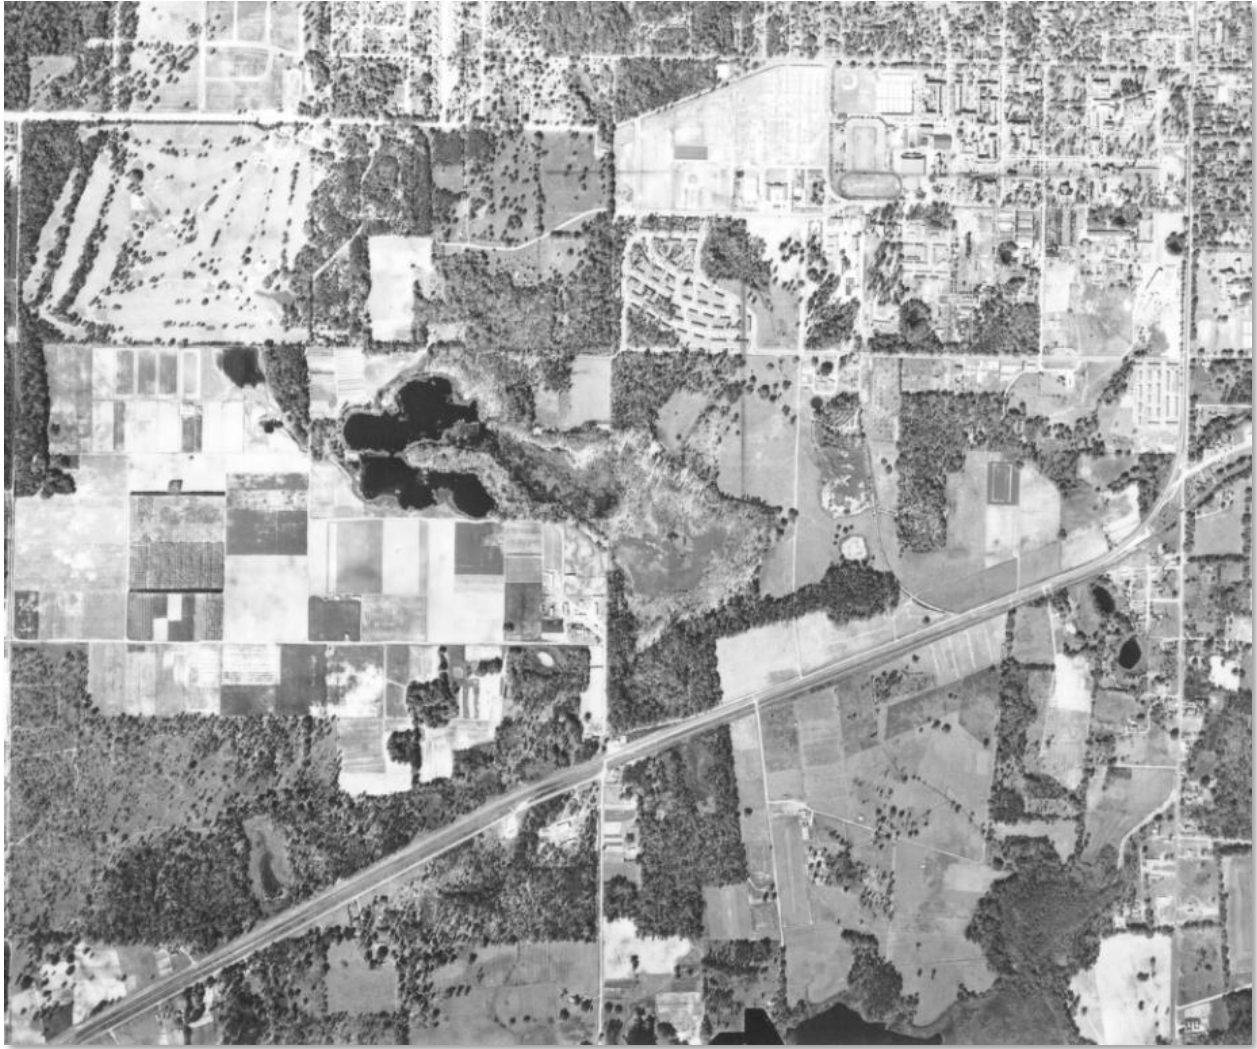
**Figure 4. 1949 Aerial Image**

The woods along the north side of the Lake and Wetlands as well as the woods that were the south edge of the Lake in 1937, but are now a middle peninsula, show some signs of damage in a northeast, southwest line. That may be mechanical clearing or possibly wind damage from a storm.

At the north end of Jennings Creek there is a ditch constructed to drain the wetland under what will become the Honors Dorms. Jennings Creek and Diamond Creek join, flow through Bartram-Carr Woods and into a sink, just barely visible through the trees.

McCarty Woods has been thinned enough that the "karst window" known as Liberty (fka Green) Pond is visible as are the karst features known as Ocala Pond, Gator Pond, Dairy Pond, and the Digital Design Wetlands. The stream from the Digital Design Wetlands, shown on the 1890s survey, is not visible on the aerial. At the north end of the Digital Design Wetlands is a dark, round circle which is the Trickling Filter for the wastewater treatment plant. In the 1940s, effluent from the wastewater treatment plant was routed to the Digital Design Wetlands where it drained to a karst feature known as Sweet Sink. Jennings and Diamond Creek may also be connected to this sink by an apparent defined channel connecting the Digital Design Wetlands to Bartam-Carr Woods. Graham Woods also appears to drain to a small creek that flows into the Digital Design Wetlands.

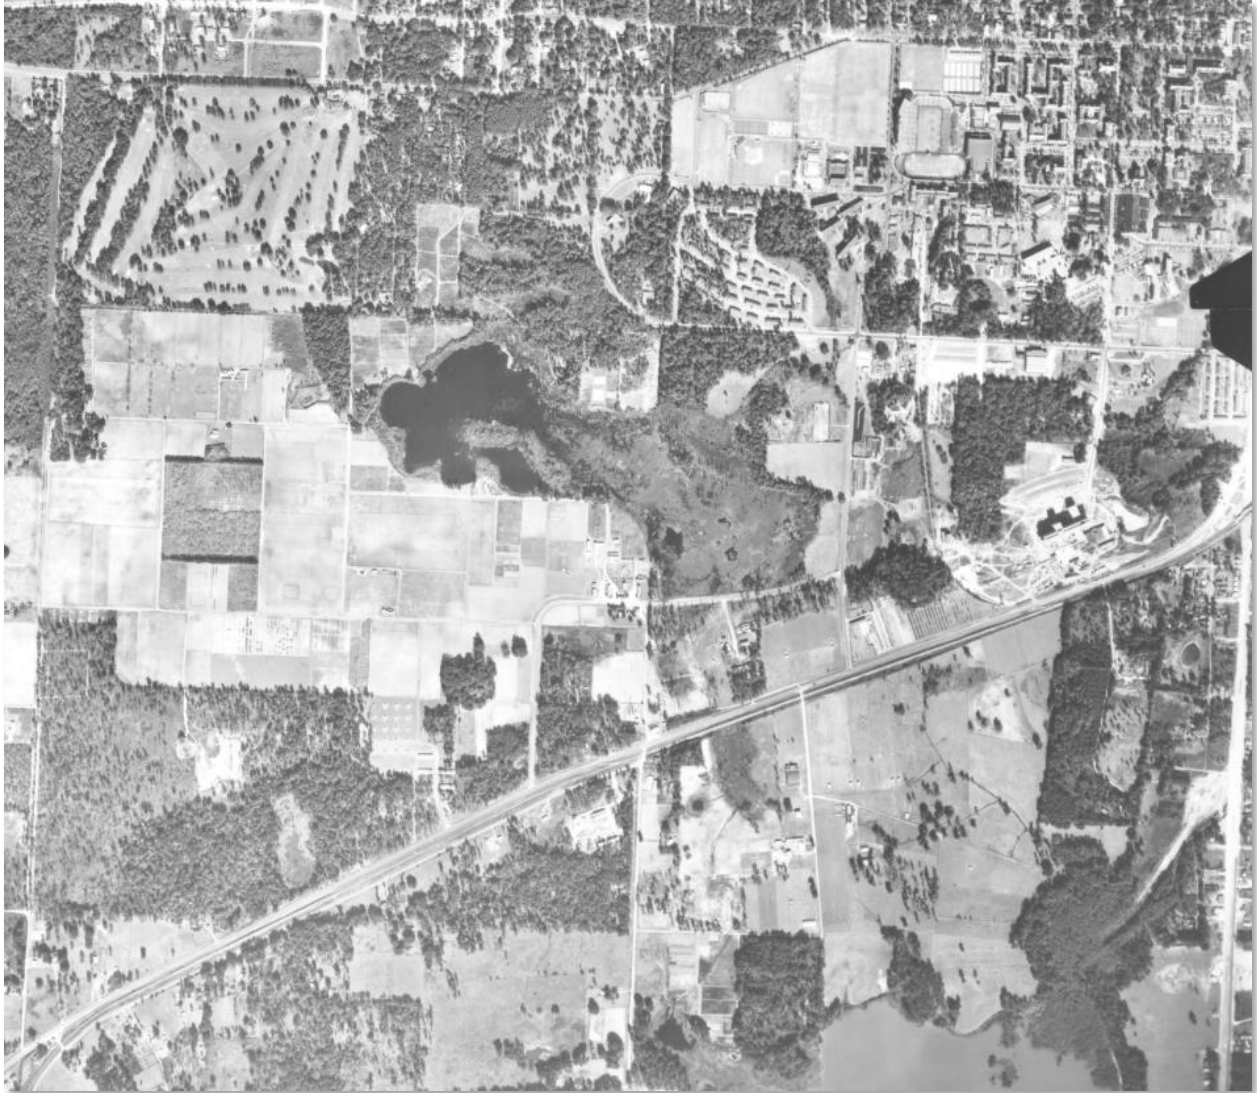
**Exhibit 1. 1956 Aerial Image**

The wastewater plant now includes an oxidation ditch and sludge drying beds, with effluent still routed to Sweet Sink. Roads are visible around the sink's boundary.

Museum Road and Gale Lemerand Drive (formerly North-South Drive) have been improved, as has Graham Pond. Drainage from Graham Woods to the north has been redirected to Lake Alice, which has expanded southward, flooding areas across Museum Road and the east end of Radio Road.

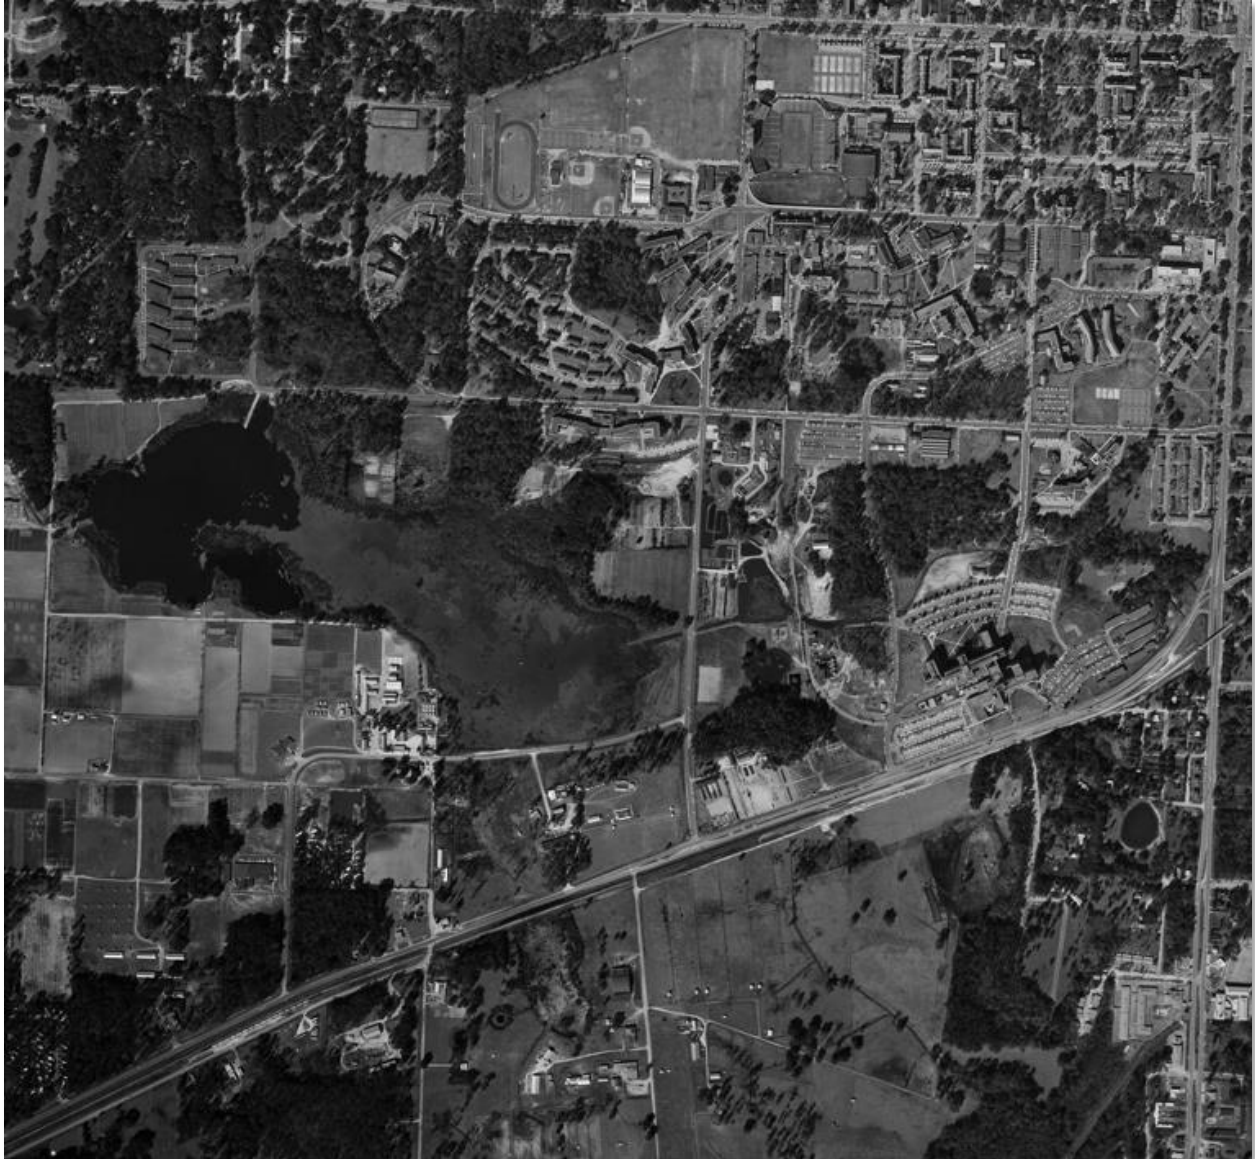
**Figure 6. 1964 Aerial Image**

The sloped stream that flowed into Lake Alice from the north on the 1890s map is no longer visible. In its place is a steeply sloped depression surrounded by Fraternity Drive, and presumably an underground pipe.

The newly constructed Graham Pond is visible to the south of Graham Hall and to the north of Museum Road. The stream that flowed out of Graham Woods on the 1957 Aerial is also not shown. In its place is a depression with steep banks on the north side, and a building with a pipe presumably flowing under it on the south side.

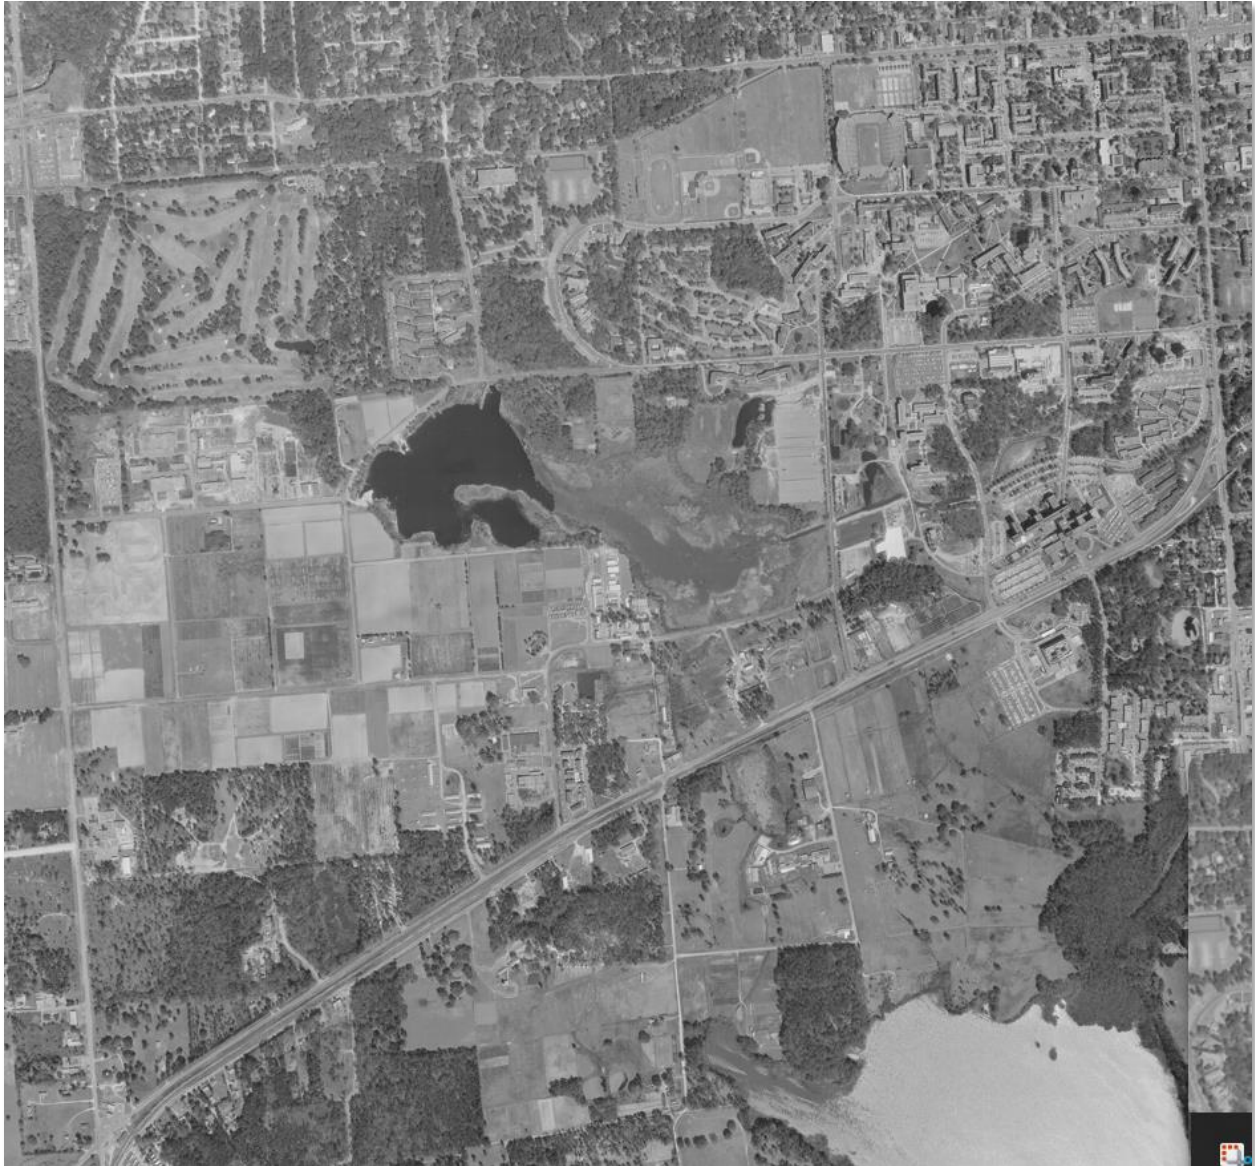
**Figure 8. 1971 Aerial Image**

In the late 1960s and early 1970s the nutrient content of the wastewater effluent to the lake contributed to massive growth of water hyacinth that covered Lake Alice. Draglines were used to mechanically remove much of the hyacinth from the lake in the 1970s. A fence was also used to prevent the hyacinth from entering the open water portion of the lake as seen in the 1971 aerial (Figure 8).

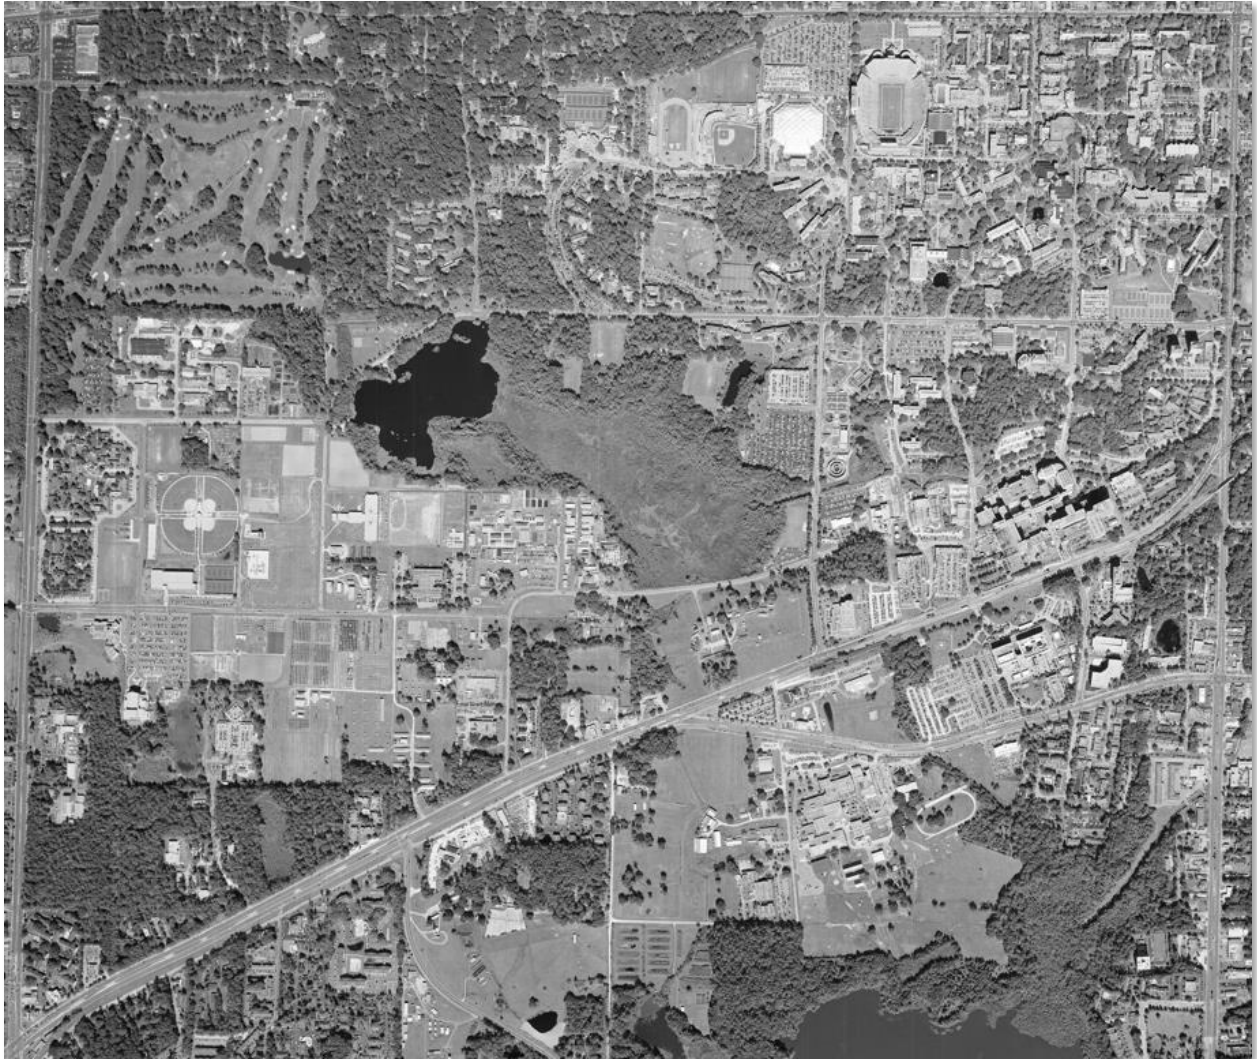
**Figure 9. 1994 Aerial Image**

As of 1994 (Figure 9) campus has developed more in the southwestern areas of the University with sports fields, structures, parking, and new IFAS facilities. Lake Alice now has a vegetated eastern edge that is similar to today. There has also been significant expansion of forest around the lake, Hume Pond, and other Conservation Areas. Additional development within the Lake Alice Watershed includes the

O'Connell Center, an expansion of the stadium, the old baseball field, the track, and significant new parking lots. Additionally, the health science and hospital facilities have expanded to include additional structures and parking.

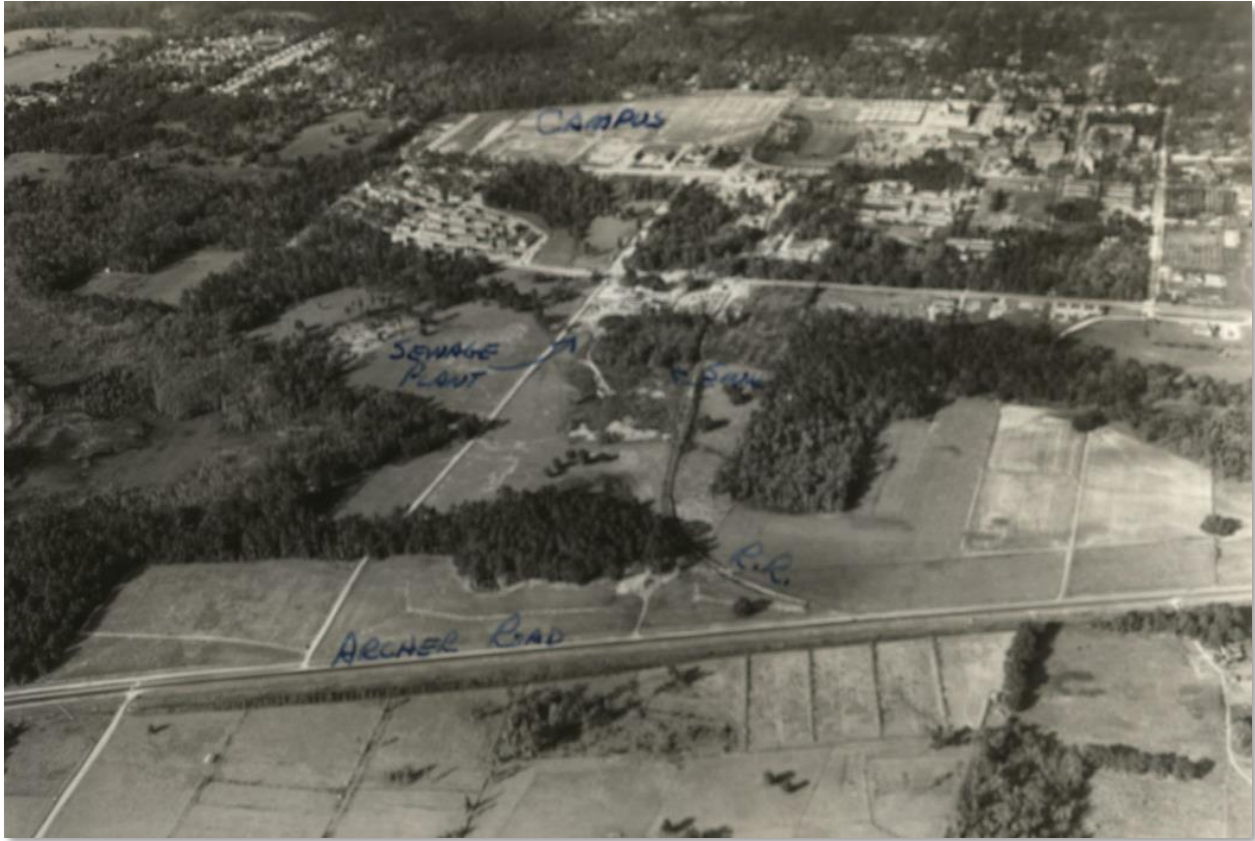
**Figure 10. 1947 Aerial Showing Sewage Plant, Railroad Spur, and Sinkhole Drainage Feature**

The reports discussion of the original, pre-developed drainage system states: *“Drainage areas marked II to VIII, inclusive, drained directly into a pond near the University Spur Railroad in the vicinity of the sewage plant, (t)hence into a crevice in the limestone – labeled Sink Hole. Areas marked IX and X drained into the pond known as Lake Alice and, when the water level reached approximately elevation 65, overflowed through a creek channel into the same sink hole.”* Discussion of other subbasin drainage suggested that the sinkhole near the spur railroad, south of the WWTF was the original stormwater drainage for about 537 acres of campus. An aerial view of this area from 1947 shows the features in this area (Figure 10).

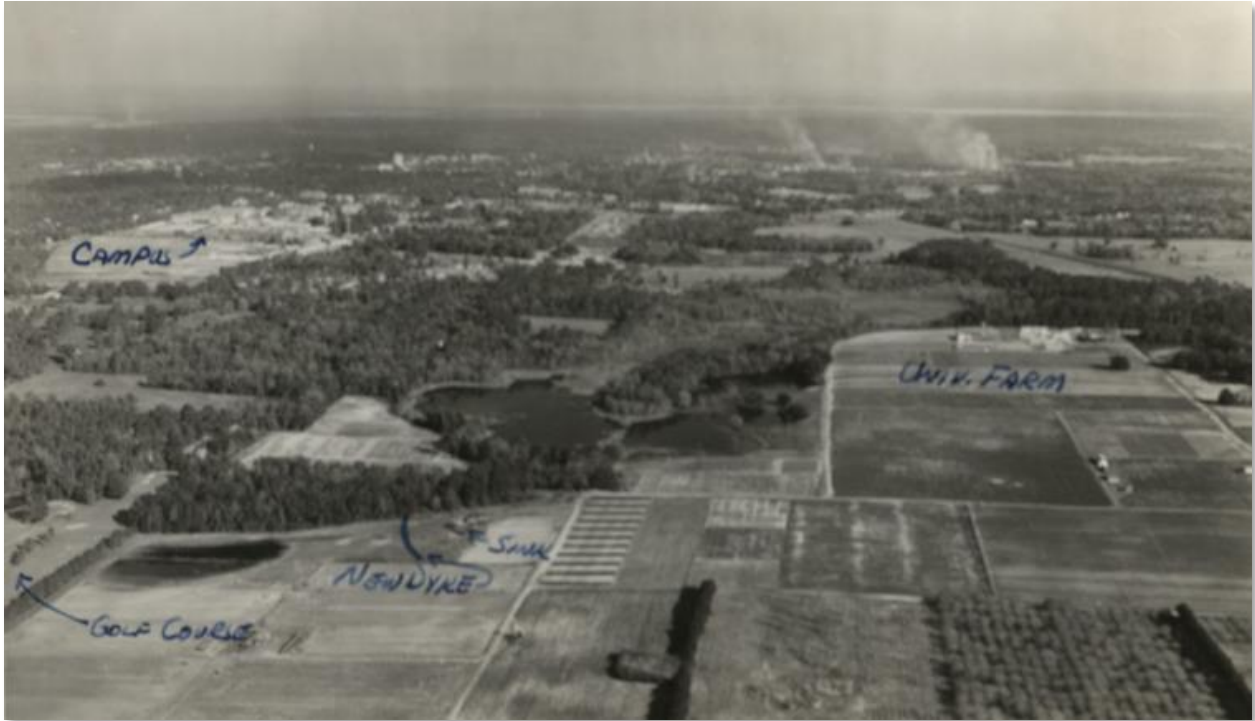
**Figure 11. 1947 Aerial Photograph Showing Lake Alice, New Sinkhole, and Constructed Dyke**

Discussion of the period from 1933 to 1947 contains key milestones: *“The flow of water (stormwater) was changed in 1933 by the filling of the connecting channel between Lake Alice and the main outlet sink near the railroad. This channel was filled to elevation 73, dividing the general drainage area into two distinct parts.”* This modification removed drainage east of the lake and heavy rainfall in 1933/34 caused the lake to fill to the highest elevation of 72 with approximately 132 acres inundated. *“The exact date has not been determined but, approximately in 1934, a dyke was constructed along the west end of Lake Alice preventing the water from entering Area XI (closed basin) and the golf course, so long as it did not rise above elevation 70. While this dyke completed the confinement of Lake Alice, its construction did not violate the natural direction of flow toward the east (which was already altered in 1933). Without the dyke, overflow from Lake Alice would enter Area XI, flooding property other than that owned by the University. This overflow and flooding could not have occurred had the natural drainage (the sinkhole near the railroad) been preserved.”* An aerial image from 1947 shows the location of the new sinkhole west of Lake Alice and the location of the constructed dyke (Figure 11).
