Attachment E – Lake Alice Watershed – Conservation Area Vegetation Inventory and Recommendations

Prepared for
University of Florida

August 2024

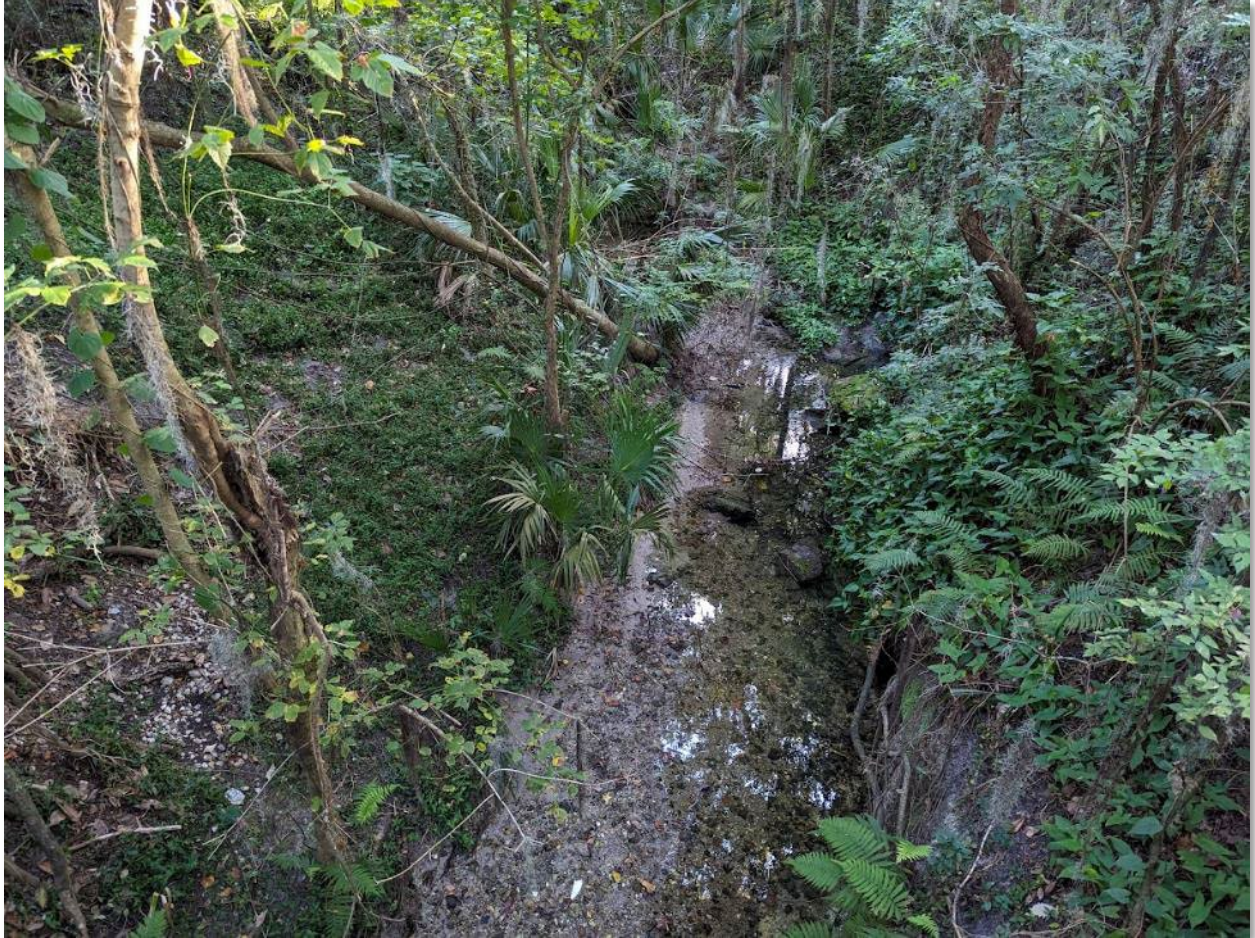
Figure 1. Bottomland Forest Community Adjacent to a Creek in the Reitz Ravine Woods Conservation Area

Bottomland forests are deciduous, or mixed deciduous/evergreen, closed-canopy forests on terraces and levees within riverine floodplains and in shallow depressions. An example bottomland forest community in Reitz Ravine Woods Conservation Area is shown in Figure 1. Generally located between swamps and uplands, the canopy is often diverse with both deciduous and evergreen hydrophytic to mesophytic trees. Characteristic plant species are presented below, summarized from the 2010 *Guide to the Natural Communities of Florida* (Florida Natural Areas Inventory, 2010).

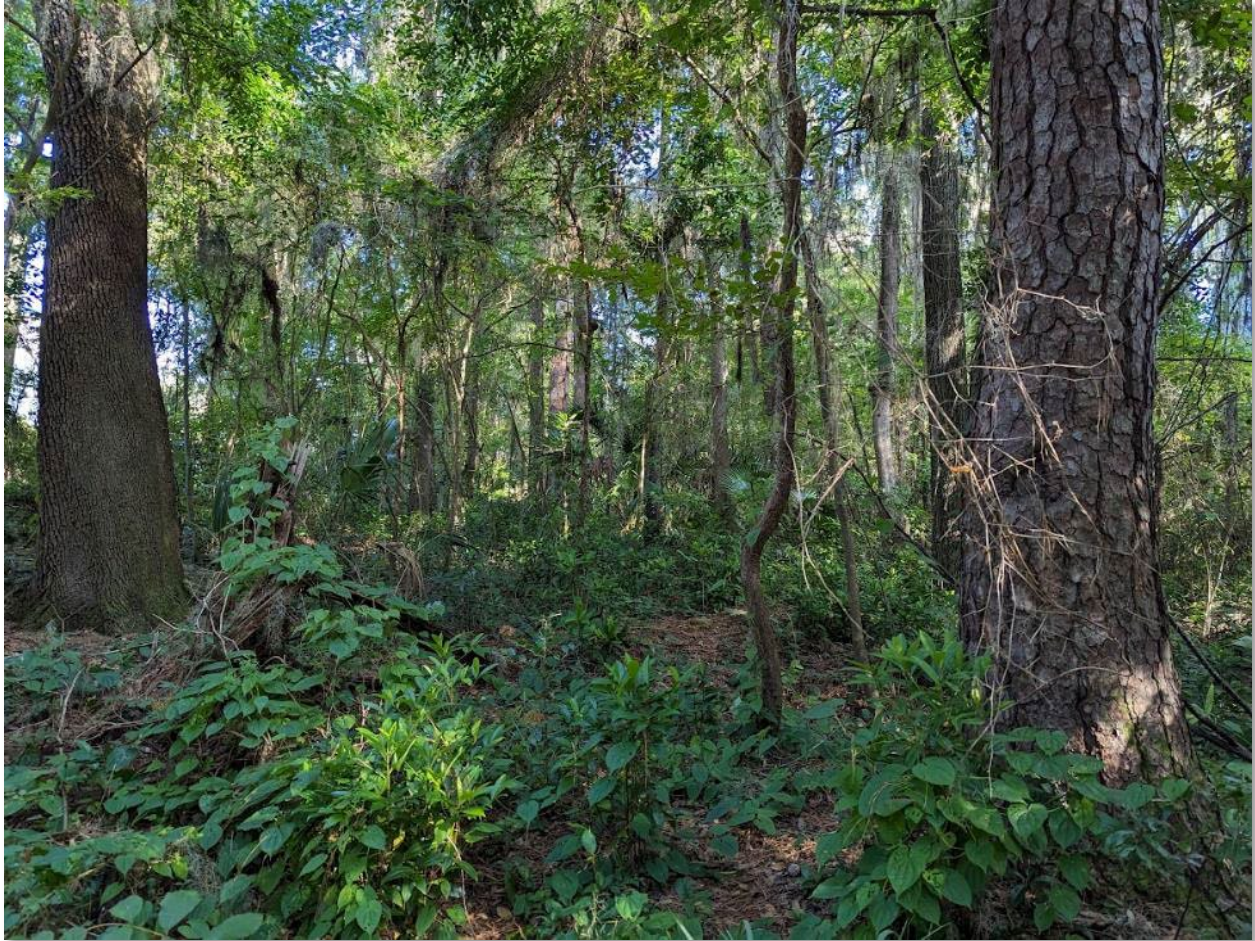
Figure 2. Upland Hardwood Forest in the Fraternity Wetland Conservation Area

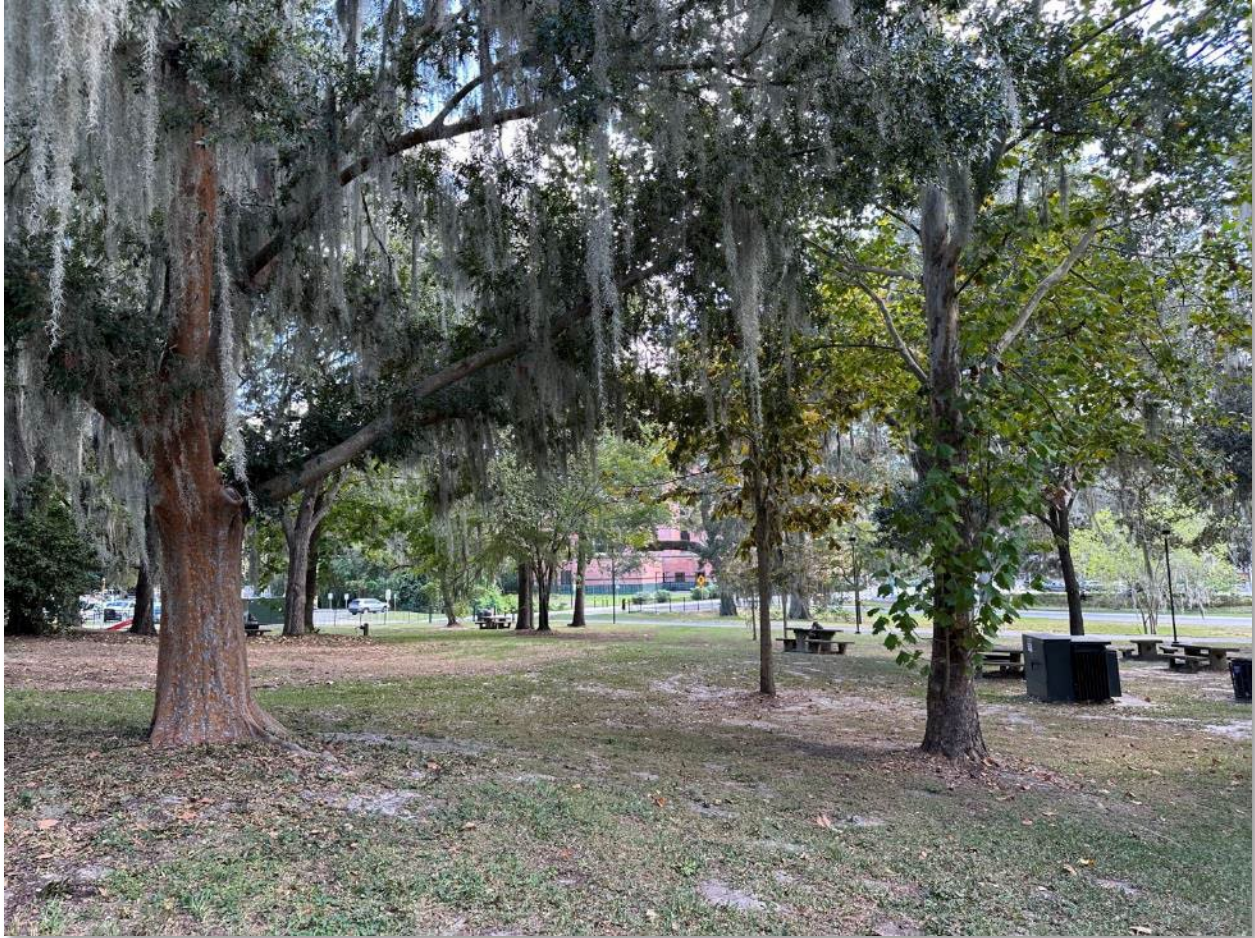
Figure 5. Landscaped Portion of the Bartram-Carr Woods Conservation Area

The Bartram-Carr Woods Conservation Area is located roughly 200 feet south of Museum Road between Center Drive and South Newell Drive (Figure 4). This Conservation Area includes landscaped areas maintained with a mowed groundcover and widely spaced trees (Figure 5) and areas resembling a more natural upland hardwood forest community including a fuller canopy, subcanopy cover, and reduced groundcover disturbance (groundcover in the forested areas still resembles that of a disturbed upland hardwood forest). The site is readily accessible with paved trails connecting the Psychology Building, Carr Hall, and the Harrell Medical Education Building. A bridge to the south crosses Lake Alice Creek connecting the Conservation Area's southern border to the health center facilities across the creek. Concrete picnic benches are located in the upland hardwood forest and in the more landscaped portions of the property. These amenities provide students and faculty with recreational and contemplative natural spaces in the center of campus. Bartram-Carr Woods also provides an educational destination to supplement ecology, land management, urban planning, and natural resource management lectures with in-person field trips.

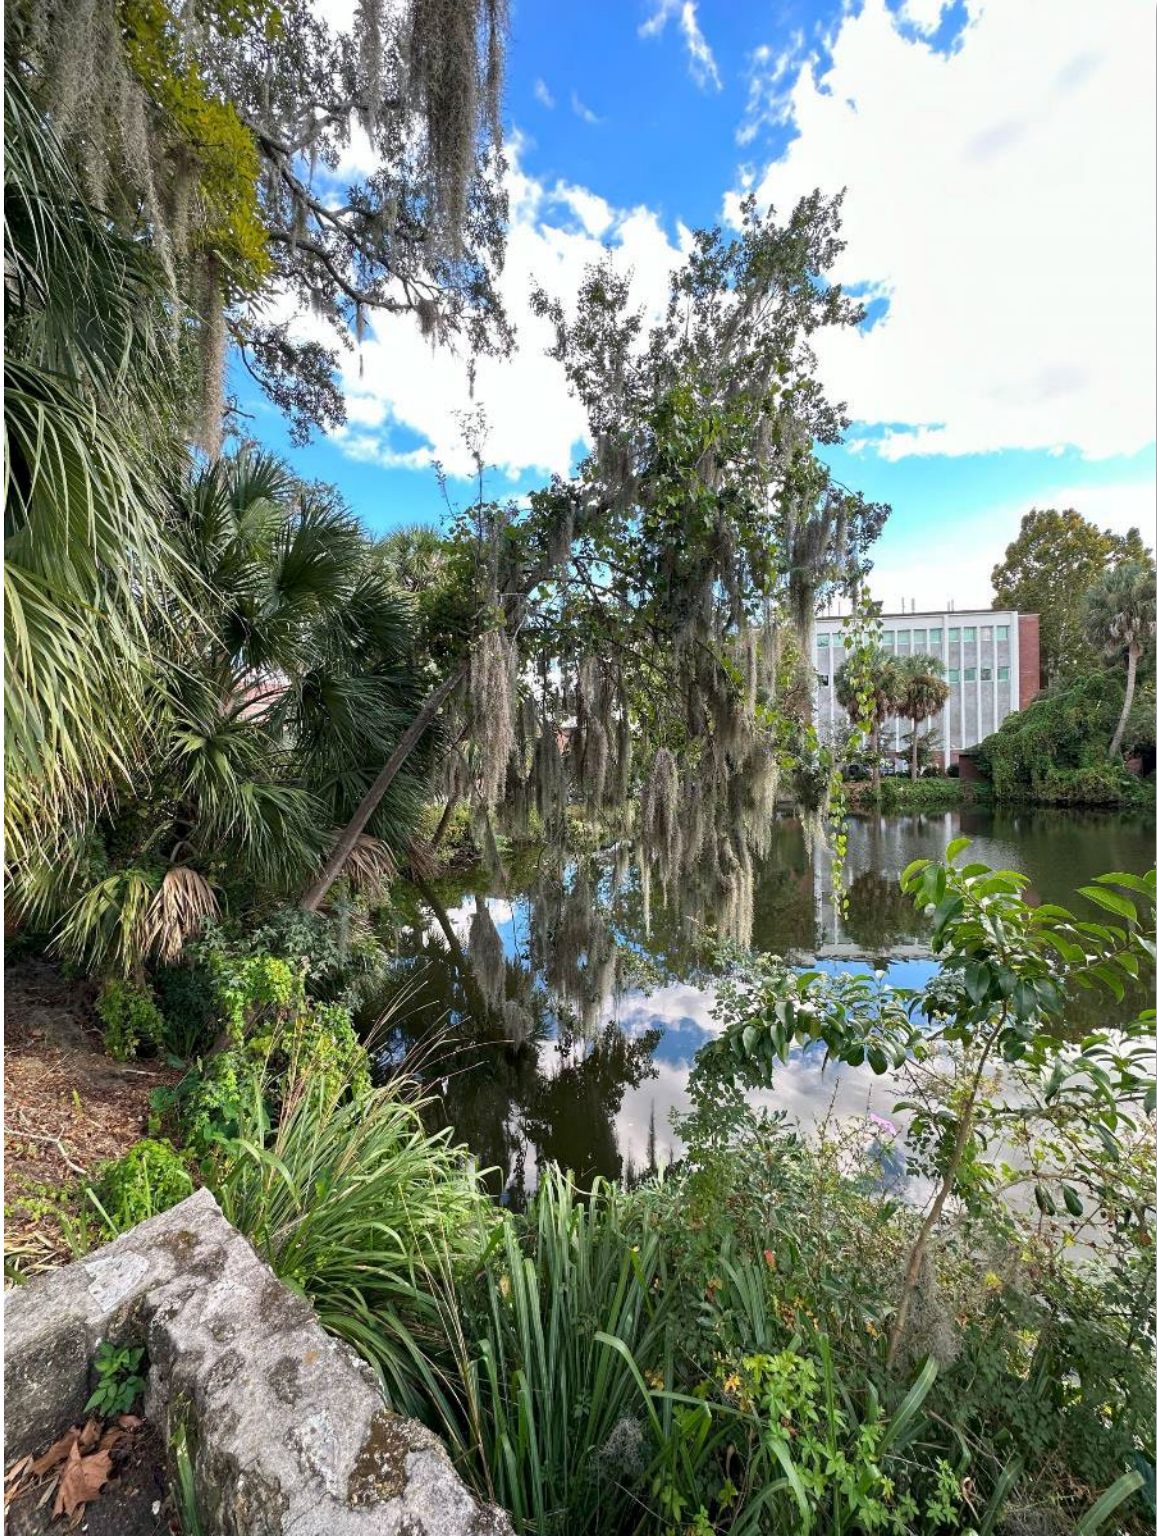
The sinkhole lake portion of Dairy Pond is a small, open water system with steep side slopes. The canopy consists of several cabbage palms and one water oak (Figure 9) rooted along the edges of the sinkhole but with a portion or all of their crowns above the sinkhole lake. Cover by subcanopy is absent. Groundcover observed in the open water footprint was confined to the littoral edge. This included taro, buttonbush (*Cephalanthus occidentalis*), and Mexican primrosewillow (*Ludwigia octovalvis*).

Figure 9. Water Oak Tree Leaning Over the Sinkhole Lake in the Dairy Pond Conservation Area

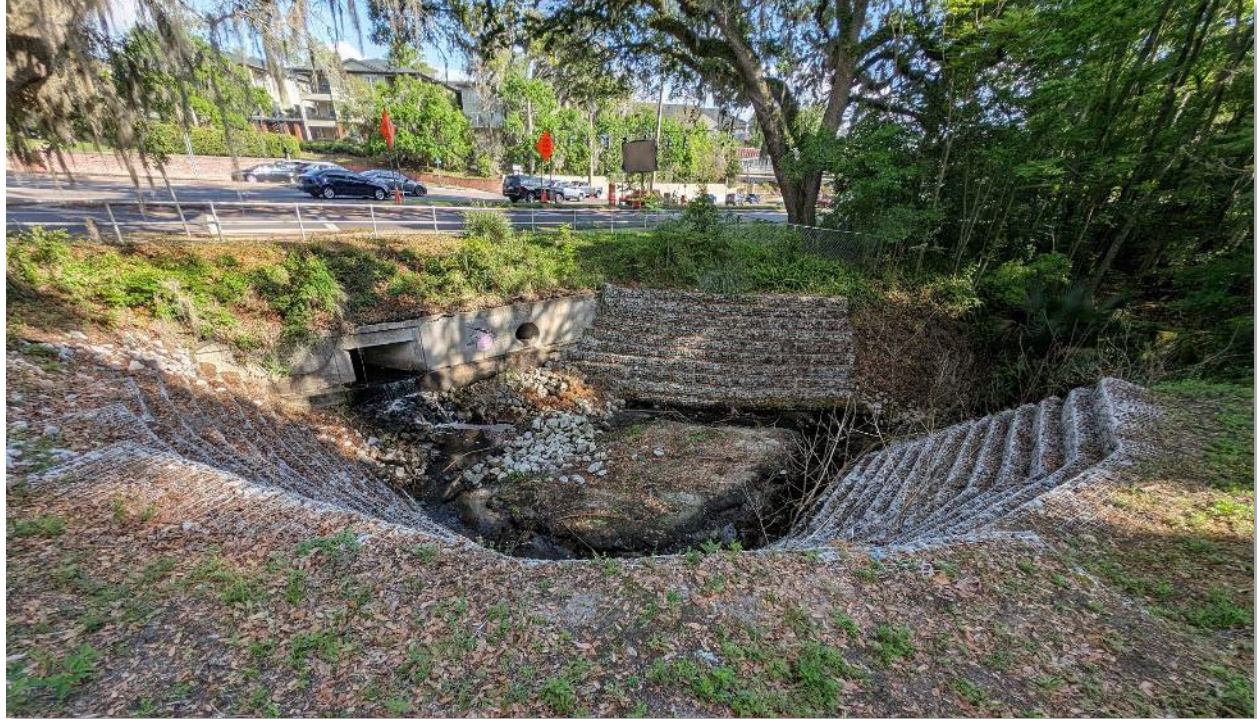
The bottomland forest community at the Diamond Creek Conservation Area has been largely eliminated as a result of stormwater erosion that has caused the failure and collapse of the creek banks. This erosion has been partially addressed through hardening of the side slopes near the pipe under SW 13th Street where gabion baskets were installed in 2008 (Figure 12) although erosion and steep creek banks remain an issue further downstream.

Figure 12. Diamond Creek Bank Stabilization

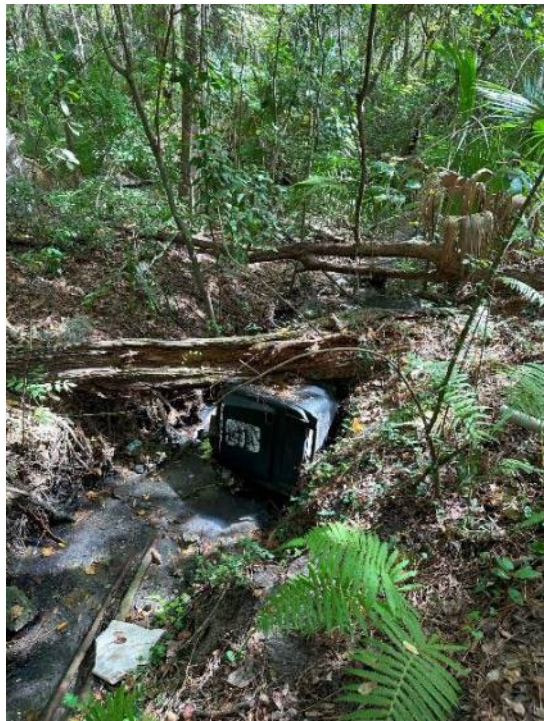
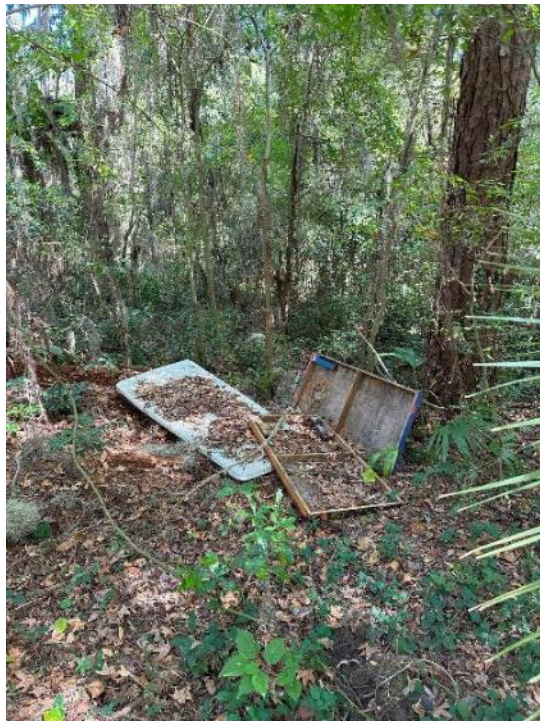
Impacts to both natural communities (upland hardwood forest and bottomland forest) include large amounts of litter from the adjacent fraternity houses (Figure 17 and Figure 18). Trash observed during the site visit included:

- A 35-gallon trash receptacle in the creek (Figure 17), two wooden tabletops, and one foldable plastic table in the upland forest community,
- Dense patches of litter in several forested areas within 100 feet of the dumpsters (Figure 18) and an area littered with over 100 aluminum/glass beer bottles and cans.

Figure 17. Trash Bin (left) and Tables (right) in the Fraternity Wetland Conservation Area

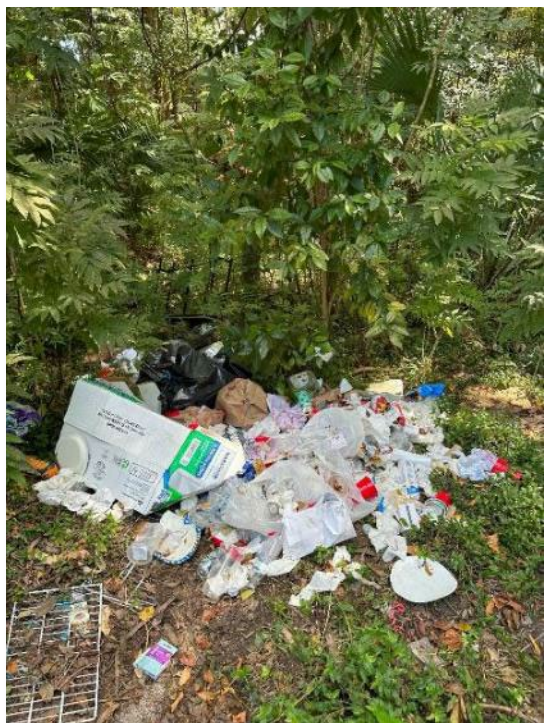
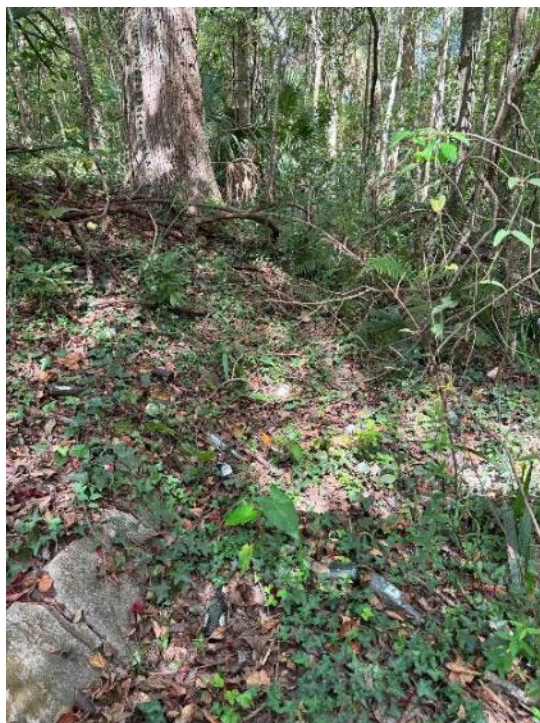
Figure 18. Litter in the Fraternity Wetland Conservation Area

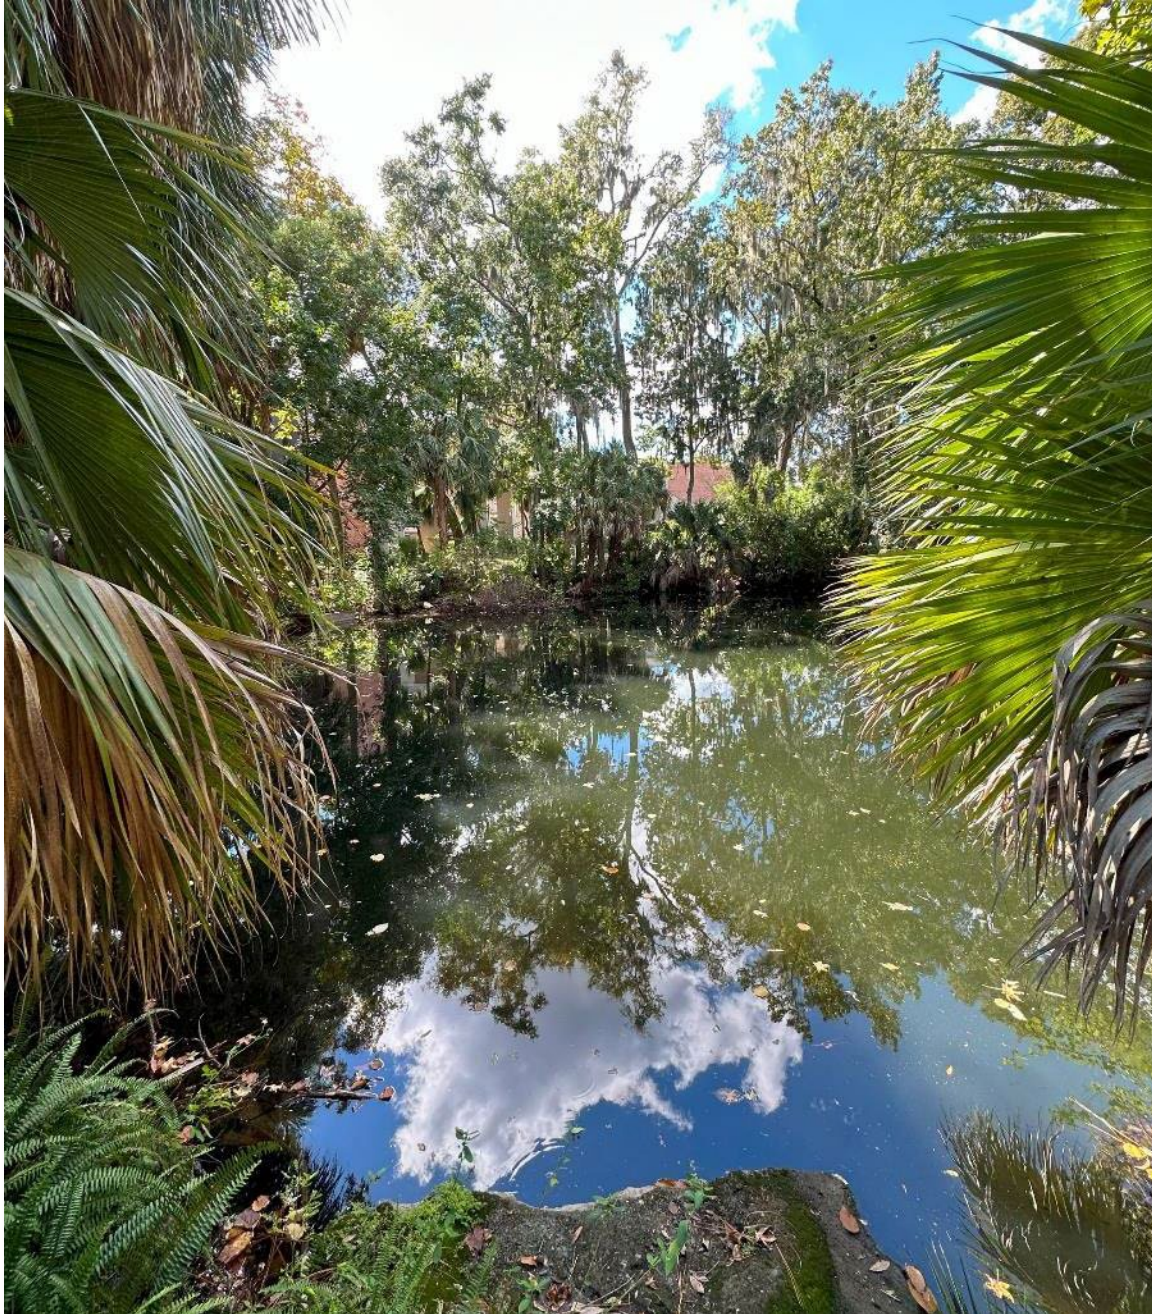
The sinkhole lake portion of Gator Pond is a small (roughly 0.25 acres), circular, open water system with steep side slopes and exposed limestone along its northeastern edge (Figure 21). The canopy consists of sweetgum and cabbage palm trees that are rooted along the sinkhole edges but have a portion of their crown over the open water system. Cover by subcanopy is more scarce including buttonbush and sweetgum. Sweetgum was the only observed groundcover in the open water system with saplings (less

Figure 21. Sinkhole Lake Community at Gator Pond

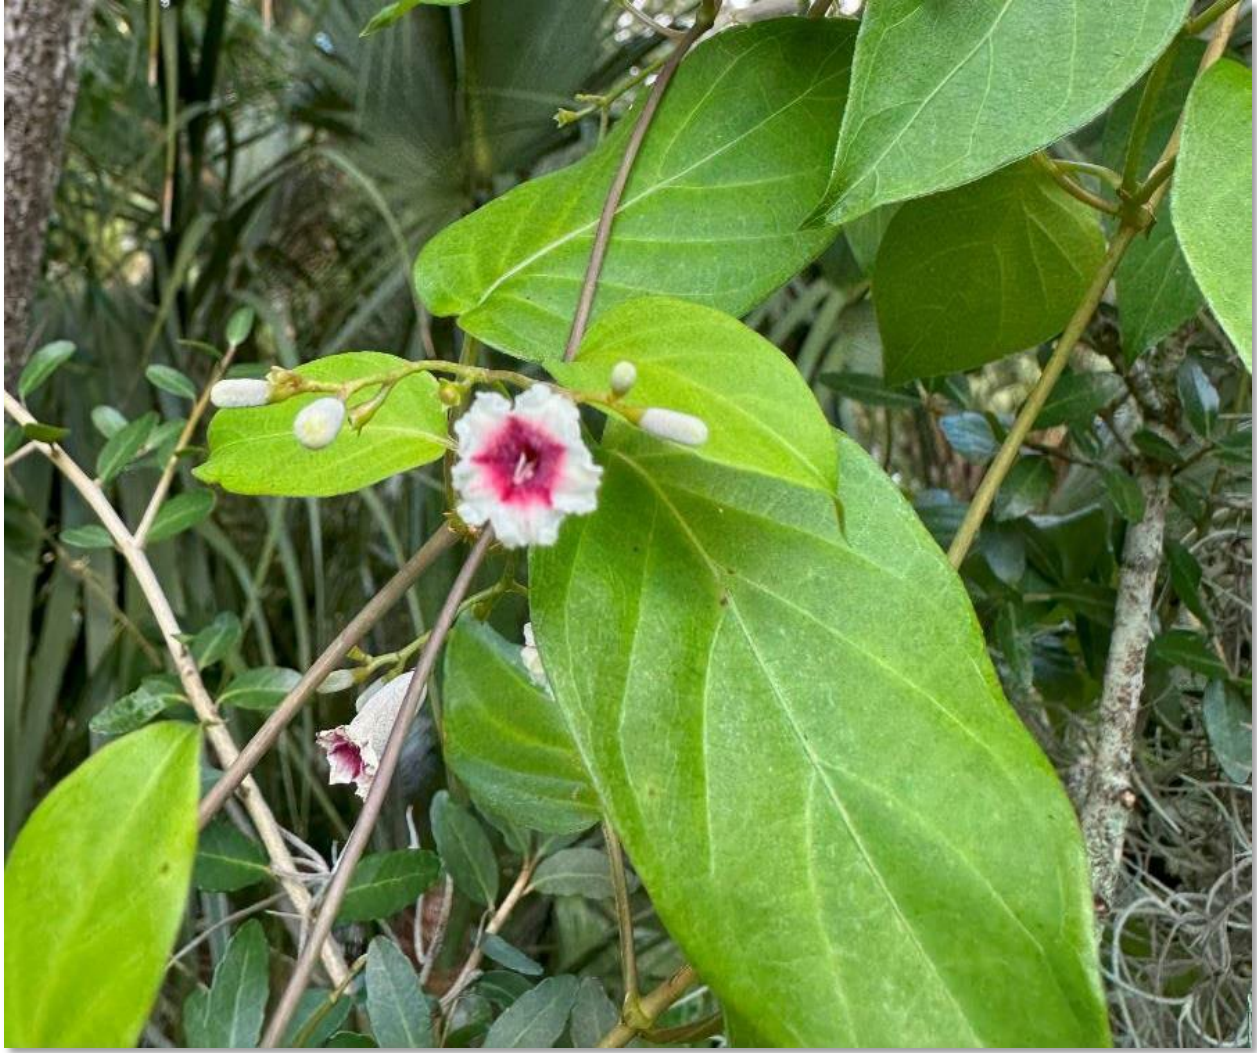
than 1" DBH) rooted on the edge with their crown extending over the open water as with the canopy stratum. Invasive skunkvine was observed along the edge of the lake (Figure 22), as was wildlife (Figure 23).

Figure 22. Skunkvine (*Paederia foetida*) (FISC Cat I) Blooming in the Gator Pond Conservation Area

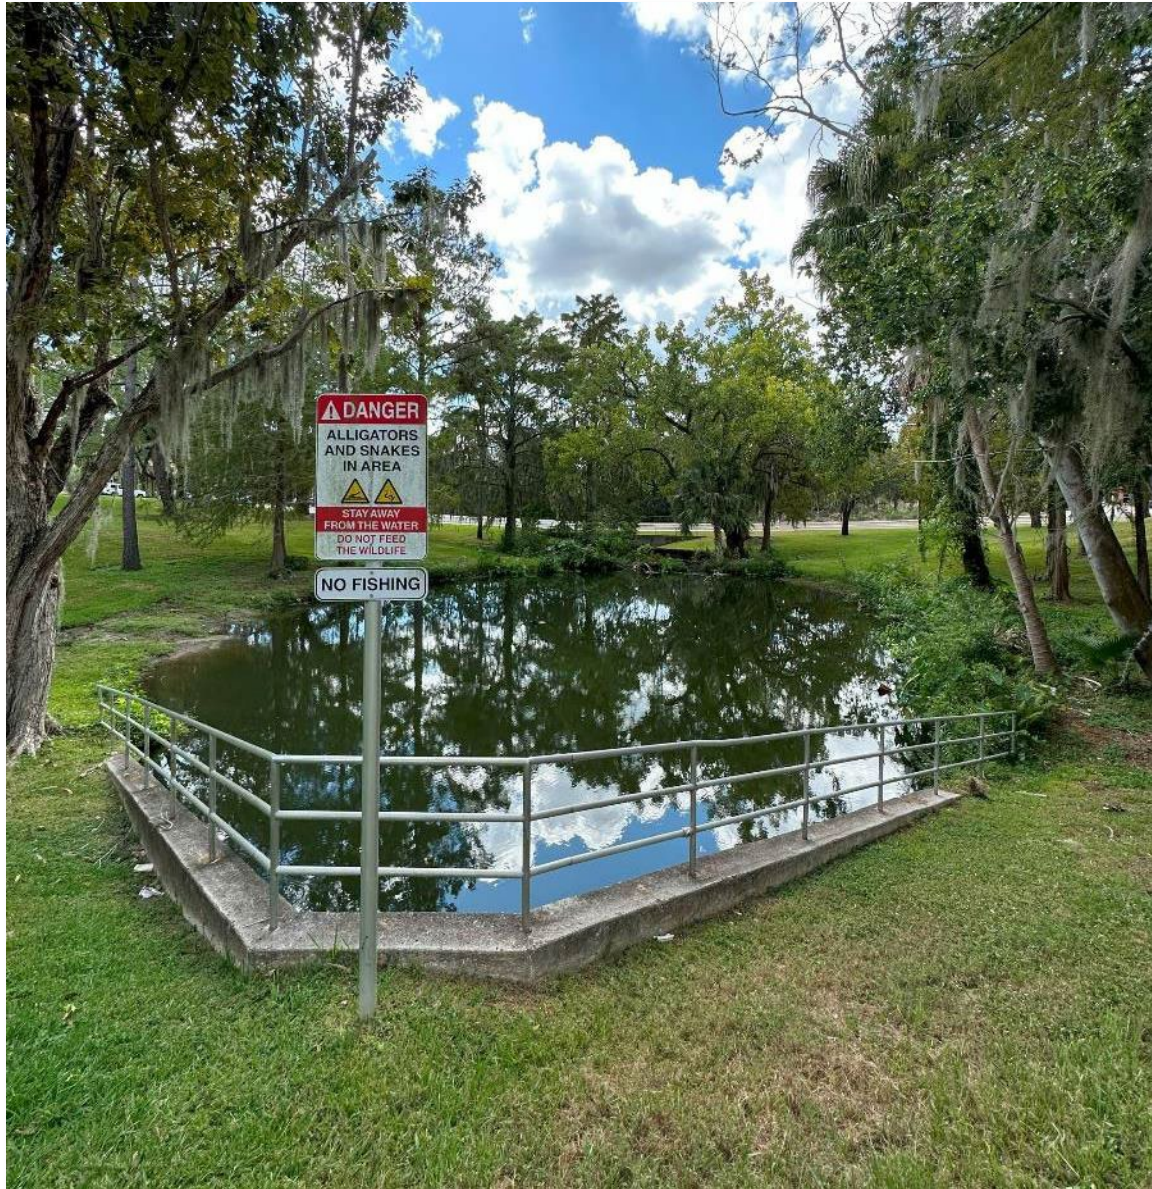
Figure 26. Mowing Buffer on the Western Portion of Graham Pond (right) and Mowing to Waterline on the Eastern Edge (left)

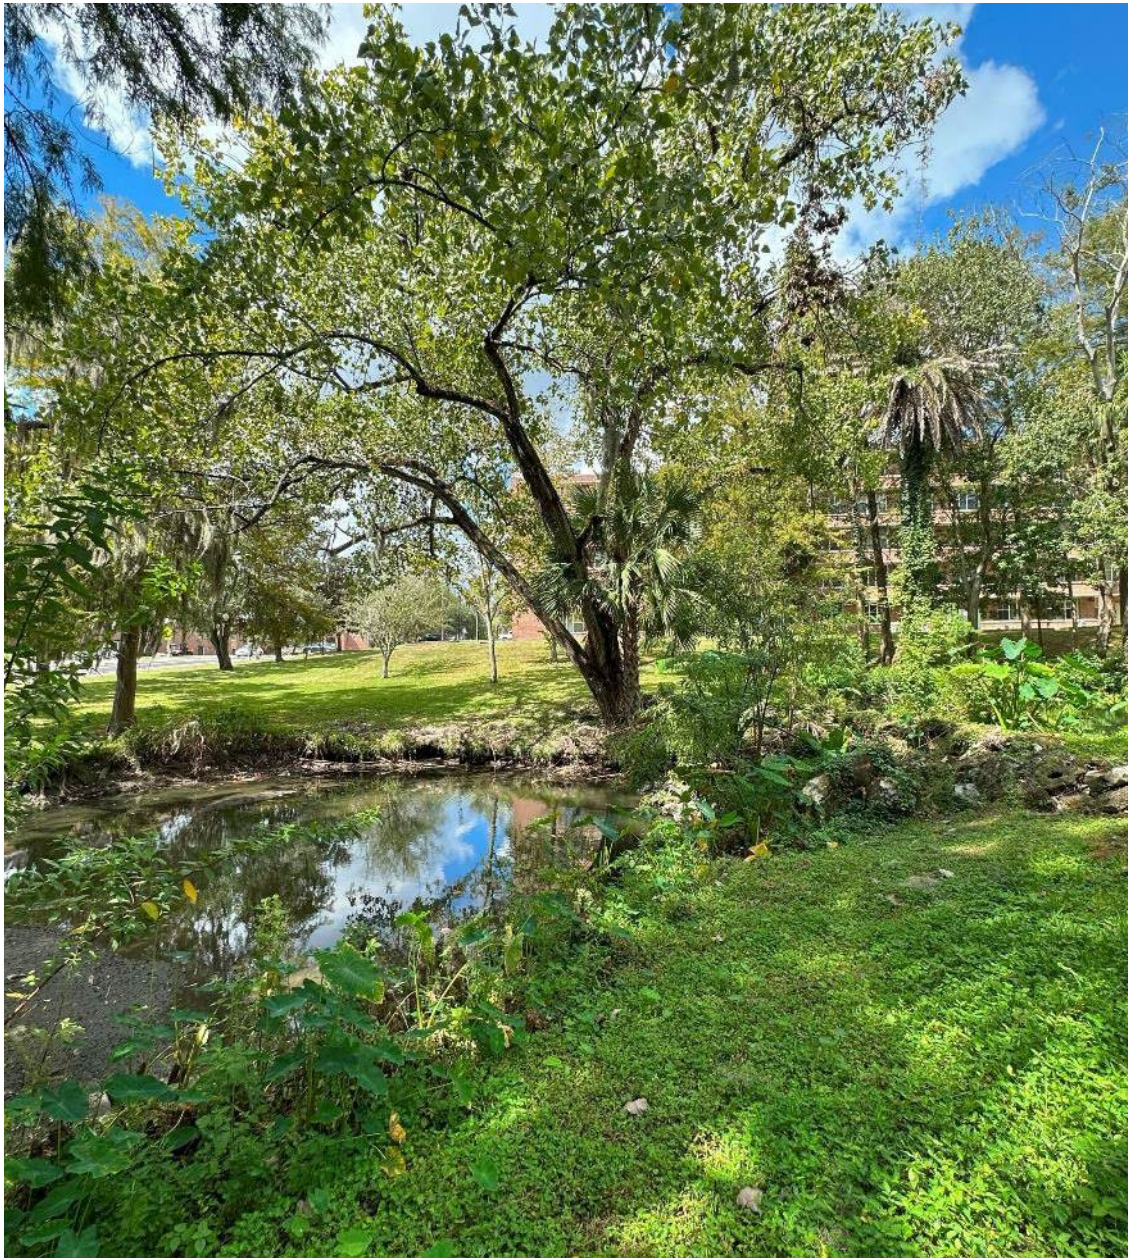
Figure 27. Poned System and Impacted Groundcover in the Graham Pond Conservation Area

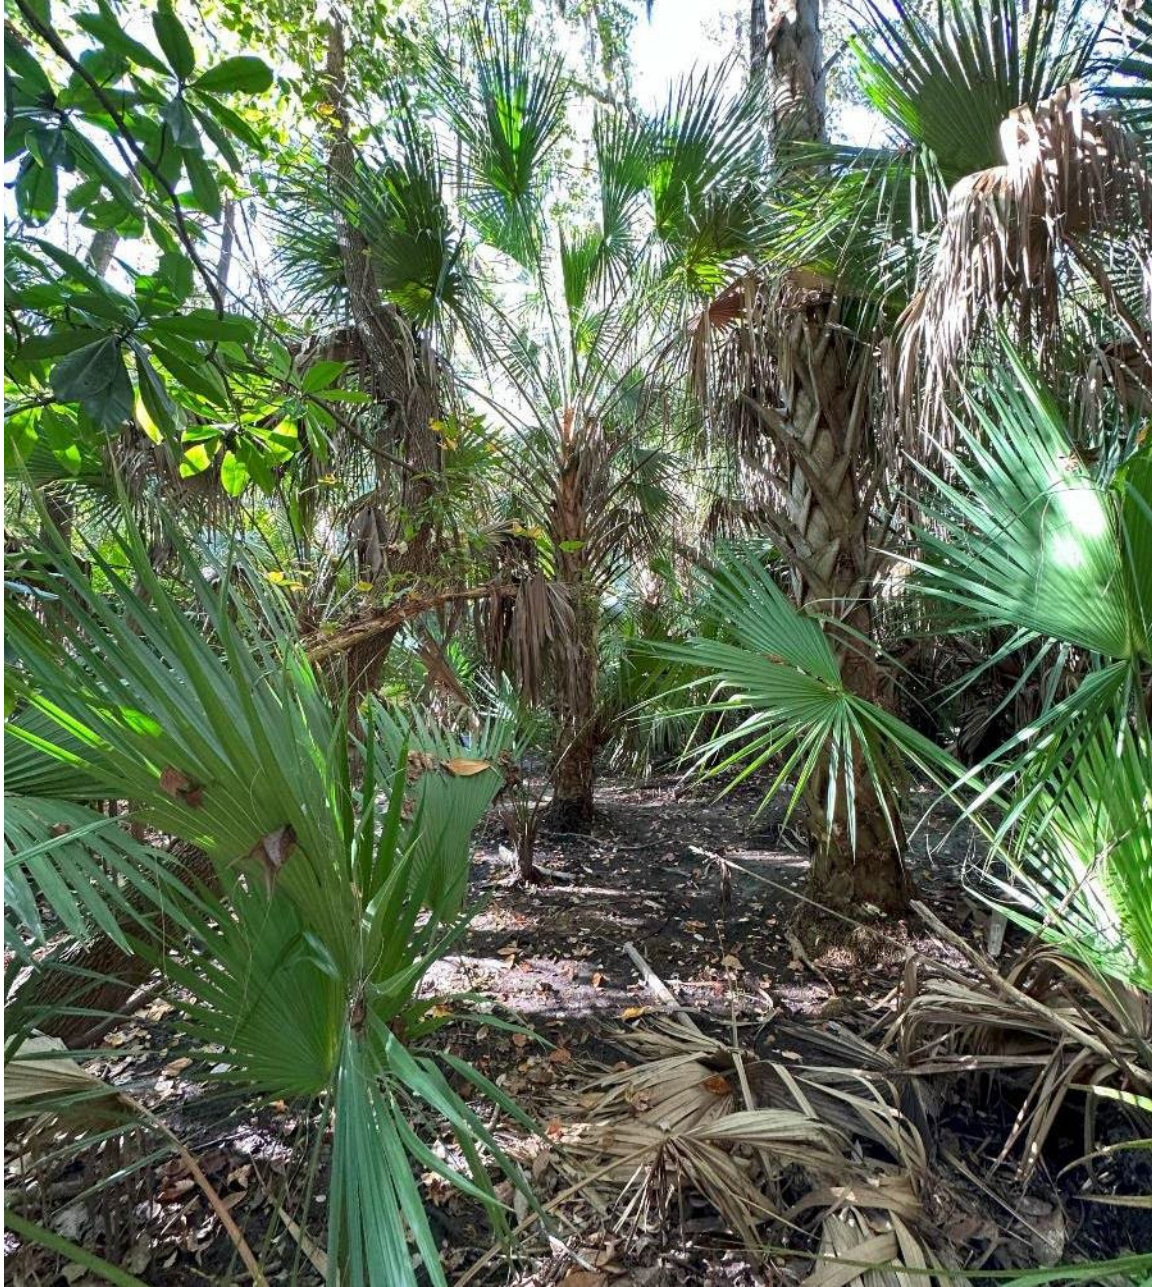
The bottomland forest is an open canopy system including cabbage palm (Figure 30), sugarberry, sweetgum, swamp tupelo, and red maple. Other common canopy species include southern magnolia, swamp chestnut oak, white ash, and white mulberry (*Morus alba*). The subcanopy is scarce and includes American hornbeam, glossy privet, and buttonbush. Common groundcover species include small-leaf spiderwort, dwarf palmetto, and wild Boston fern (*Nephrolepis exaltata*). The transport of low-quality water and undesirable vegetative material along with sediment transport (Figure 31) from larger stormwater events have significantly impacted the ecological structure of this forested wetland.

Figure 30. Open Cabbage Palm Canopy in the Bottomland Forest Habitat of Graham Woods

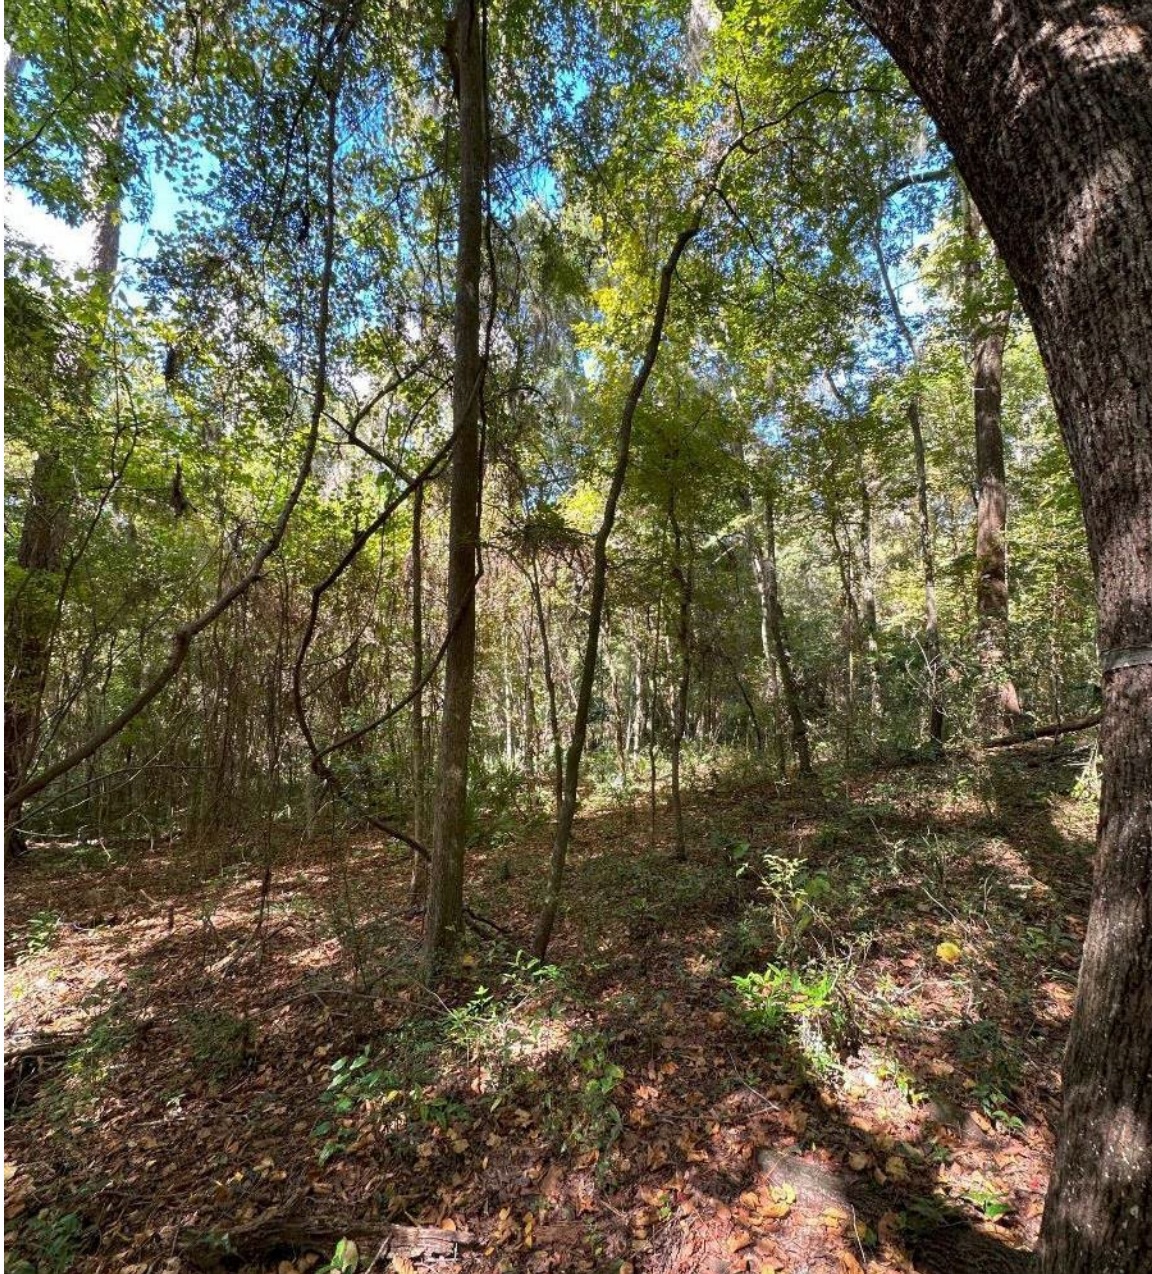
Figure 34. Forested Area in the Eastern Portion of the Harmonic Woods Conservation Area

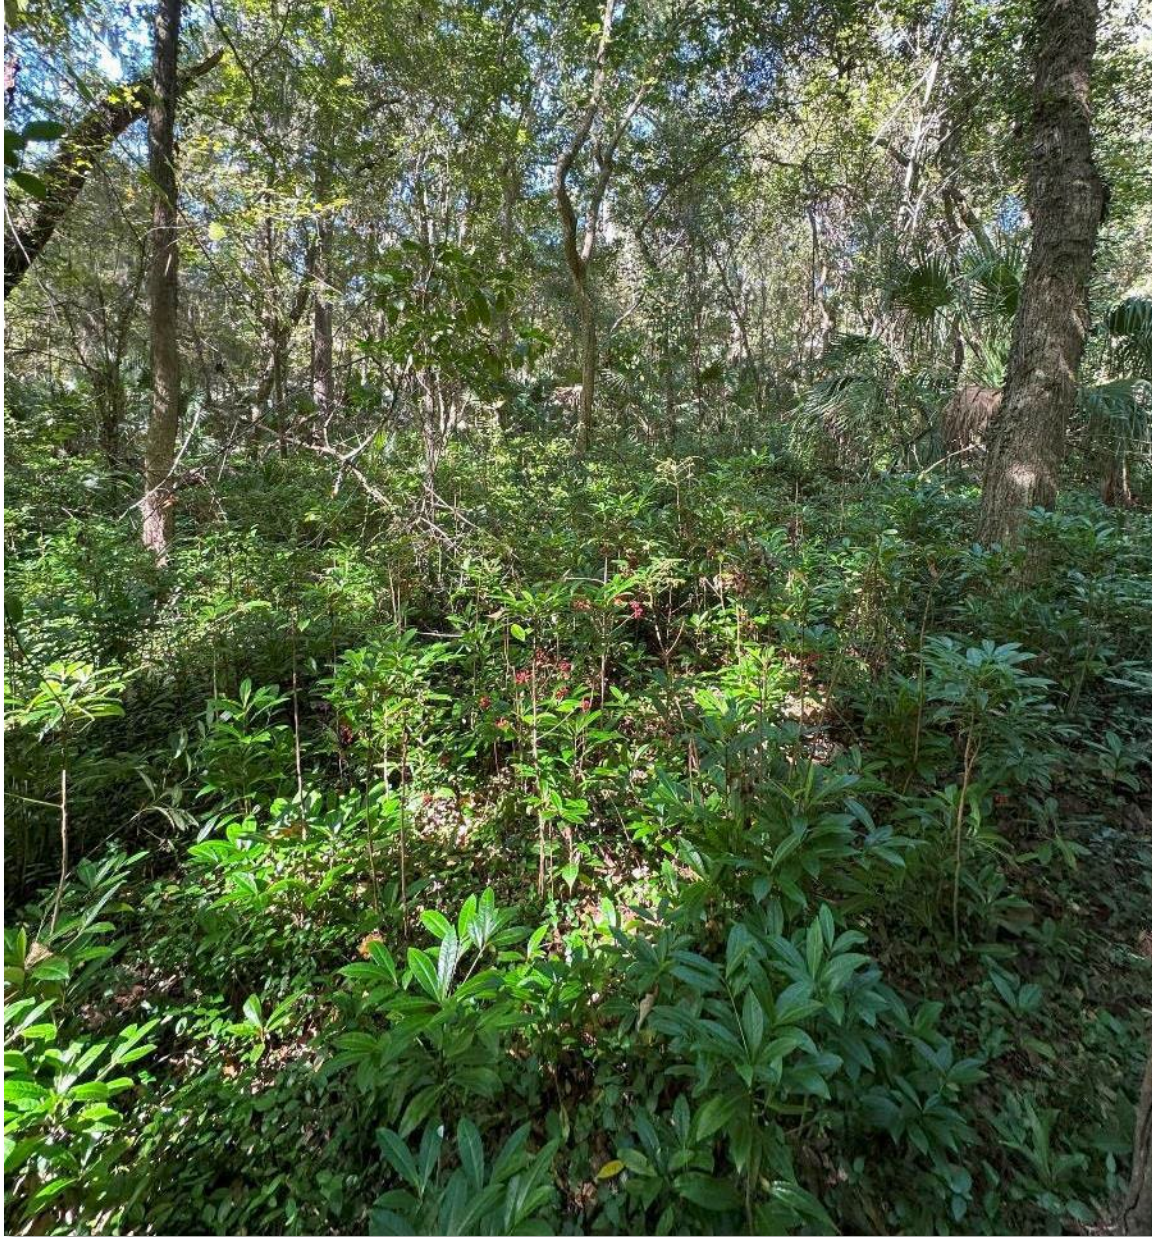
Figure 35. Mixed Vegetation Stand Dominated by Coral Ardisia (FISC Cat I) and Confederate Jasmine (Exotic) in the Harmonic Woods Conservation Area

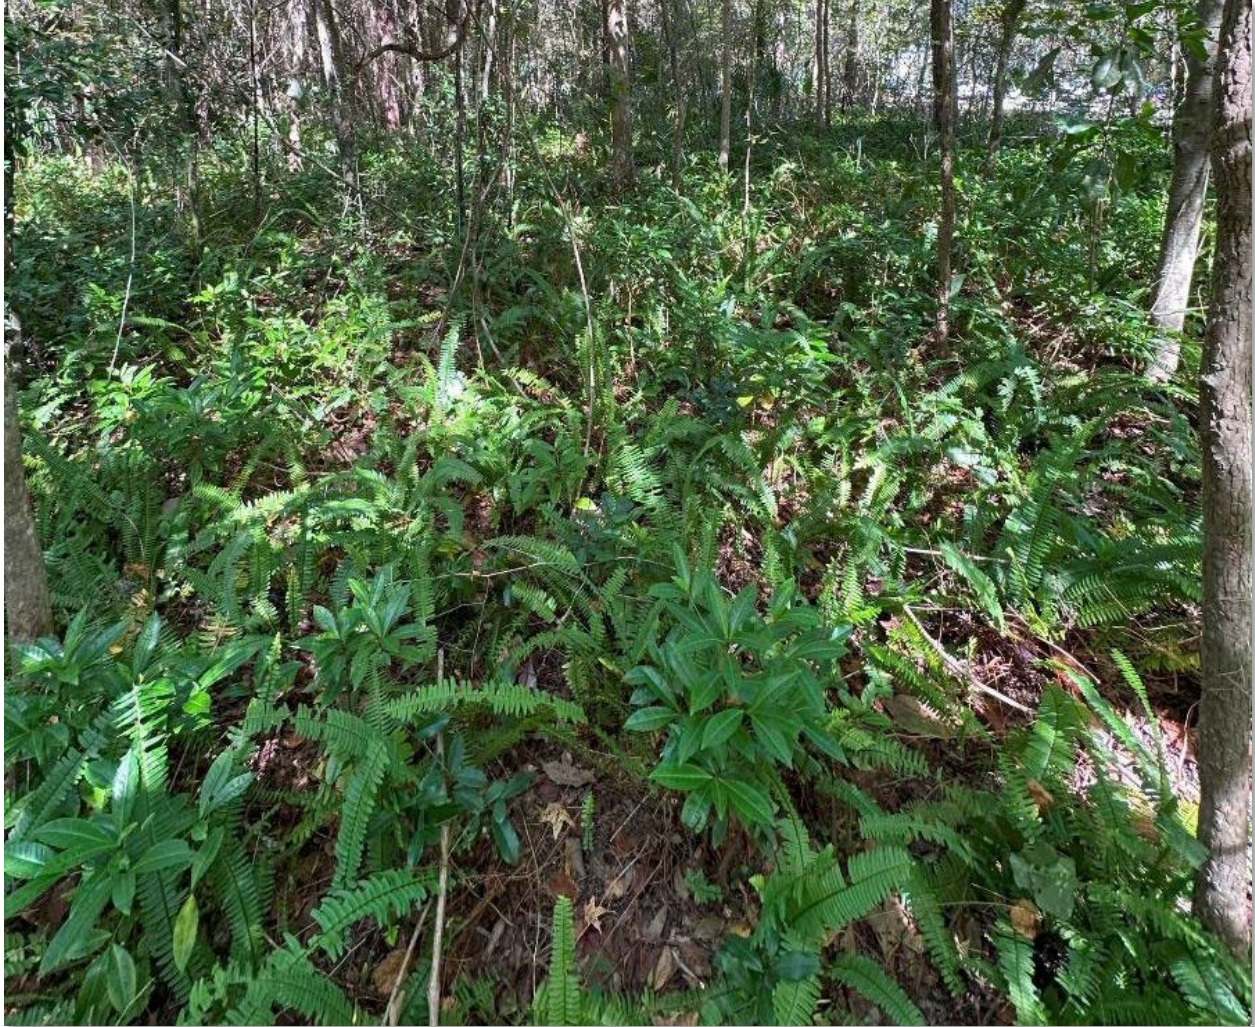
Figure 36. Groundcover in the Harmonic Woods Conservation Area Dominated by Tuberous Swordfern and Coral Ardisia (both FISC Cat I)

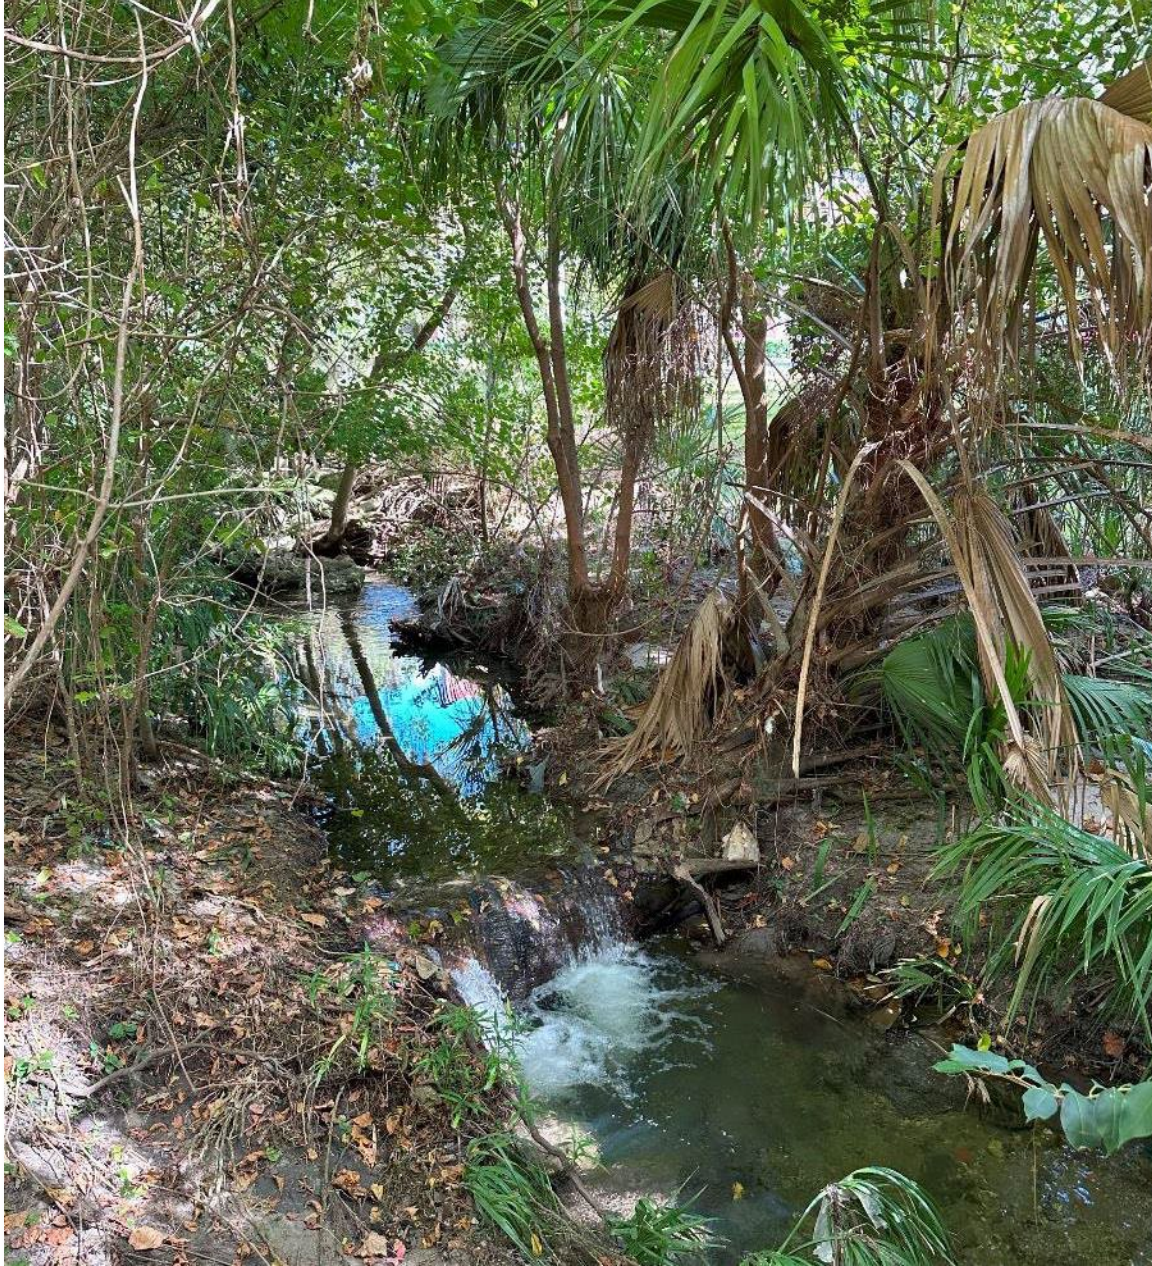
The bottomland forest is an open canopy system dominated by box elder along Hume Creek (Figure 38). Other common canopy species include sweetgum, sugarberry, American sycamore, and Chinese tallowtree. The subcanopy is less-vegetated and includes elderberry and sugarberry. The most common groundcover was the Florida grape rooted in the upland hardwood forest and growing over the bottomland forest community.

Vegetative material and soil disturbance have resulted in the encroachment of invasive (Chinese tallowtree and paper mulberry) species into the edges of the bottomland forest community.

Figure 38. Hume Creek Channel and Bottomland Forest
