Attachment E – Lake Alice Watershed – Conservation Area Vegetation Inventory and Recommendations

Prepared for
University of Florida

August 2024

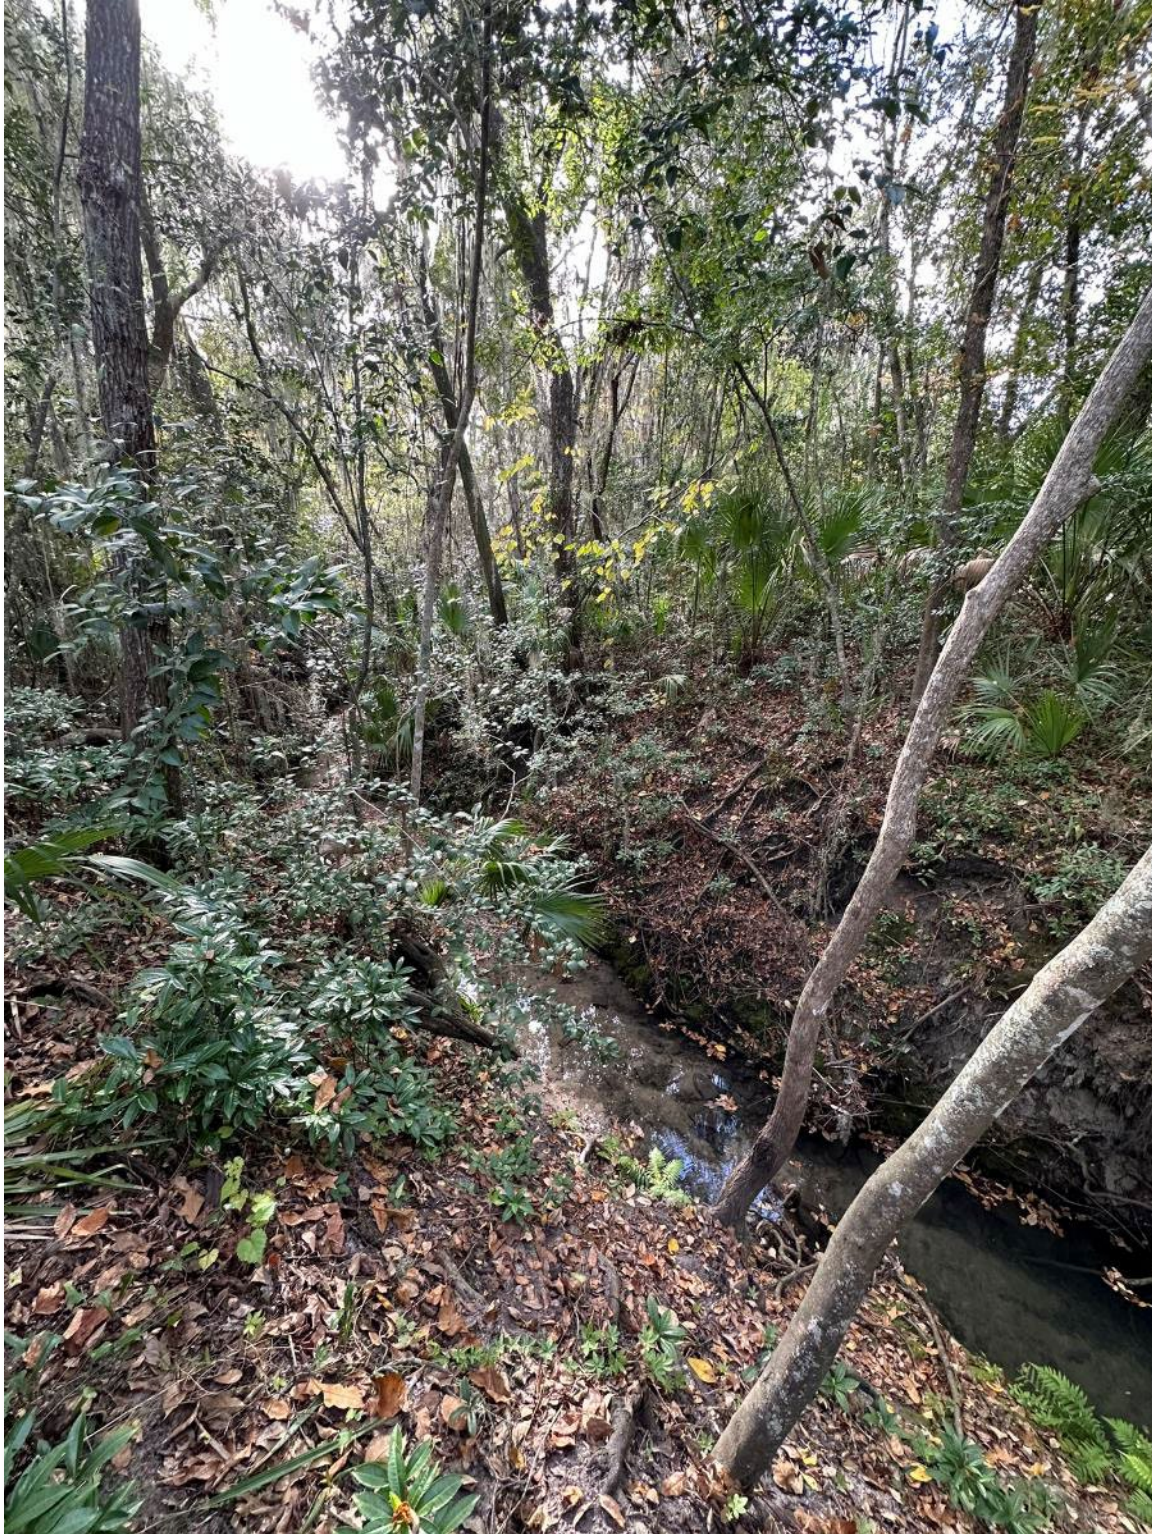
Figure 41. Jennings Creek Channel and Steep Side Slopes

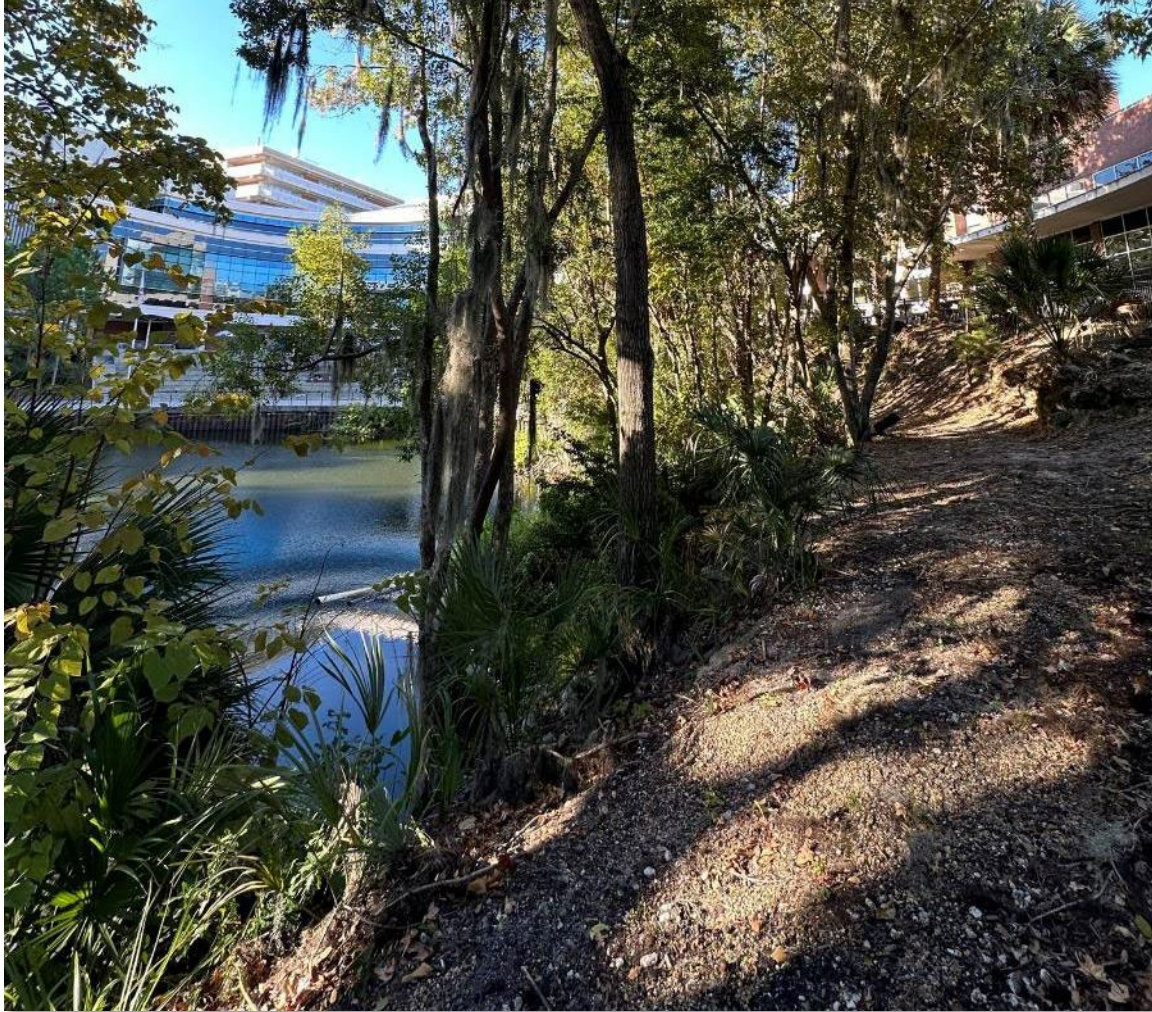
Light availability, human use, vegetative material, and landscaping inside and directly adjacent to the site boundary have resulted in the encroachment and establishment of various exotic and invasive species. Other impacts include erosion caused by stormwater (Figure 49).

Figure 49. Erosion of a Sloped Section of Sinkhole Habitat in the Liberty Pond Conservation Area

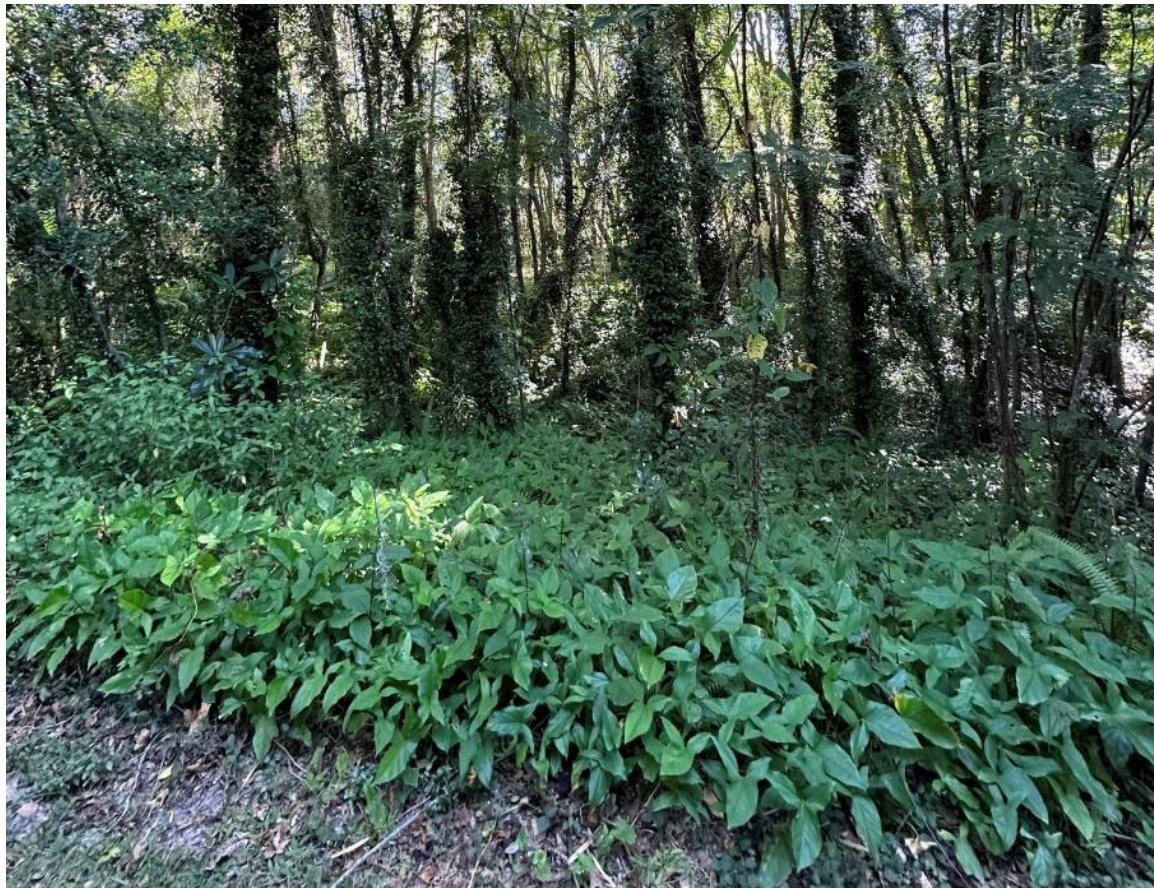
Figure 53. Terrestrial American Evergreen (FISC Cat I) Groundcover and Climbing Confederate Jasmine Groundcover on Native Tree Populations in the Law School Woods Conservation Area

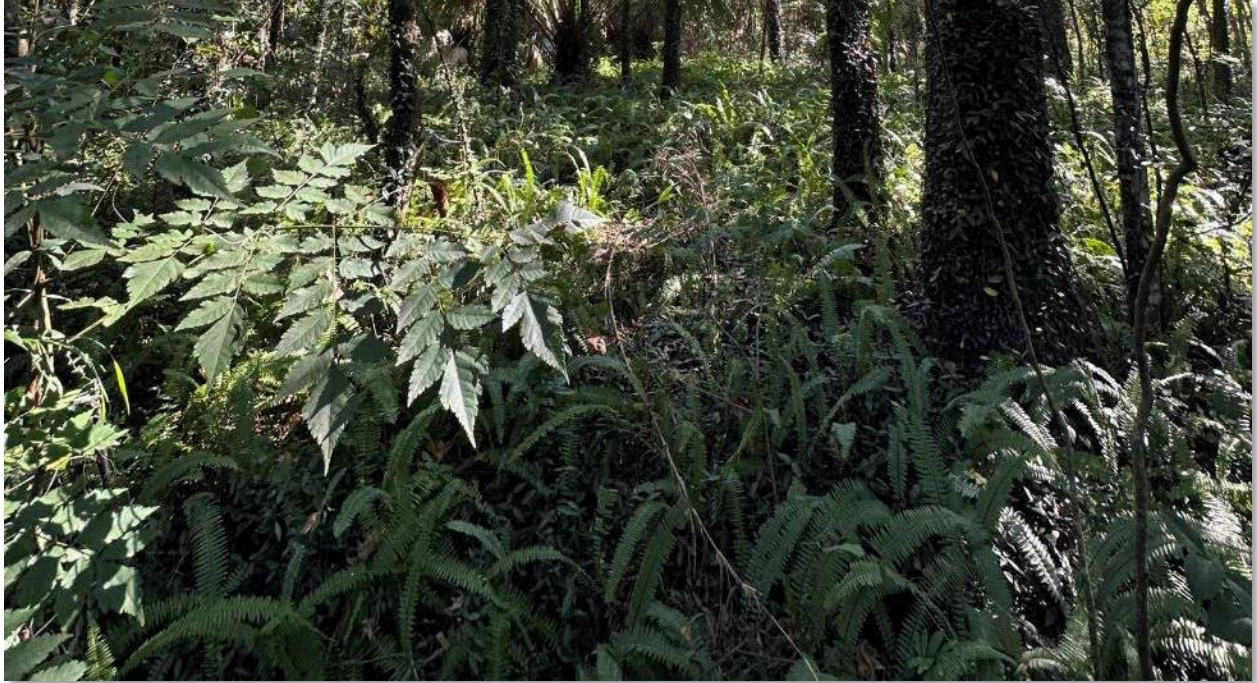
Figure 54. Tuberous Swordfern (FISC Cat I) and Flamegold (FISC Cat II) Populations in the Law School Woods Conservation Area

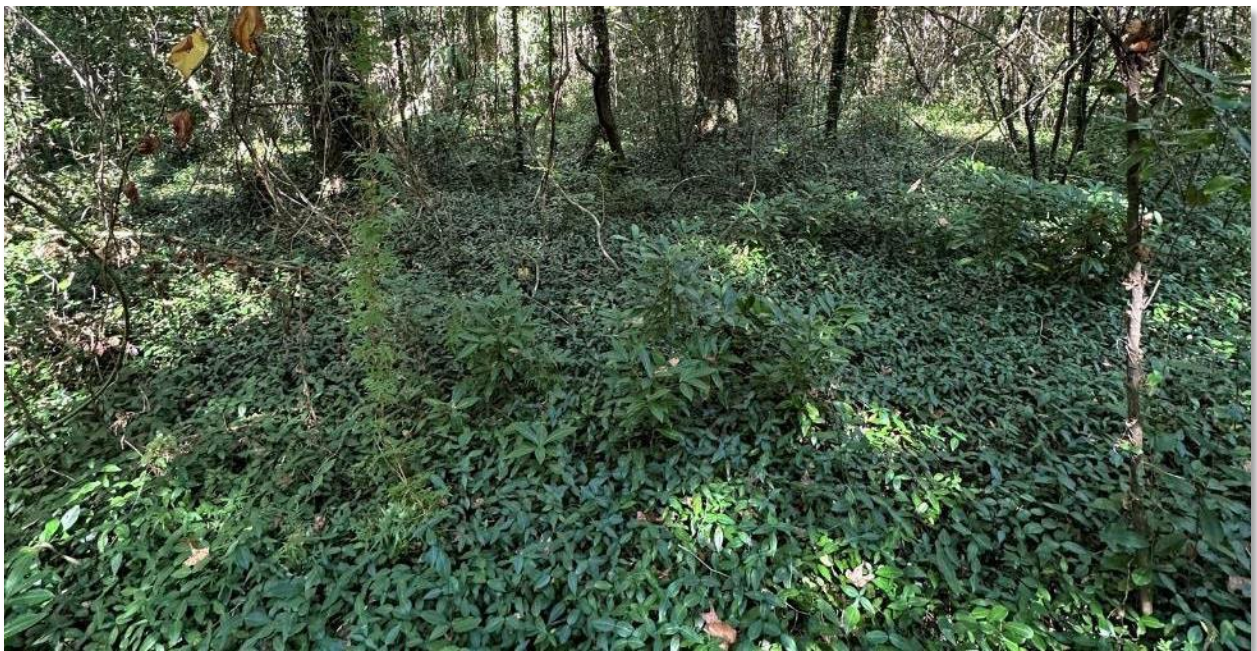
Figure 55. Confederate Jasmine (Non-native), Coral Ardisia (FISC Cat I), and Japanese Climbing Fern (FISC Cat I) Along the Law School Woods Conservation Area Border with the Golfview Neighborhood

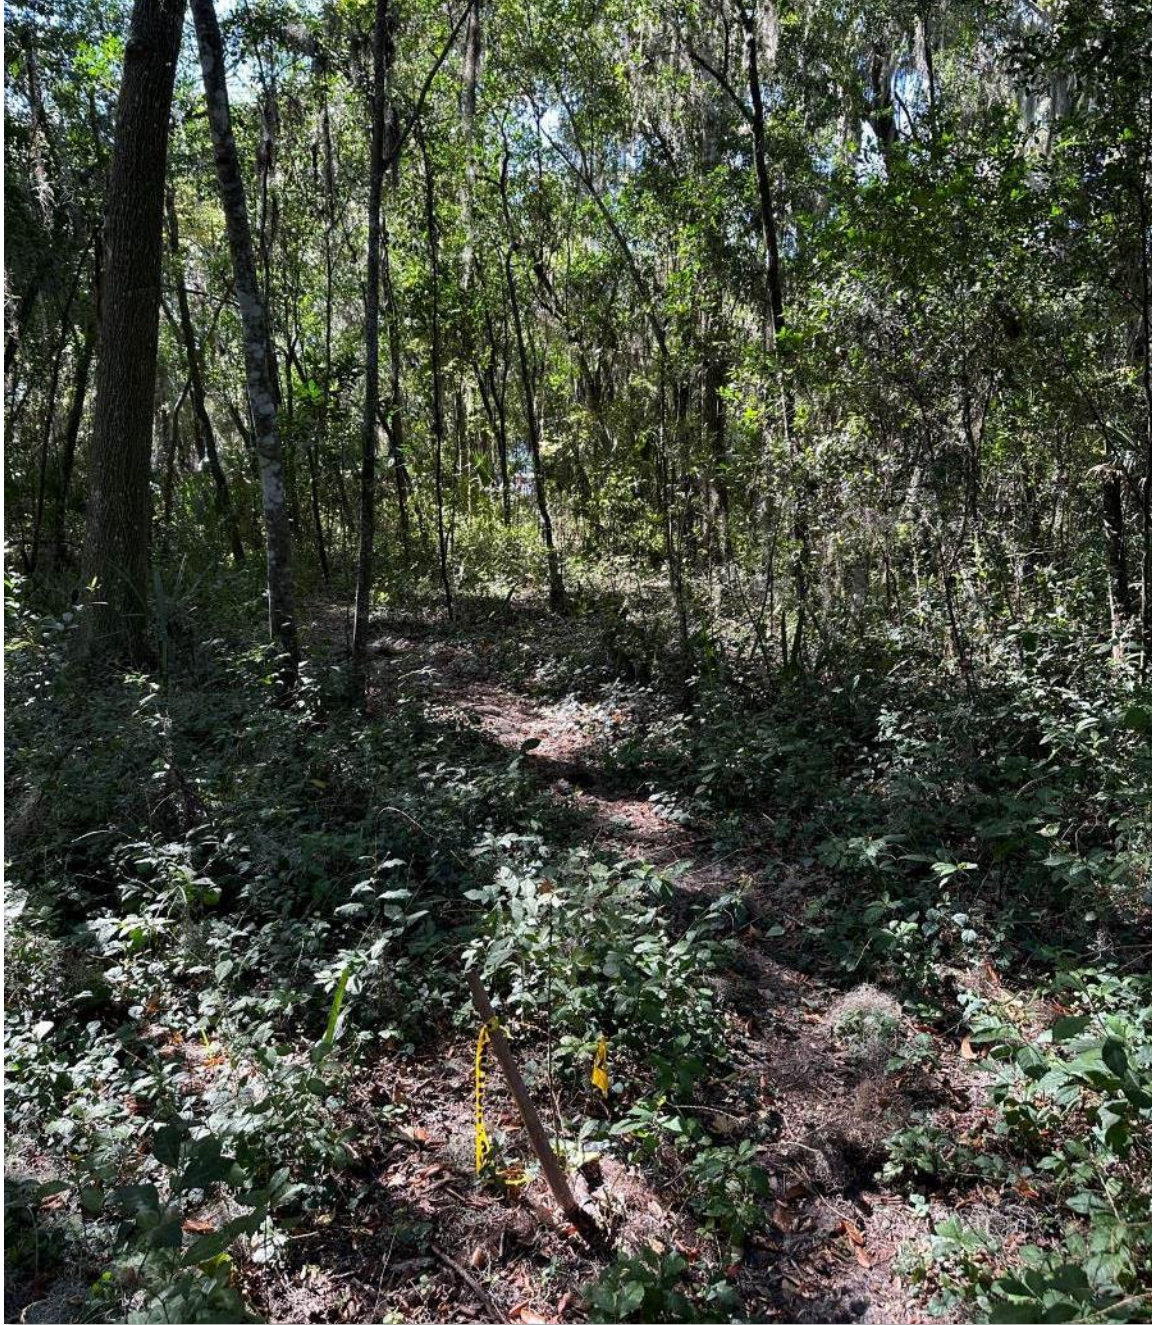
The upland hardwood forest is a closed canopy system (Figure 58) including pignut hickory, white ash, sweetgum, and Carolina laurel cherry. Other common canopy species include sugarberry, cabbage palm, and swamp chestnut oak. Species in the scarce subcanopy include sugarberry, Carolina laurel cherry, and eastern hophornbeam. Common groundcover species include Guinea hen weed, Carolina laurel cherry, Catclawvine, American pokeweed (*Phytolacca americana*), sugarberry, crossvine, yaupon, greenbriar, paintedleaf (*Euphorbia cyathophora*), and beggarticks.

Figure 58. Forested Area Along a Footpath That Bisects the McCarty Woods Conservation Area

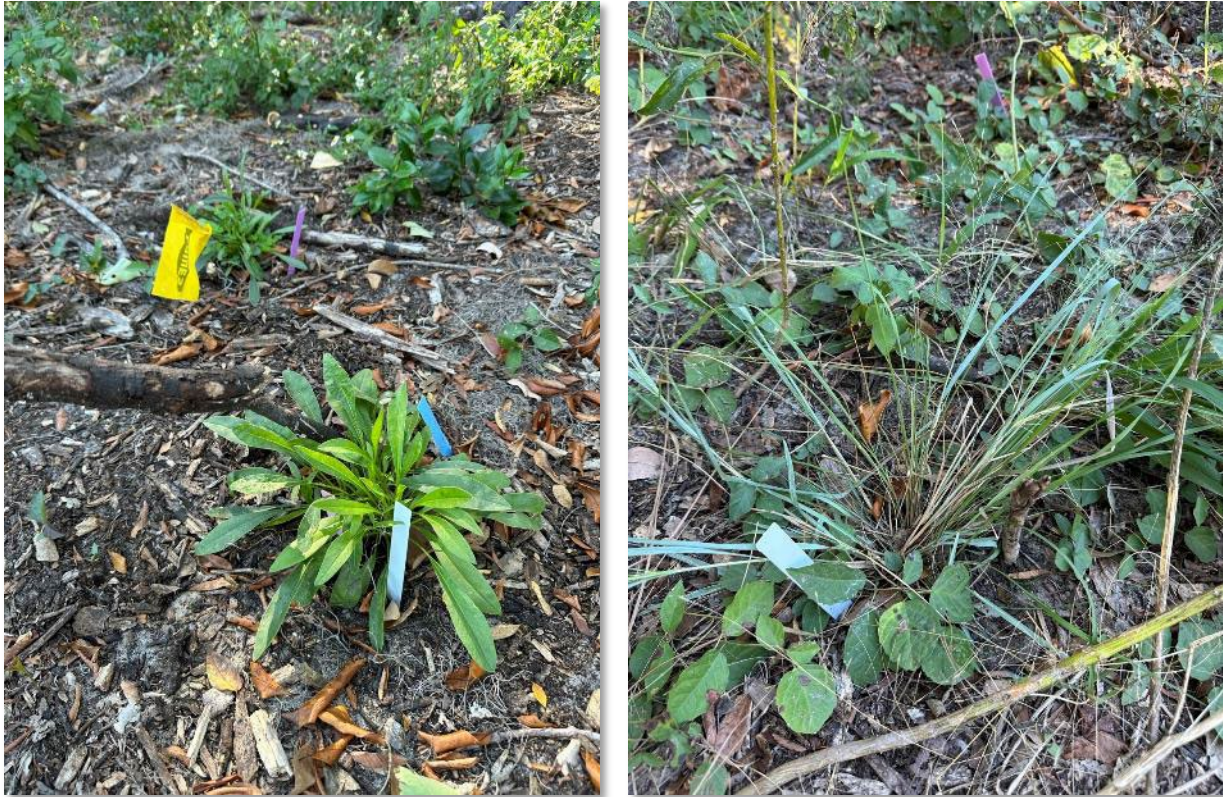
Historically, light availability, human use, vegetative material, and landscaping in the Conservation Area resulted in the encroachment and establishment of various exotic and invasive species. However, several student organizations have worked to remove non-native vegetation and replant the Conservation Area with appropriate native species. All of the Conservation Area edges are currently mowed and the groundcover in the un-mowed portions of the site is indicative of a disturbed system. Roughly half of the total groundcover is Guinea hen weed. This is likely the result of disturbances to the vegetative structure of the McCarty Woods Conservation Area including the maintenance of the (now) un-mowed forest floor as a lawn (University of Florida, 2011b). Observed during the site visit, were recently planted native

species from the UF Native Plant Nursery (Figure 59) along the eastern border of the Conservation Area along Newell Drive. Although there remains room for ecological enhancement in this Conservation Area, it is proof that the UF Conservation Areas can be successfully maintained for exotic and invasive plant cover while simultaneously serving as an outdoor educational facility and place of respite for UF students and faculty.

Figure 59. Native Plants Installed on the Eastern Edge of the McCarty Woods Conservation Area

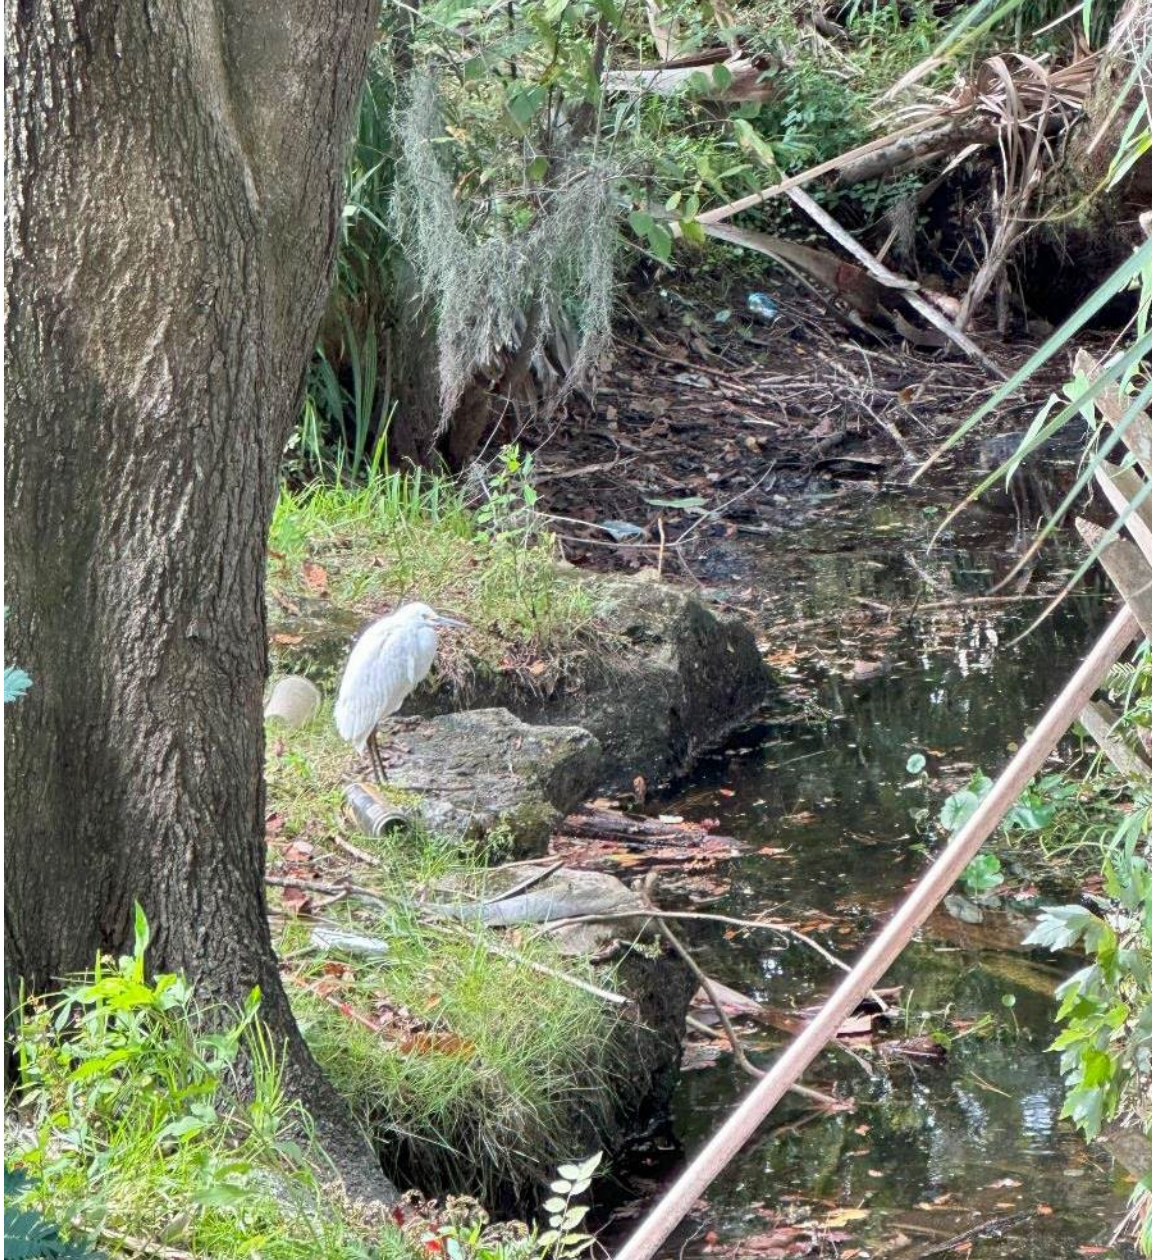
Figure 63. Little Blue Heron and Litter Along the Sinkhole Edge in the Ocala Pond Conservation Area

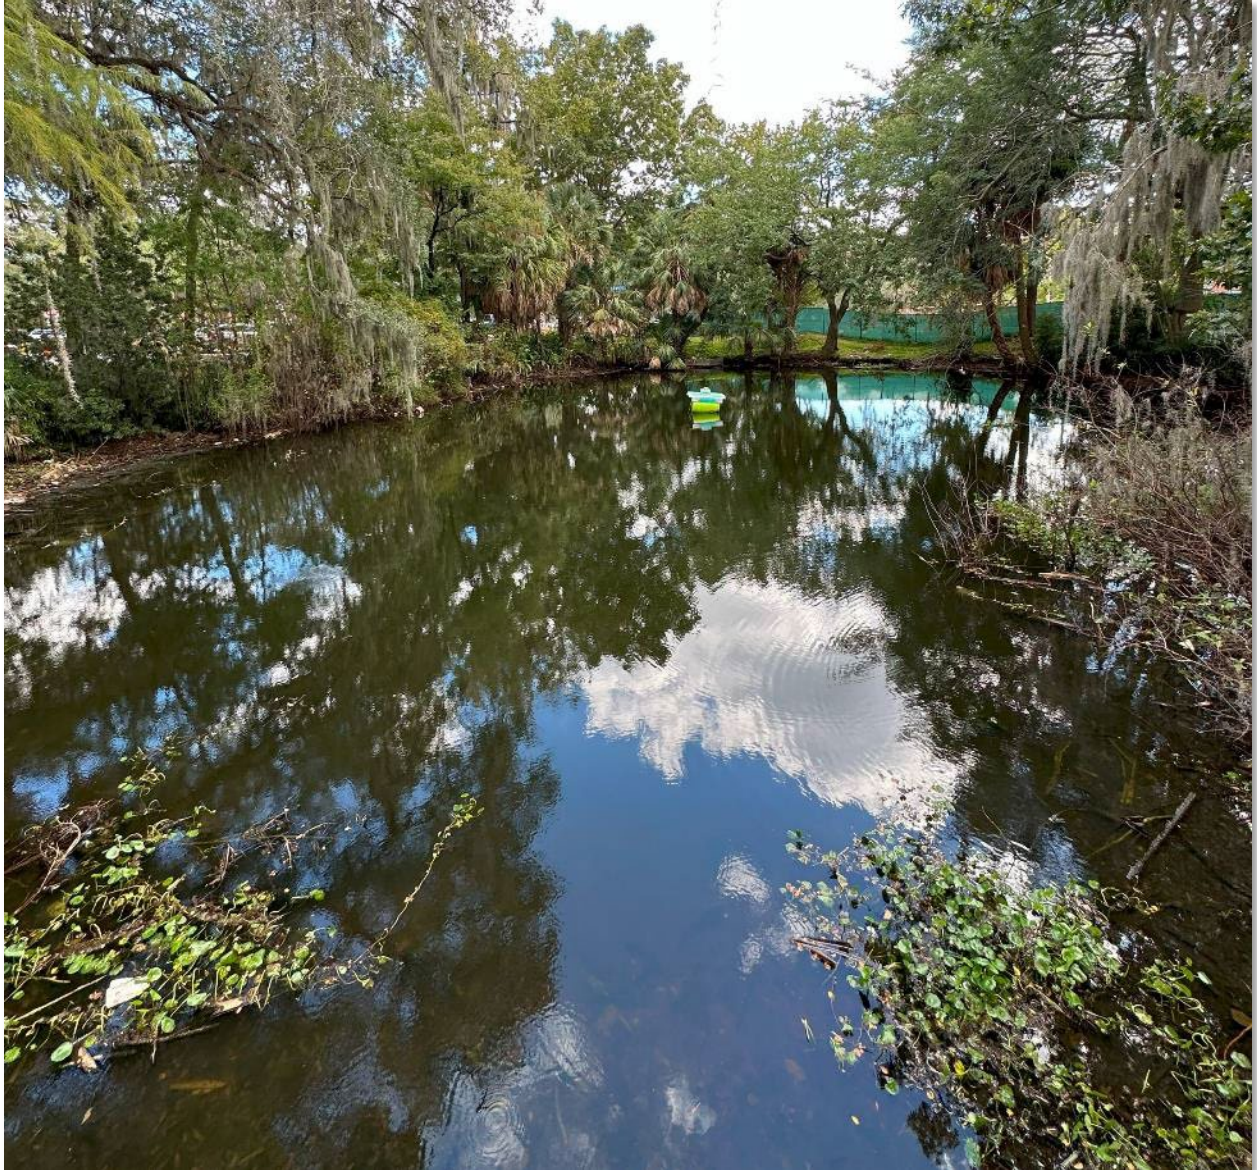
The sinkhole lake portion of Ocala Ponds is a small (roughly 0.25 acres), circular, open water system with steep side slopes and exposed limestone along its northeastern edge. The canopy consists of bald cypress, red maple, and cabbage palms rooted along the sinkhole edges but with a portion of their crown over the open water system. Cover by subcanopy is more scarce including only small sweetgum trees along the edges of the open water system. Groundcover species include buttonbush, pennywort, and sweetgum.

The open water community receives stormwater inputs from direct impervious surface runoff and stormwater pipes that are likely to impact water quality through sediment and pollutant loading.

Figure 64. Sinkhole Lake Community in the Ocala Pond Conservation Area

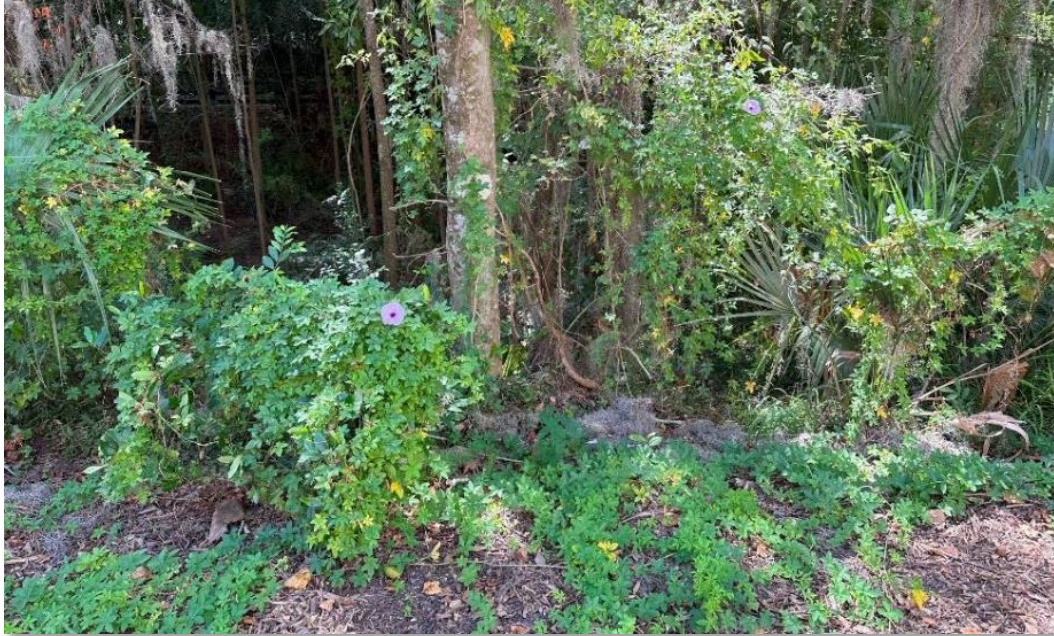
A small area directly west of the Reitz Union Drive Loop resembles a mesic hammock community but was surveyed as part of the upland hardwood forest. The upland hardwood forest is a closed canopy system including sugarberry, sweetgum, and camphor tree. Other common canopy species include box elder, southern magnolia, swamp chestnut oak, and cabbage palm. The subcanopy is scarce and includes glossy privet, pignut hickory, Florida maple, camphortree, sweetgum, and Carolina laurel cherry. Groundcover species include American evergreen, tuberous swordfern, and small-leaf spiderwort. Other common groundcover species include catclaw vine, crossvine, Carolina laurel cherry, and muscadine grape.

Figure 67. Northwestern Edge of the Upland Hardwood Forest in the Reitz Ravine Woods Conservation Area

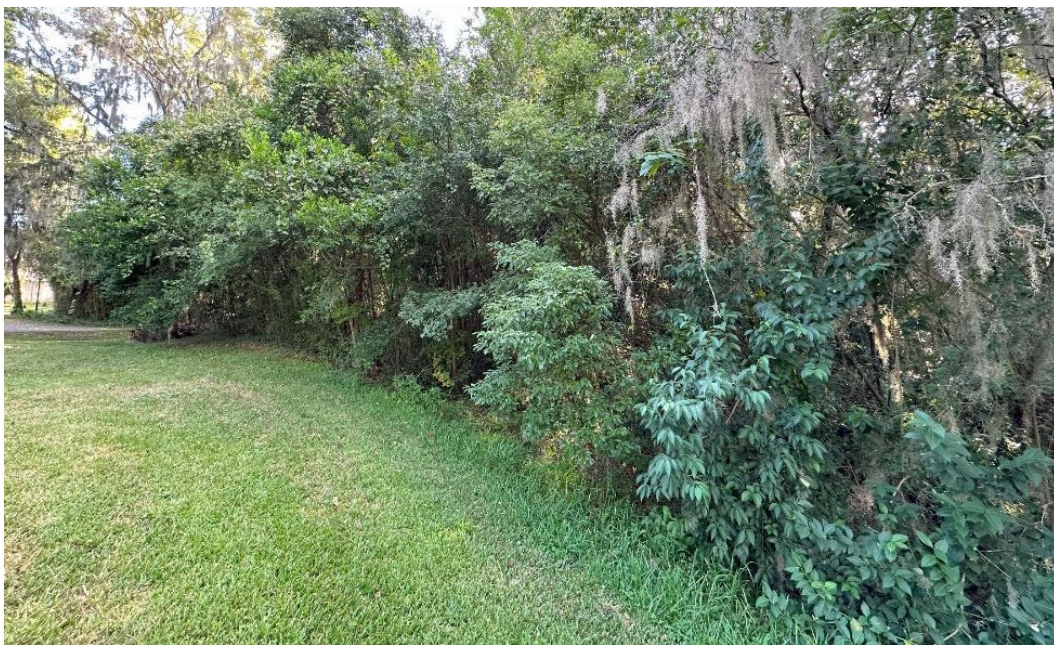
Figure 68. Reitz Ravine Woods Upland Hardwood Forest and Mowed Landscape Interface

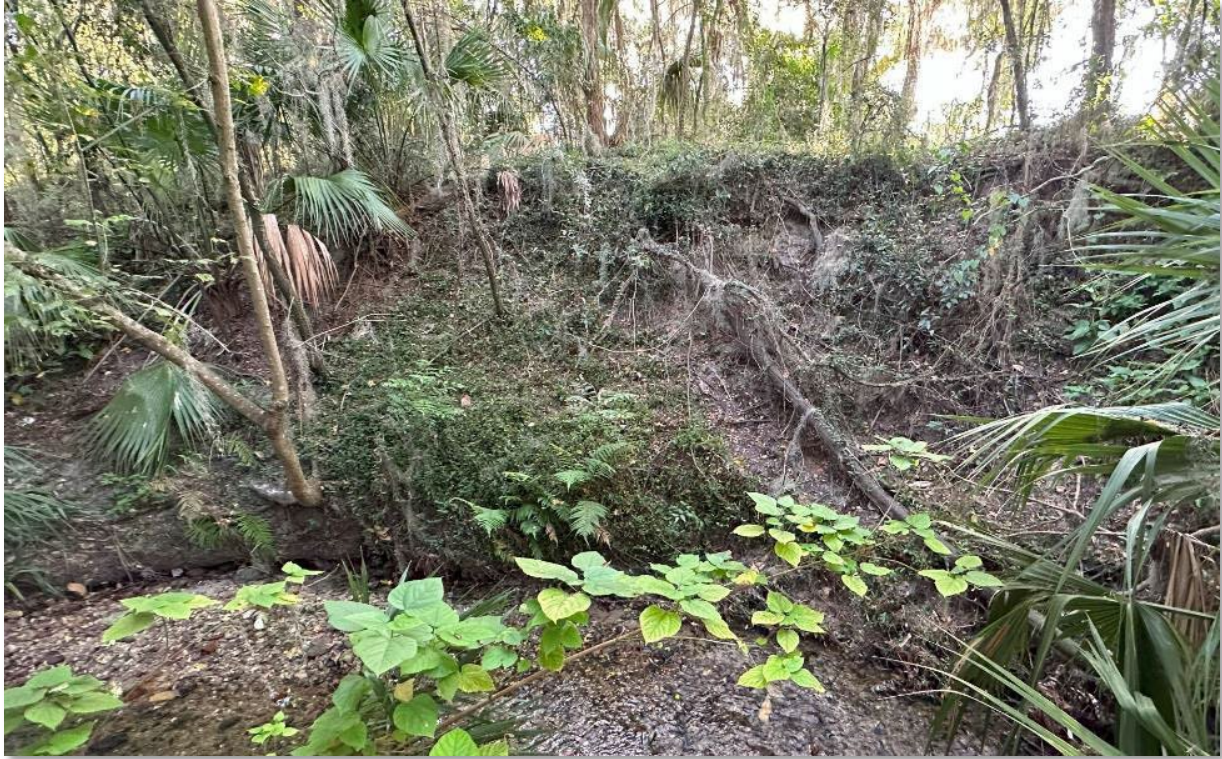
Figure 69. Erosion and Bank Failure in Reitz Ravine Woods

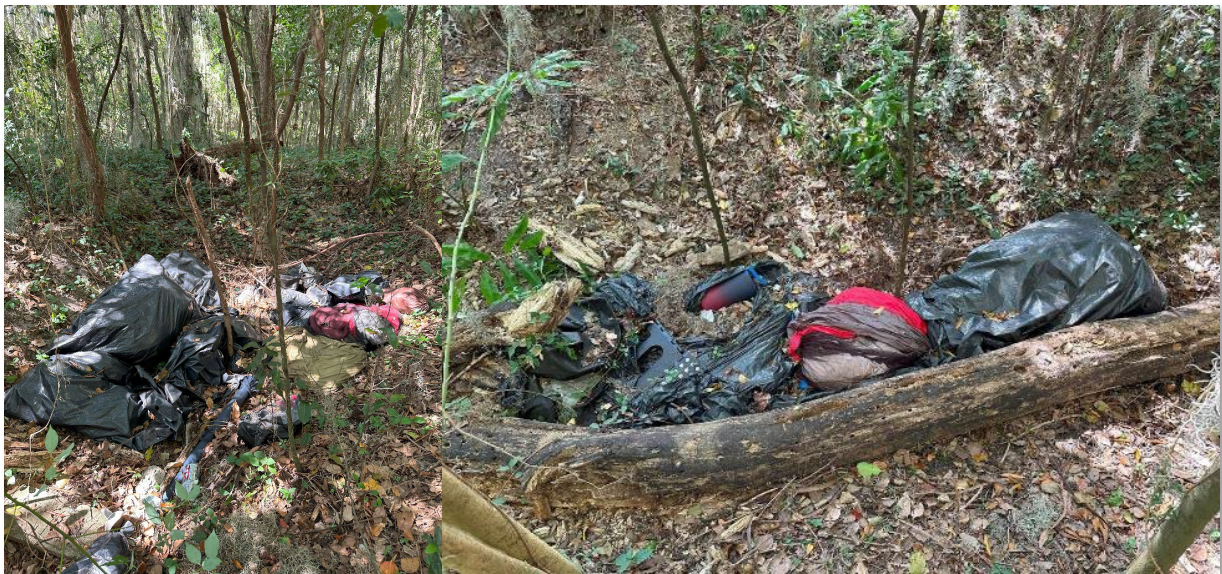
Figure 70. Litter in Reitz Ravine Woods

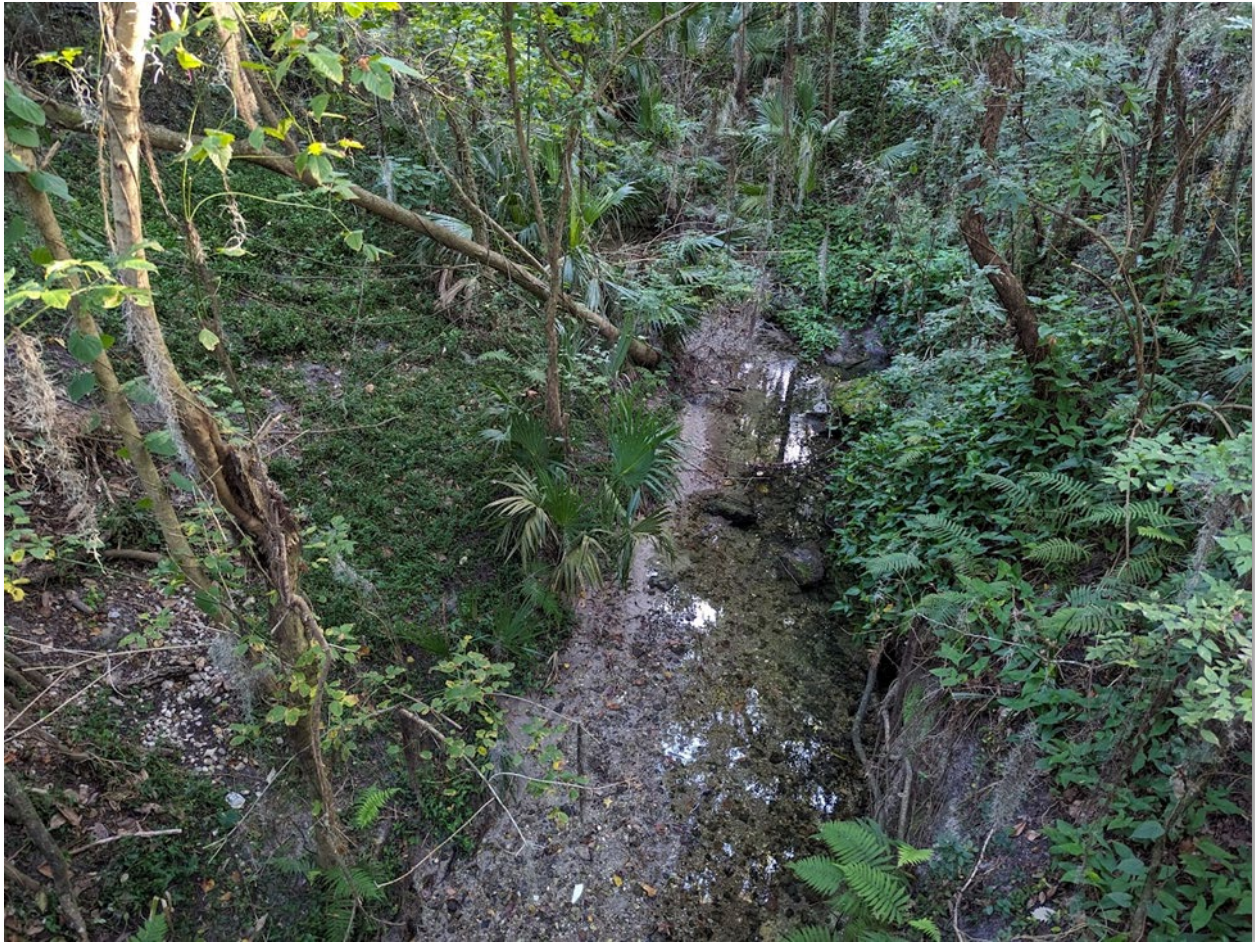
Figure 71. Dense Small-leaf Spiderwort (left of the creek) and American Evergreen (both FISC Cat I) (right of the creek) in the Reitz Ravine Woods Conservation Area Bottomland Forest

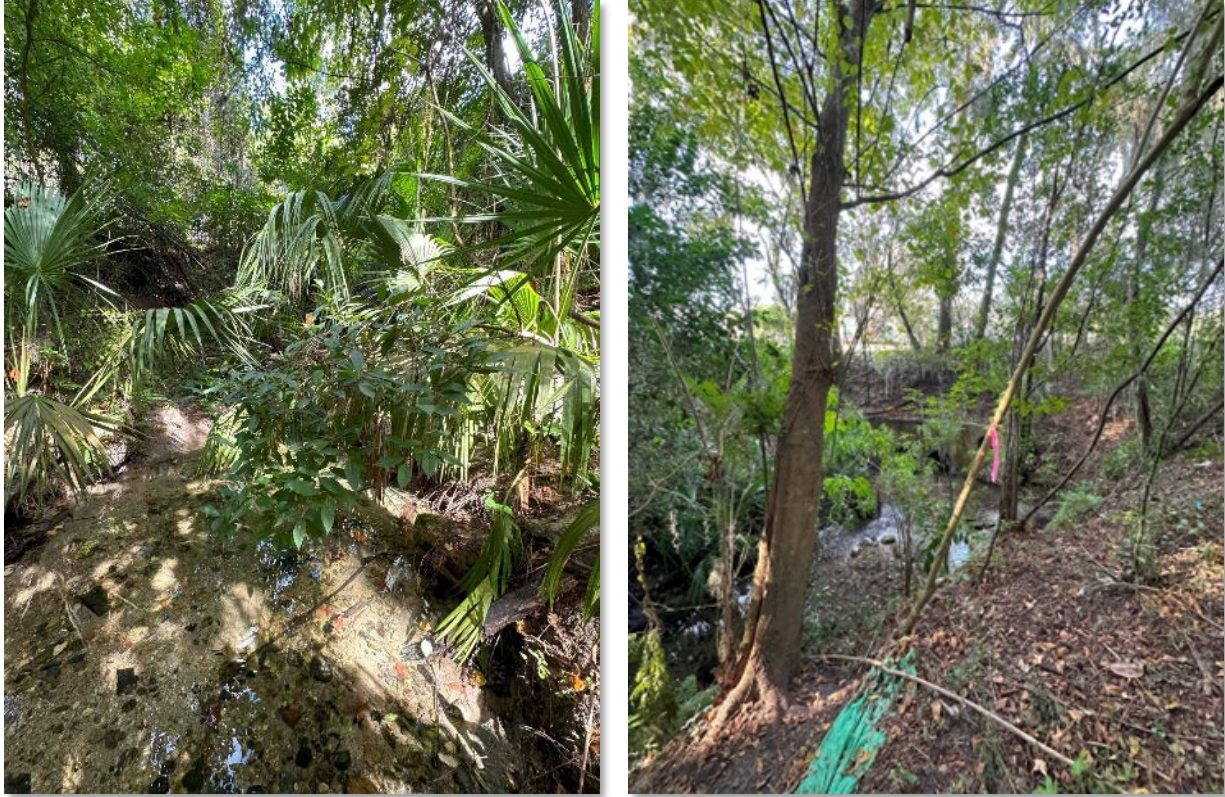
Figure 72. Bottomland Forest (left) and the Upland Hardwood Forest (Right) Communities in the Reitz Ravine Woods Conservation Area
