Attachment F – Lake Alice Watershed – Stormwater Project Prioritization and Concepts

Prepared for
University of Florida

August 2024

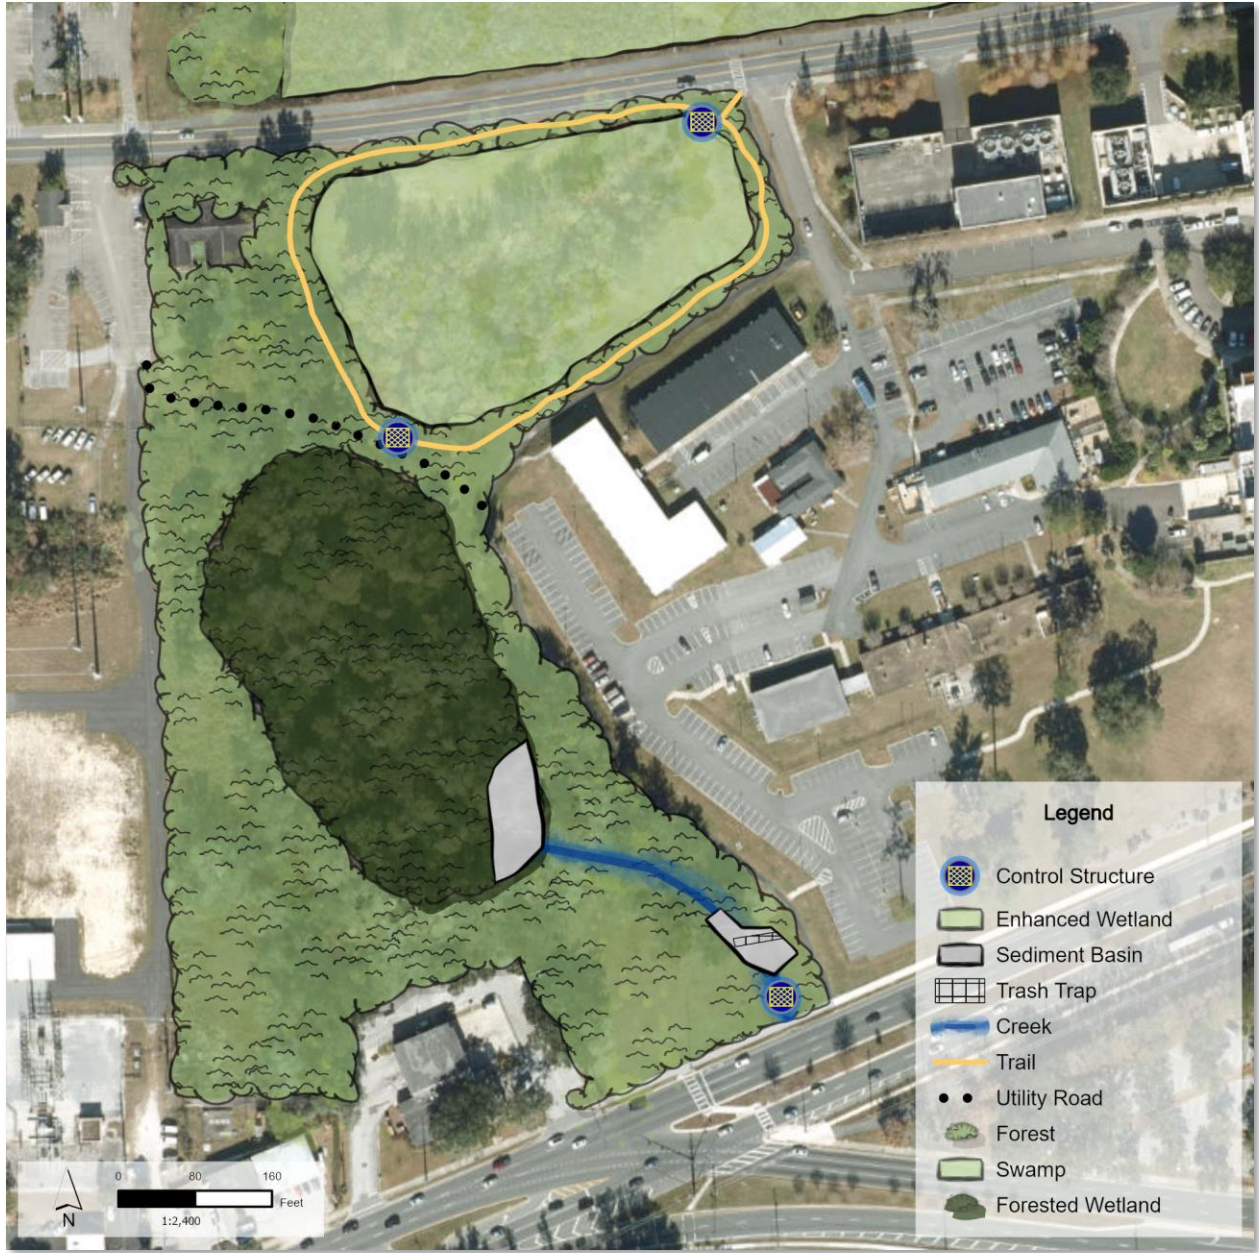
Lake Alice South is located south of Mowry Road and receives runoff from Archer Road and seepage from higher elevation areas near Archer Road. This area contributes significant flows to Lake Alice during storm events. This area has the potential to provide regional stormwater storage and treatment and reduce peak flows to Lake Alice. The concept proposed for this location includes a stormwater treatment wetland with an expanded footprint, a sediment trap, a trash trap, and control structures. This wetland design proposes to establish an upstream forested wetland and a downstream emergent marsh with a maintainable sediment basin and trash trap. This project will result in wetland impacts that will require mitigation. Given the proposed expanded footprint of this project and the improvements being made, this project may produce excess wetland mitigation credits that could be used to offset wetland impacts in other areas of campus. The project concept is shown in Figure 8. The estimated costs for this conceptual project are shown in Table 8.

Figure 8. Lake Alice South Stormwater Wetland Concept

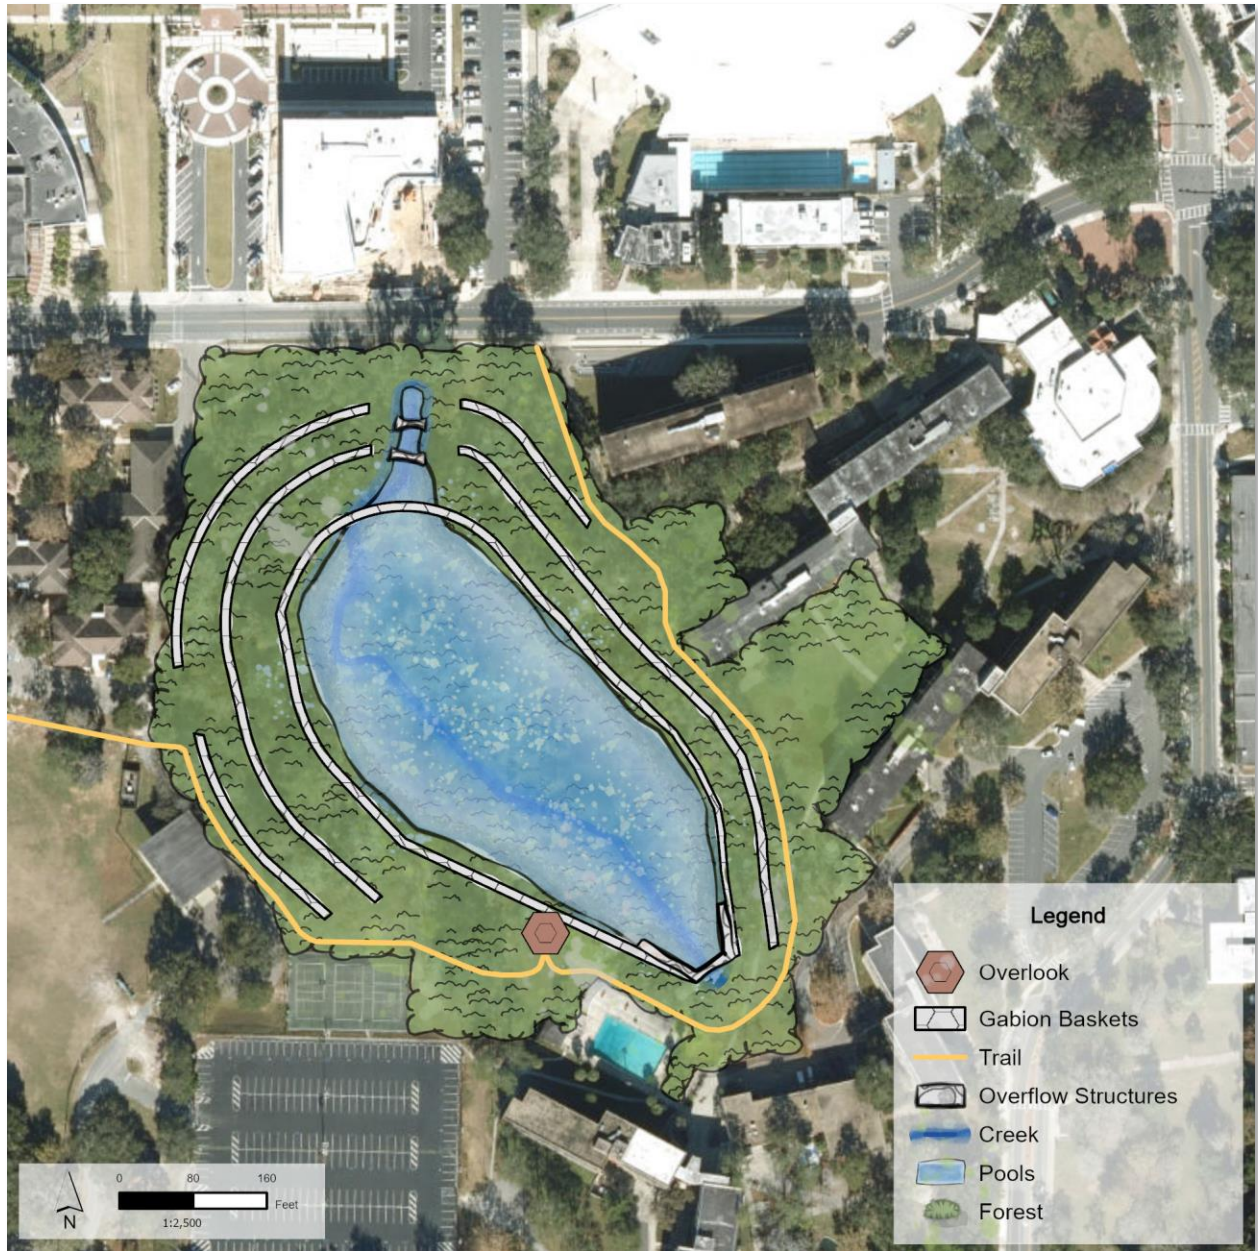
Graham Woods has been impacted by stormwater inputs from adjacent impervious areas that have increased flows into the Conservation Area and that have caused substantial erosion. These stormwater inputs have resulted in erosion that risks impacting sidewalks, electrical infrastructure, and a service drive adjacent to the Keys Complex. Within the woods, erosion has contributed to fall risks and the loss of trees. This concept proposes complete stabilization of the banks that surround Graham Woods, re-direction of stormwater from the top of slope to the bottom of the enhanced wetland, and construction of a new outlet structure that will stage water up during rainfall events to provide storage and treatment. The plan also proposes to remove invasive vegetation and establish desirable trees and groundcover. The proposed concept is shown in Figure 9 with the opinion of probable cost in Table 9.

Figure 9. Graham Woods Stabilization and Treatment Concept

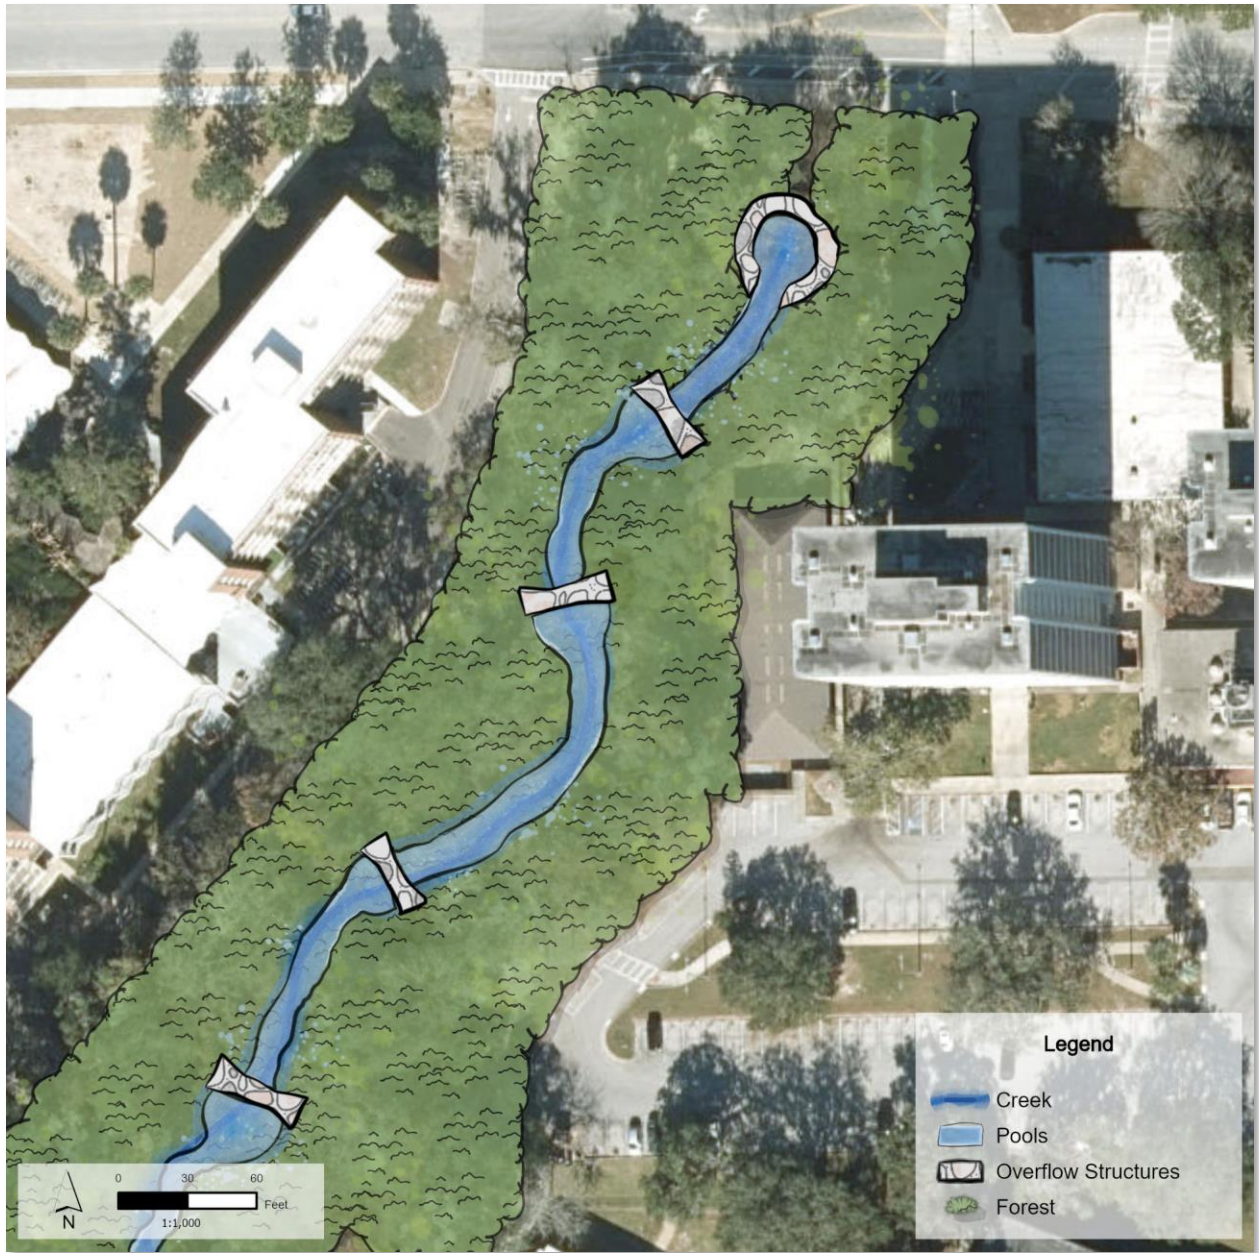
Water flows into Jennings Creek from Yulee Pit and stormwater collectors along and under Museum Road. Immediately south of Museum Road water enters Jennings Creek through a 48" RCP pipe. Water exiting this pipe has caused erosion and the failure of the headwall supporting this pipe. This has resulted in the separation of the headwall and last segment of pipe from the stormwater pipe. The failure of this headwall has also allowed additional erosion of the creek bank adjacent to Museum Road. This causes risk to infrastructure including the road and has resulted in very steep creek banks that pose a safety risk.

The proposed project for Jennings Creek includes the construction of a step-pool system that will include sheetpile oriented perpendicular to flow in the creek with directed downstream overflows to protect the bed of the channel and support a plunge pool at the outlet of the current stormwater pipe to reduce energy and erosion. Also included in the design are gabions for bank stabilization and pipe modifications to reduce erosion from current stormwater pipes that flow to the creek. The proposed concept is shown in Figure 10 with the opinion of probable cost shown in Table 10.

Figure 10. Jennings Creek Step-Pool Stabilization Concept
