Lake Alice Watershed Management Plan

Prepared for
University of Florida

August 2024

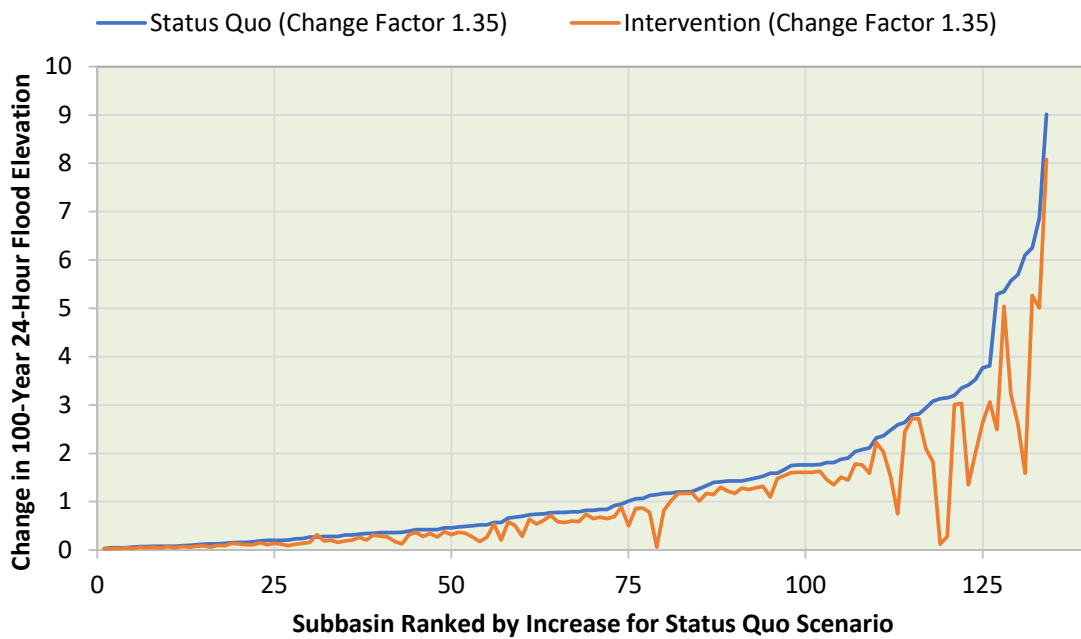
Figure 4. Change in 100-Year, 24-Hour Floodplain Elevation With and Without Stormwater Interventions (RCP4.5)

effect of implementing LID and GSI across the model domain was simulated based on the previously described assumptions. The result of these changes was a reduction in floodplain levels when compared to the status quo (without intervention). For the RCP4.5 scenario with interventions, levels increased by 0.03 to 8.08 feet in the Lake Alice Watershed. The median decrease in levels within the Lake Alice Watershed compared to the status quo simulation was 0.15 feet with a maximum reduction of 4.5 feet. The RCP8.5 simulation with interventions had a range of increases from 0.03 to 9.31 feet within the Lake Alice Watershed. The median decrease in this simulation compared to the status quo scenario was 0.12 feet with a maximum reduction of 2.25 feet. Figure 4 and Figure 5 show the changes in floodplain levels for each subbasin, ranked based on the increase in the status quo (without interventions) scenario. For the RCP4.5 scenario with stormwater interventions the total model domain floodplain was 327 acres with 171 acres of floodplain within the Lake Alice Watershed. For the RCP8.5 scenario the floodplain was 348 acres within the model domain with 180 acres in the Lake Alice Watershed.

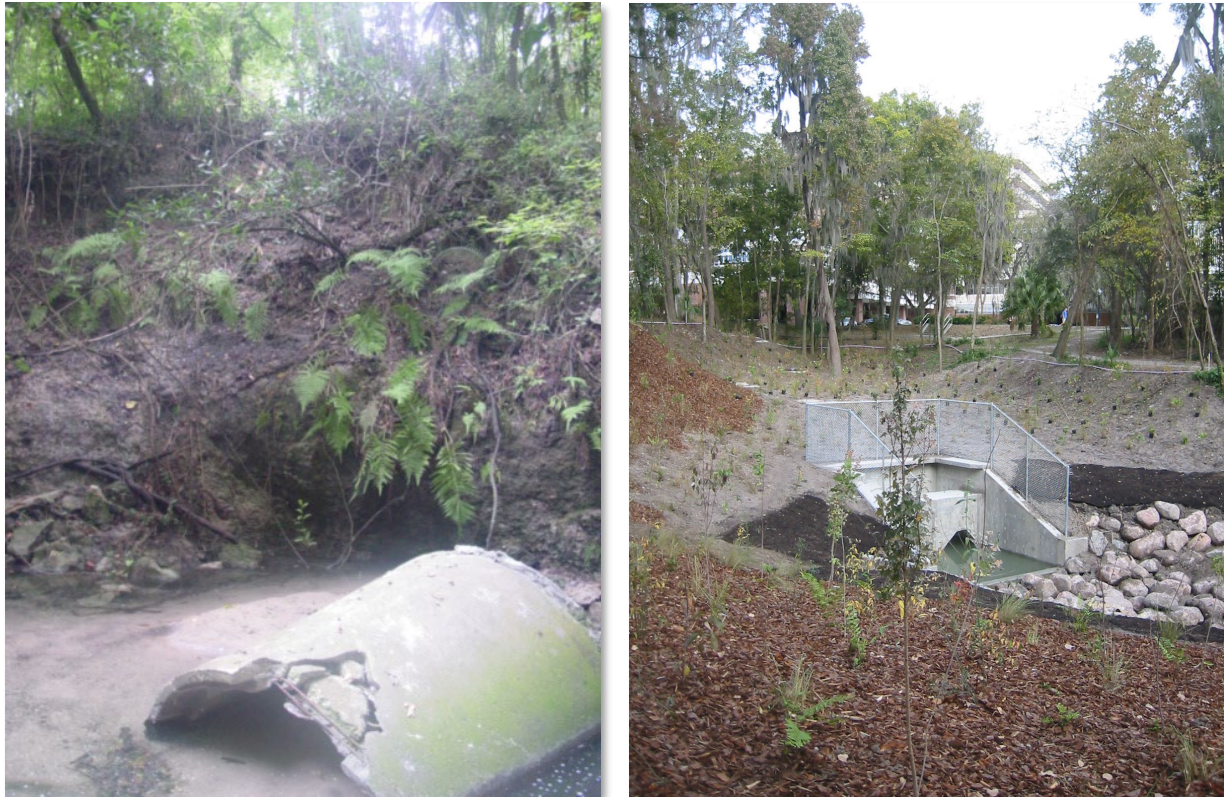
Figure 7. Reitz Ravine Before (2004) and After (2007) Repair and Stabilization

Projects identified as critical projects are needed to address failing infrastructure and life safety issues. All of the critical projects address extreme channel erosion. The University has successively completed similar repair projects in the past at Reitz Union Ravine, as shown in Figure 7, and at Diamond Creek. These projects were completed using a combination of new, hard infrastructure to provide energy dissipation and reduce erosion and vegetative restoration to stabilize slopes, reduce erosion, and improve habitat.

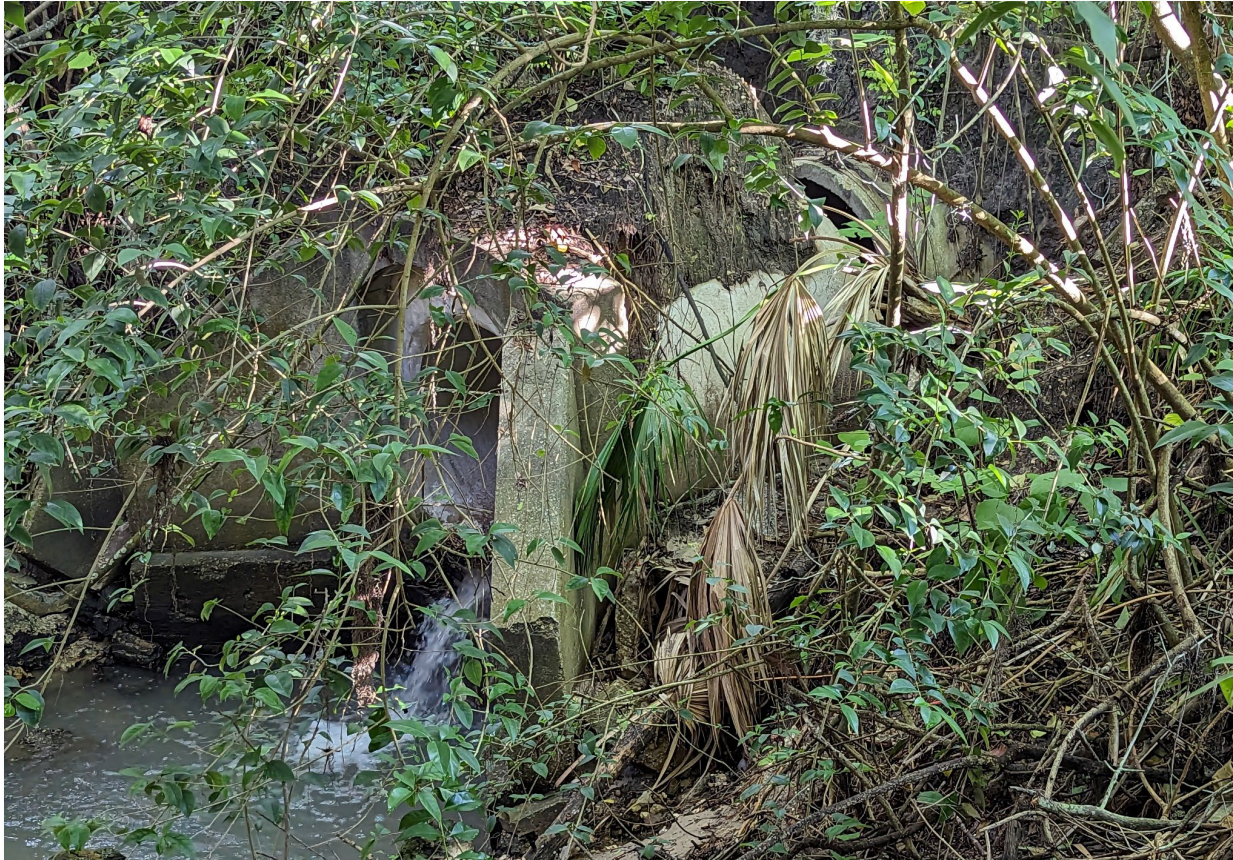
Figure 8. Jennings Creek Headwall Separation

Jennings Creek is one of the primary creeks on campus that conveys stormwater to Lake Alice. The creek begins at Yulee Pit, located just west of SW 13th Street, and flows through a 48" pipe under Museum Road, northwest of Beaty Towers. At the downstream end of the pipe under Museum Road, the headwall that supports the pipe has collapsed and created a separation in the last joint of the pipe (Figure 8). This collapse is due to the volume and velocity of stormwater moving through this pipe falling on an unprotected creek bed which caused the erosion of material that previously supported the headwall. During a site inspection by UF Facilities on July 5, 2023, the pipe was evaluated using a remotely-operated camera. At that time, it was determined that no additional pipe joints were separated. Upon inspection of the channel further downstream, a failed weir stretches across the creek. This feature appears to have historically backed water up, creating a pool that would have absorbed the energy coming through the Jennings Creek pipe. This weir appears to have failed due to water flanking around the end of the weir,

which resulted in bank instability and the loss of trees along the channel edge. The loss of this pool allowed for upstream erosion of the material supporting the headwall and contributed to its collapse.

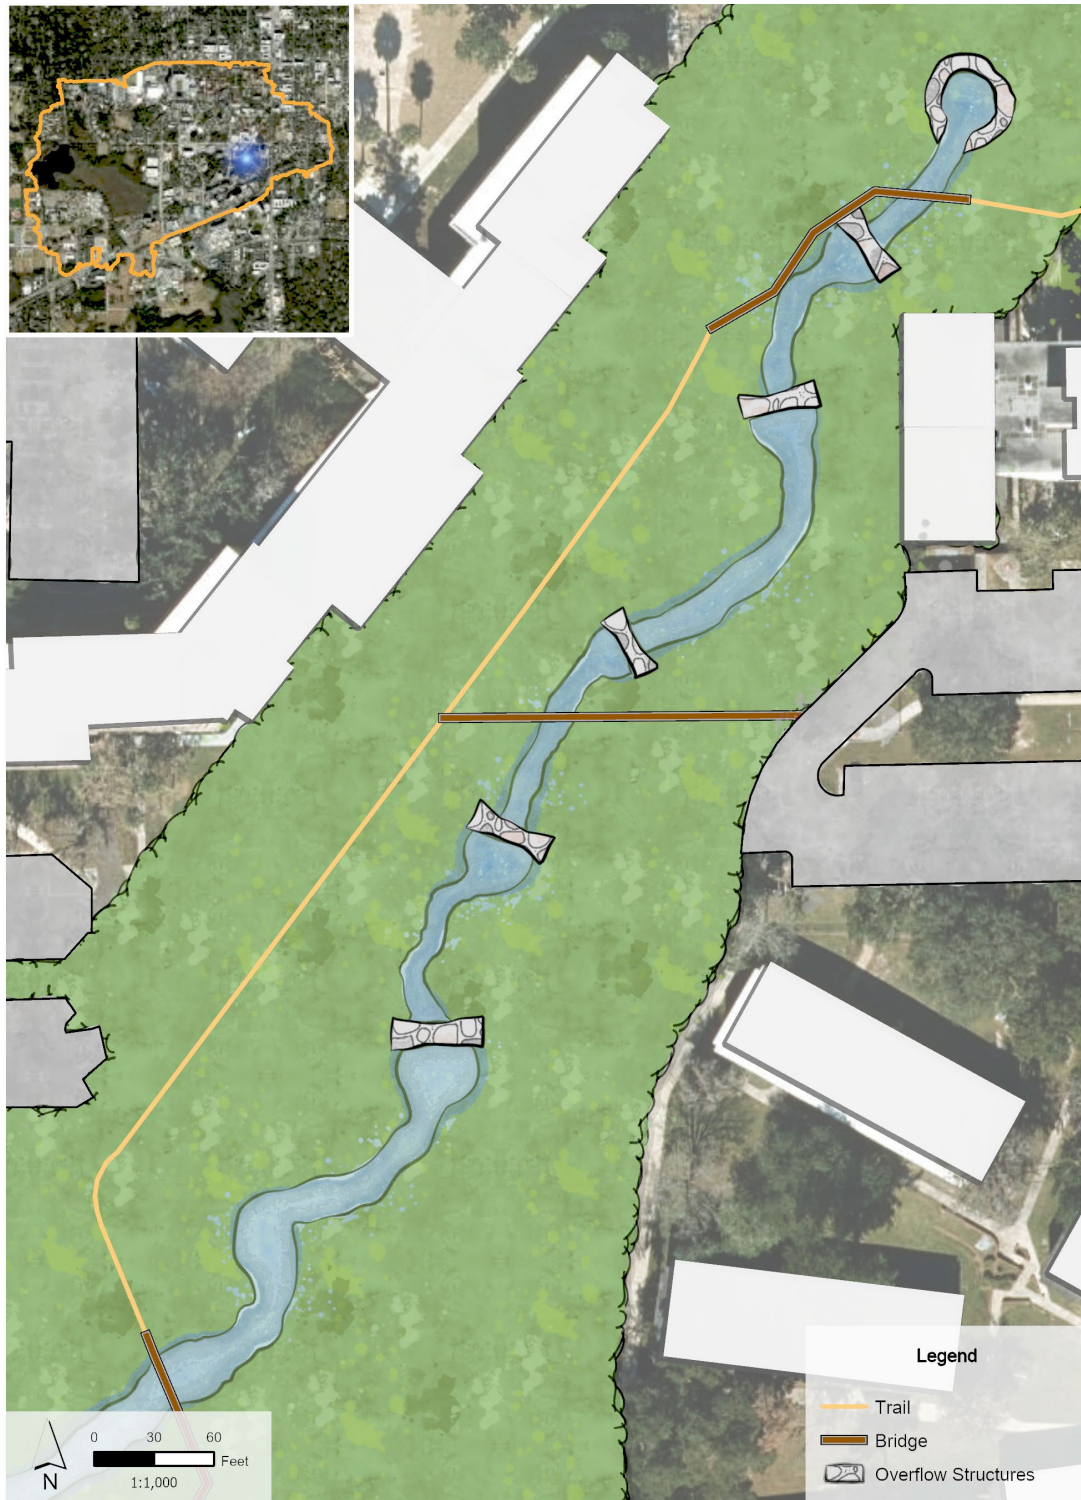
Figure 9. Jennings Creek Headwall and Step-Pool Improvements

The proposed project in this area consists of a series of step-pools with a new headwall installed on the Jennings Creek pipe. The conceptual design performs two necessary functions. The headwall replacement is necessary to allow flow through the pipe without additional upstream failure that might affect the integrity of the pipe and Museum Road. Pairing this replacement with the step-pool design will allow for energy dissipation on the downstream end of this pipe, which will protect the headwall and downstream channel. Rather than the rock and concrete weir that existed downstream on Jennings Creek previously, this project proposes using sheetpile overflow structures installed perpendicular to the direction of flow and beyond the edge of channel to ensure that flows will not erode around or underneath the wall. The sheetpile will be topped with cemented stone to improve aesthetics in the installed system. The existing steep creek banks, depending on location, will be either laid back (slope decreased) or will have gabion baskets to retain the slope and to ensure bank stability. In both cases native planting will be used to increase habitat value, enhance slope stability, and improve aesthetics. The conceptual layout for this feature is shown in Figure 9. The figure includes the conceptual layout for the trails as shown in the Campus Trails Master Plan. The northern-most trail alignment may need to be revised to ensure the trail supports do not increase scour at the toe of the west creek bank.

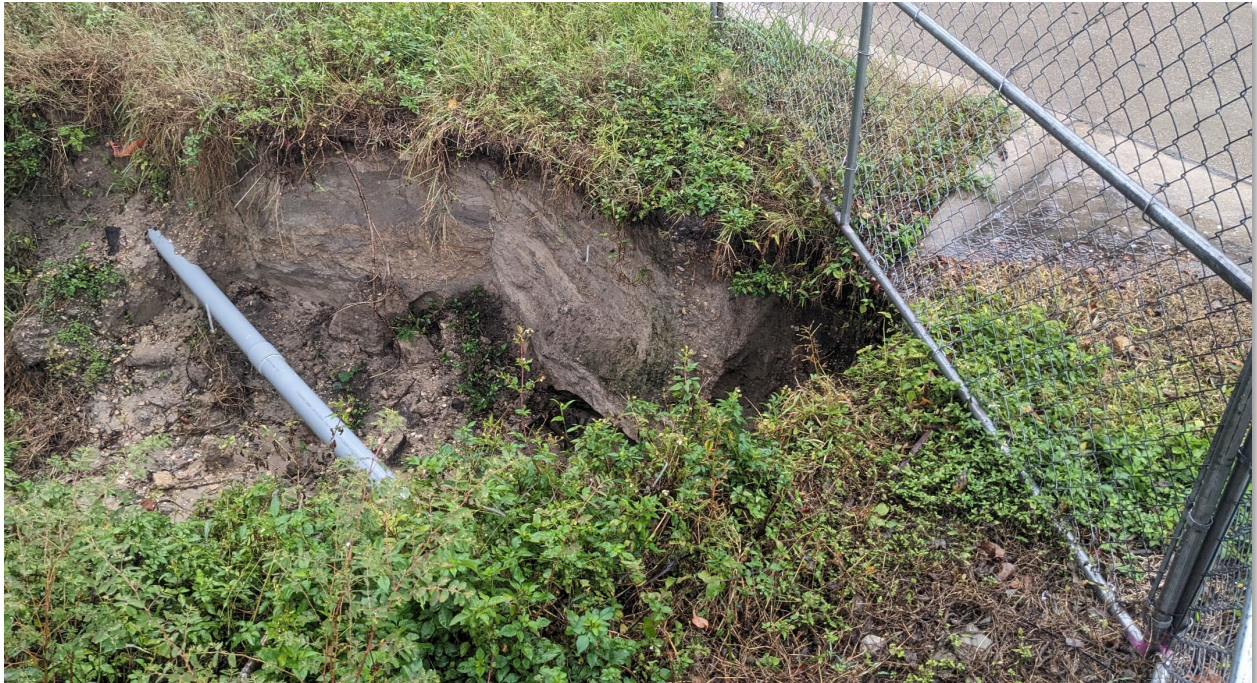
Figure 10. Keys Complex Erosion

The fifteen known pipes that enter Graham woods terminate upslope of the channel, and nearly all terminate outside of the jurisdictional wetland. This configuration has resulted in substantial erosion and bank instability on the perimeter of Graham Woods. At the northwest corner of Graham Woods, stormwater that bypasses inlets along Stadium Road is directed through a curb cut along the Keys Complex maintenance drive and into a vegetated area along Graham Woods. With the construction of the Heavener Football Complex and Student Health Care Center north of Stadium Road, additional stormwater was routed to this location which has resulted in an erosive channel forming along this surface drainage feature. Following initial channel formation, subsequent storms have contributed to additional erosion resulting in a vertical-walled channel approximately six feet deep that extended all the way back to the Keys Complex Drive (Figure 10). This feature exposed a communications conduit and was beginning to undermine the curb cut. Facilities Services used aggregate to form a temporary repair to reduce the potential for additional damage near the driveway.

The resulting channel continues into Graham Woods and has resulted in the loss of soil supporting large trees within the Conservation Area, causing their collapse. The termination of this erosive feature is a deep stormwater feature with a sand-cement riprap wall and two additional pipe outlets (Figure 11). At this location, the higher elevation pipe outlet is collapsing into the deep feature and there are apparent bank stability issues due to the near vertical sides of the stormwater feature. While temporary fencing has been installed to reduce access, the fence has been repeatedly damaged by people to allow access. Temporary repairs have been made in this area to resolve the erosion near Keys Complex Drive as of August 2024.

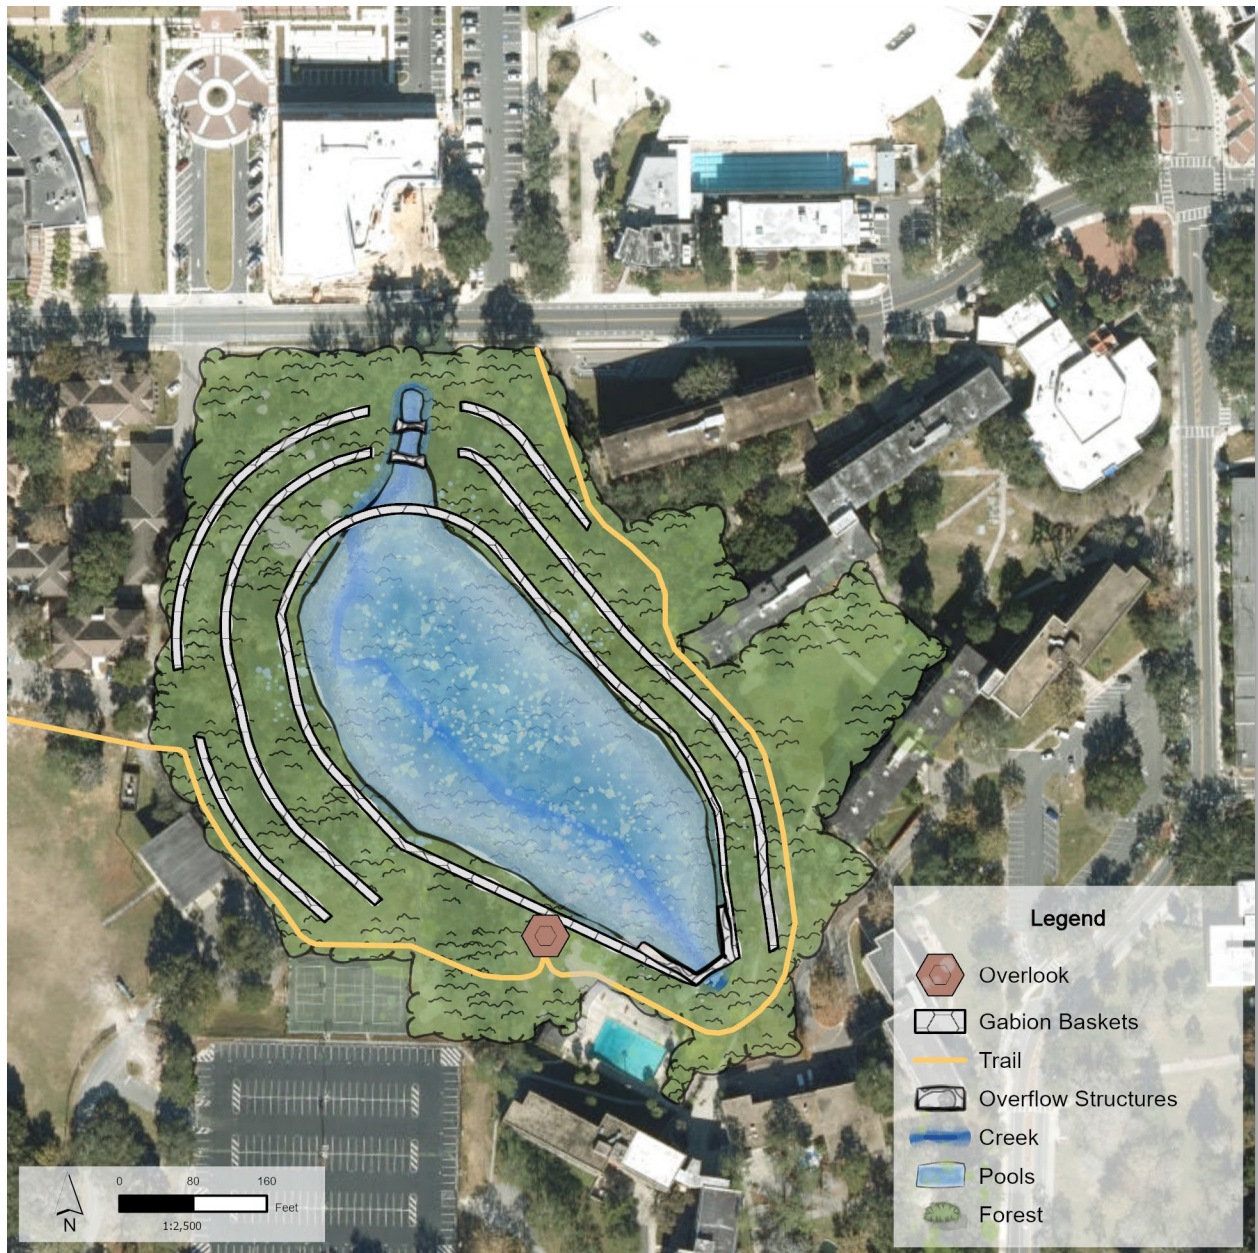
Figure 12. Graham Woods Stabilization and Stormwater Basin

The proposed project in this area includes constructing one or more grade control structures in the bottom channel. Concrete structures, such as baffled end walls and riprap aprons, will dissipate energy for stormwater inflows and provide erosion protection for the various stormwater pipes currently discharging into Graham Woods. To reduce erosion along the edges of Graham Woods, the side slopes will be recontoured and strategically hardened with gabion baskets, stormwater pipes will be extended with inverts lowered to enter the bottom of Graham Woods, and native vegetation will be installed to secure soils. Native plantings will also be used to restore habitat value and to improve aesthetics and recreational opportunities. To address upstream stormwater inflows, inlets along Stadium Road will be milled to capture flow more effectively, and a new stormwater inlet and pipe will be considered along the Keys Complex driveway to route flows into one of the existing stormwater inflow pipes rather than overland. Ideally the proposed project will also re-route the stormwater conveyance around Graham Hall rather than under it. The proposed concept for Graham Woods is shown in Figure 12.

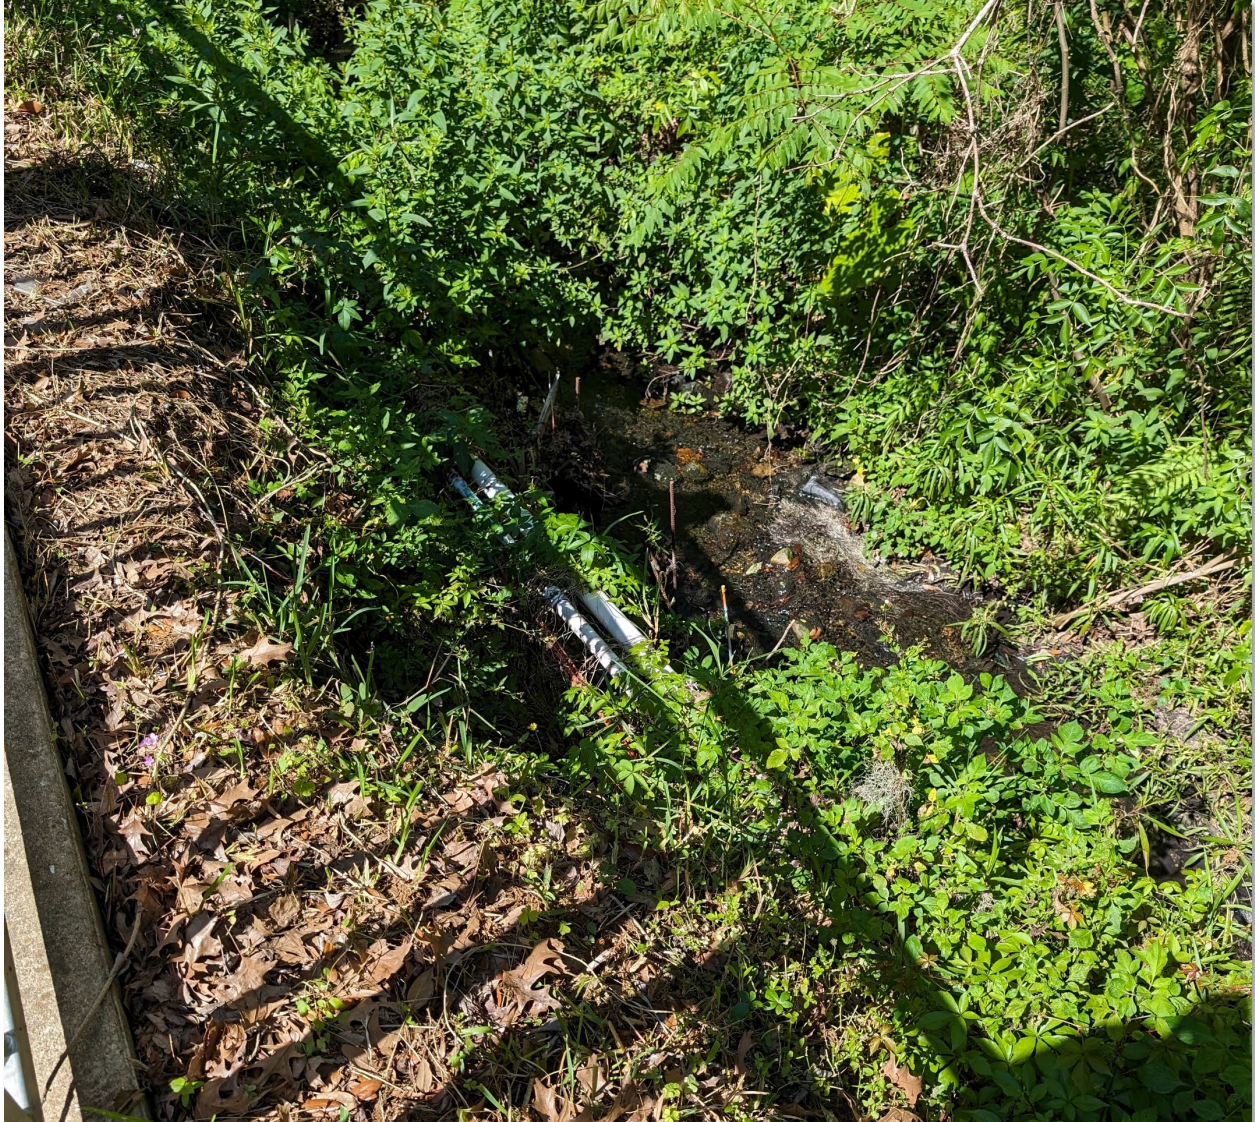
Figure 13. Lake Alice Creek Along McKnight Brain Institute Sidewalk

The McKnight Brain Institute is located downstream of the confluence of Jennings and Diamond Creeks. In this location, the sidewalk was constructed into the wetland that buffered the creek channel. The earthen embankment next to the sidewalk was constructed with a steep slope and included utilities between the sidewalk and the creek. The creek has eroded the toe of slope due to sheer stress and changes in the flow characteristics of the system. This has resulted in flows being directed toward the

edge of the sidewalk, which has exposed utility conduits (Figure 13). This erosion risks undermining the existing sidewalk, and if it migrates further, a road and loading dock may also be impacted.

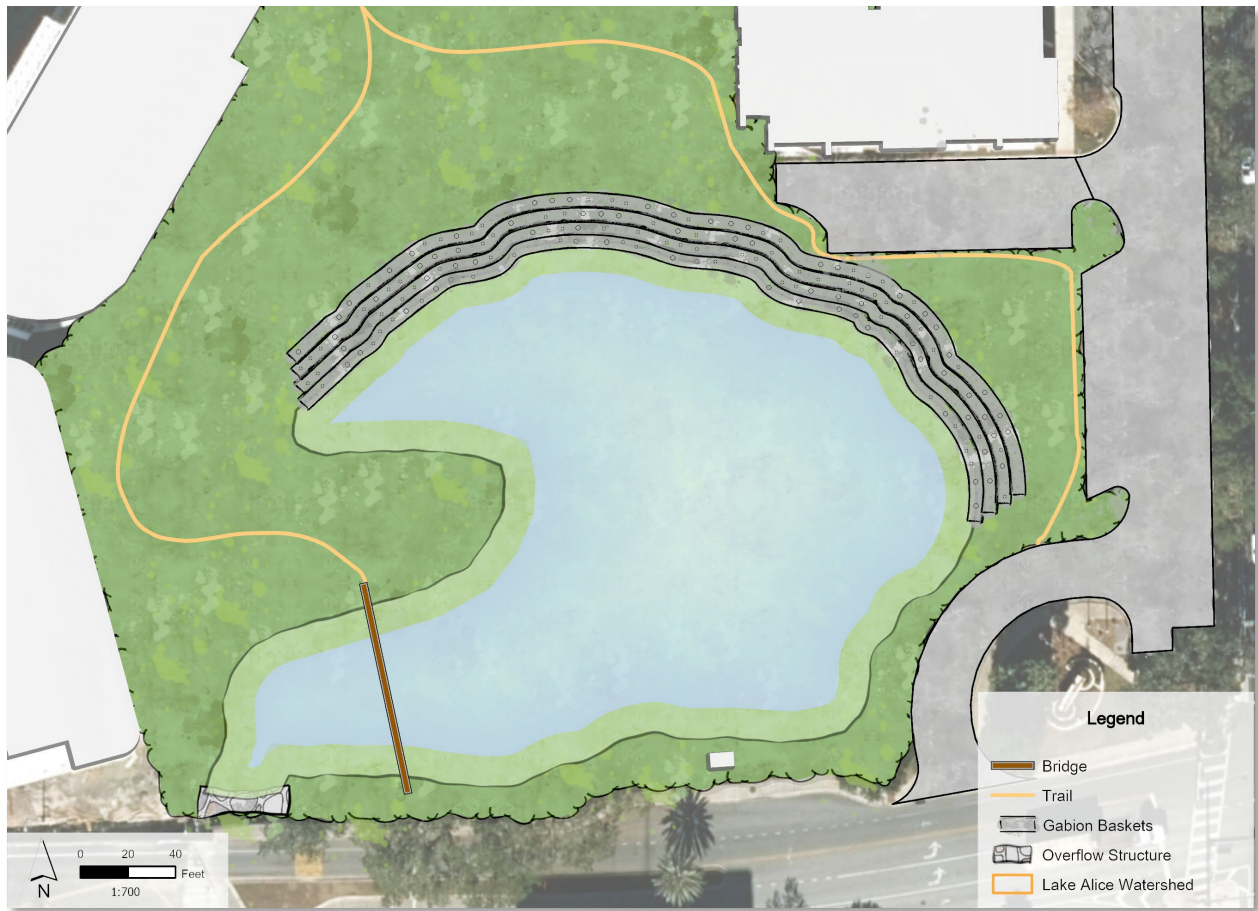
Figure 15. Yulee Stormwater Park

The recommended project at this location is a stormwater park that includes an open-water feature, fountain/aerator, littoral fringe, stabilized slopes, and human use features. Developing this feature will serve four primary purposes: increasing storage in the headwaters of Jennings Creek, dissipating energy associated with new multi-story development, improving water quality, and creating an inviting and accessible gateway to UF. This feature was conceptualized as a stormwater amphitheater with stabilized and landscaped slopes which would provide a functional outdoor space for recreation, relaxation, and outdoor learning. Trails would be developed to connect adjacent buildings efficiently and would include overlooks of the park-like setting. The concept developed for this location is shown in Figure 15.

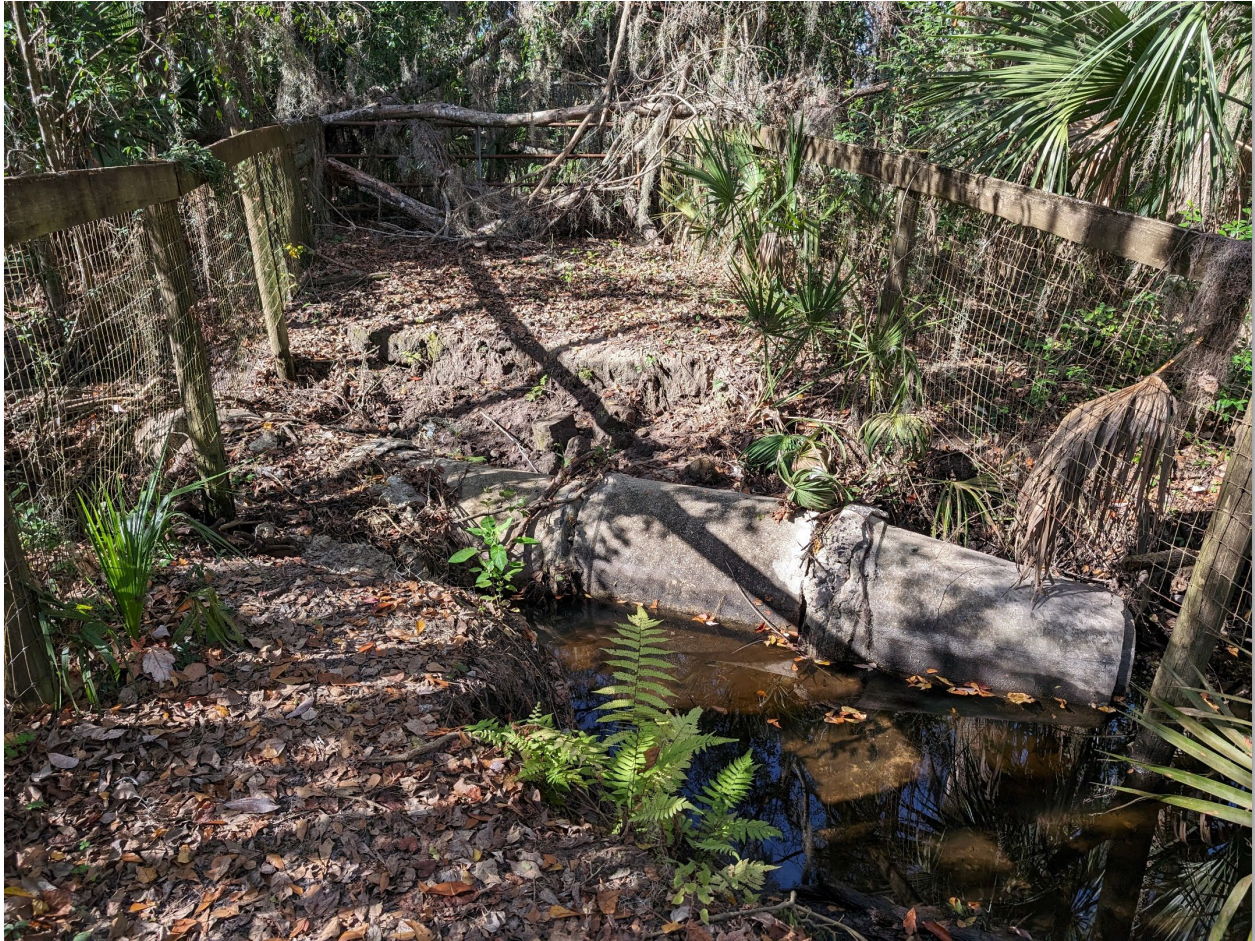
Figure 16. Washed-Out Dirt Road in Lake Alice South Conservation Area

The proposed project in this area includes installing a trash trap downstream of Archer Road and expanding the wetland to incorporate upland and grassed areas downstream of a former culvert and road crossing that has eroded and failed (Figure 16). A trash trap will help capture refuse that currently migrates to Lake Alice from Archer Road and will facilitate efficient collection and disposal of the accumulated material. Given that this trash is generated from Archer Road, discussions should be initiated with FDOT to install and maintain this system. Repair of the existing creek crossing and expansion of the wetland will provide the following benefits to the watershed and Lake Alice: improved water quality, increased

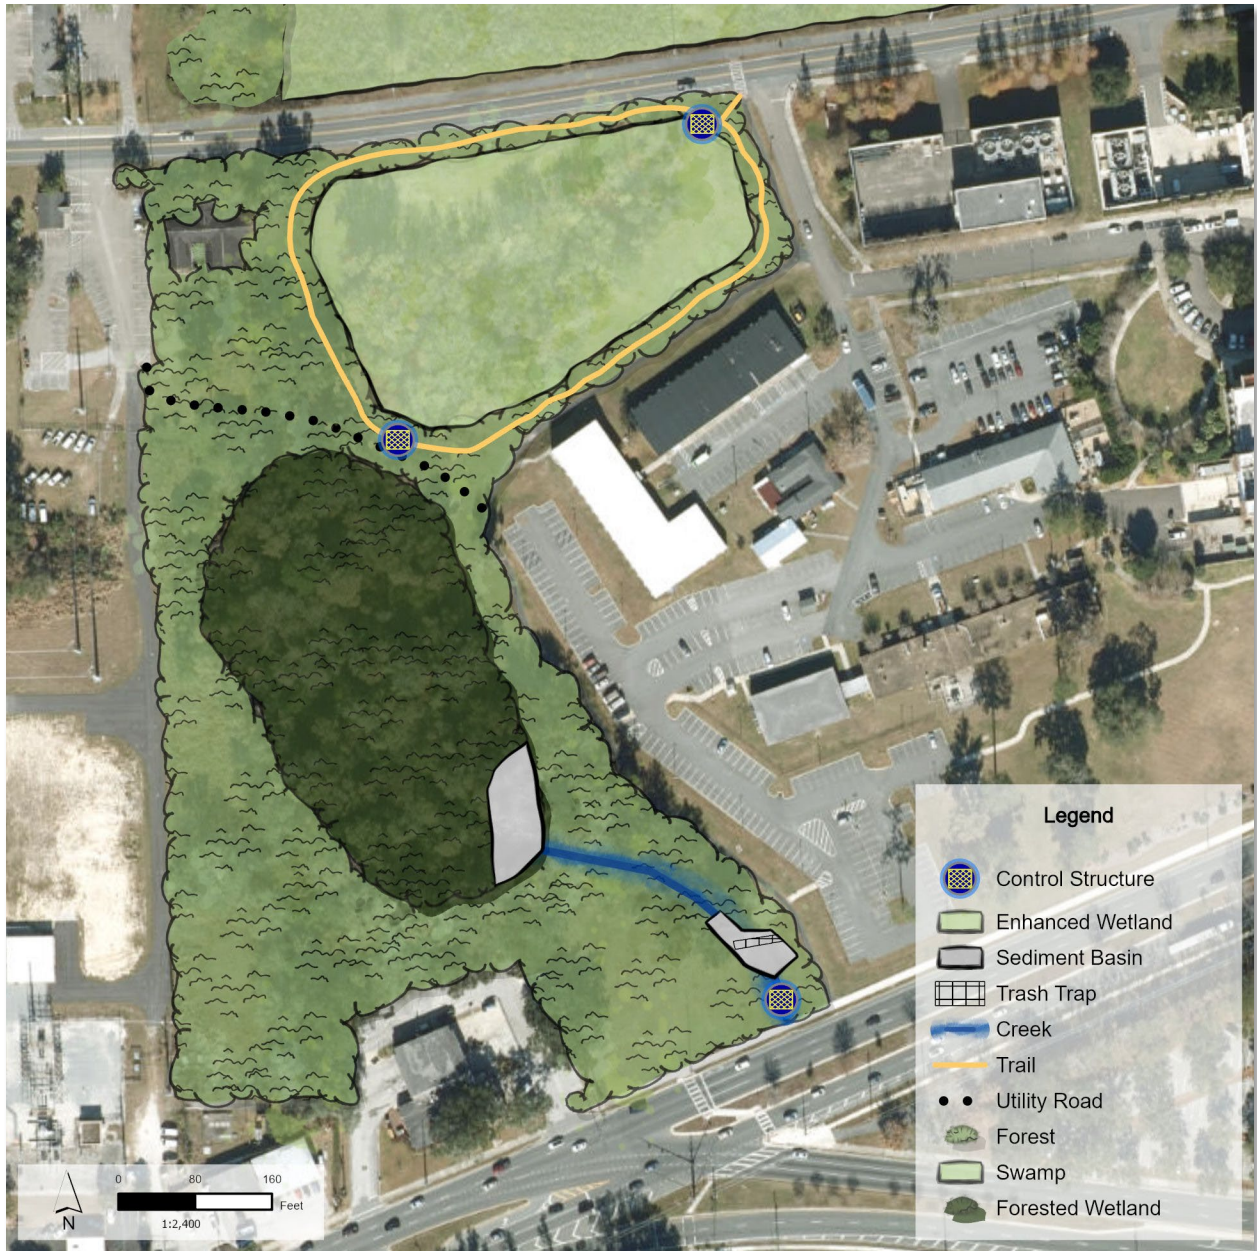
Figure 17. Lake Alice South Stormwater Wetland

stormwater attenuation, and the creation of a passive use wetland park as a recreational amenity in the southern portion of campus. The proposed layout for this location is shown in Figure 17.

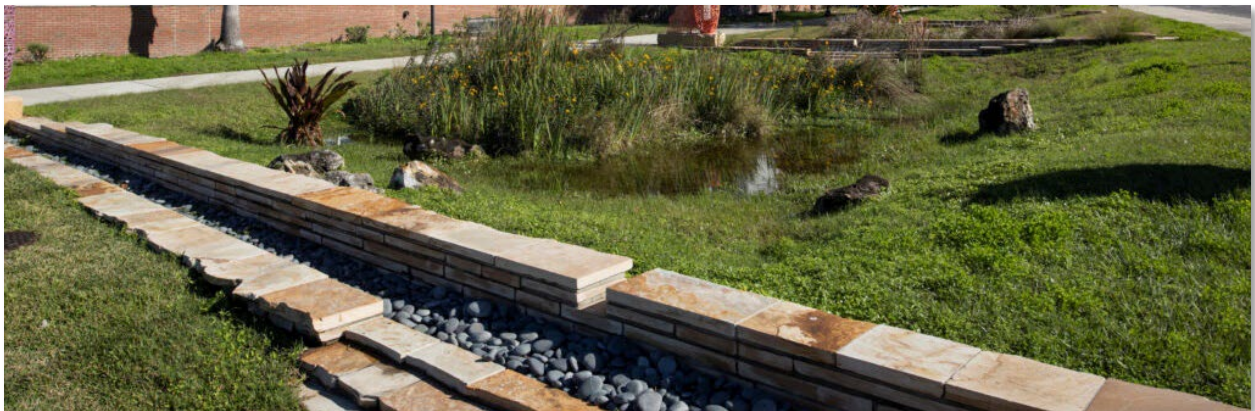
Figure 18. UF Southwest Recreation Center Rain Garden (The Nature Conservancy, n.d.)

Available forms of LID/GSI that would be optimal for developed areas of campus include bioretention, rain gardens, vegetated swales, curb cuts with recessed median storage, and permeable pavement. The Southwest Recreation Center has a rain garden, as shown in Figure 18. Many of these practices can be incorporated in the existing landscape through minor changes to grade, slopes, and small structural modifications. As an example, the surface parking lot at the O'Connell Center currently includes vegetated swales and curb cuts. However, the structures that convey this water into the stormwater network are at or near grade, meaning that minimal water is stored in these features before discharge. By modifying these structures to increase the grate elevation and incorporating a lower elevation orifice, these features could provide storage while still draining back to the bottom of the swale within 48-72 hours. There are opportunities for vegetated landscaped beds that are often bordered by brick curbs or seat-walls in many locations on campus. These areas could be redesigned with lower grades and curb cuts or orifices to allow water to infiltrate into the ground or drain into the stormwater network in a more controlled fashion during storm events.
