7.
CONSERVATION
DATA & ANALYSIS

I. Introduction

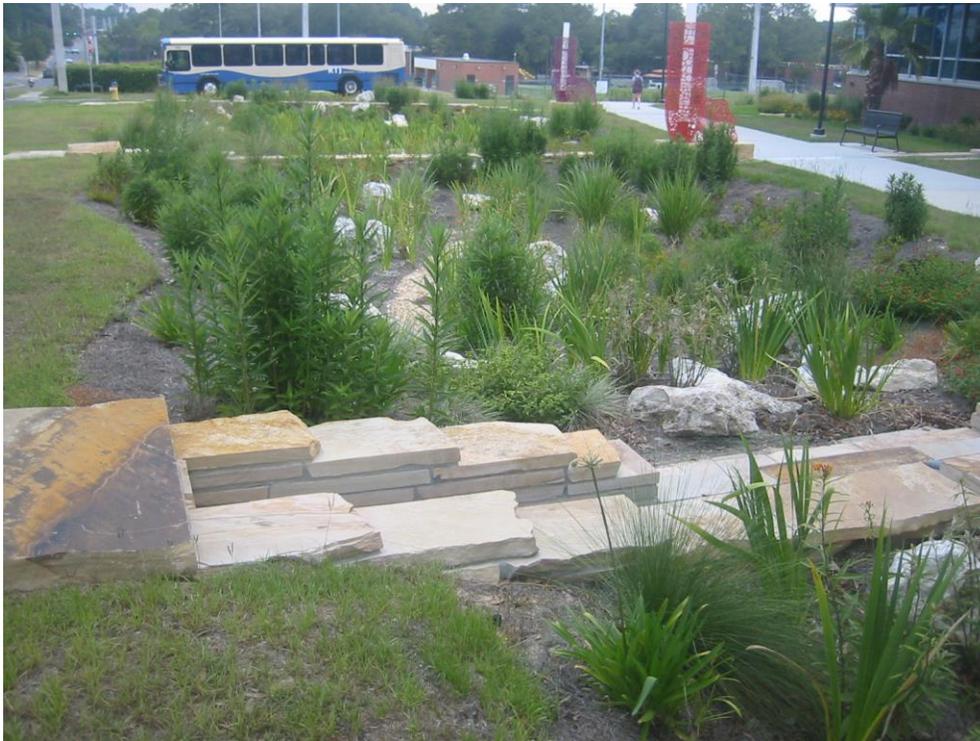
This example illustrates a bio-retention (rain garden) stormwater treatment in front of the Southwest Recreation Center.

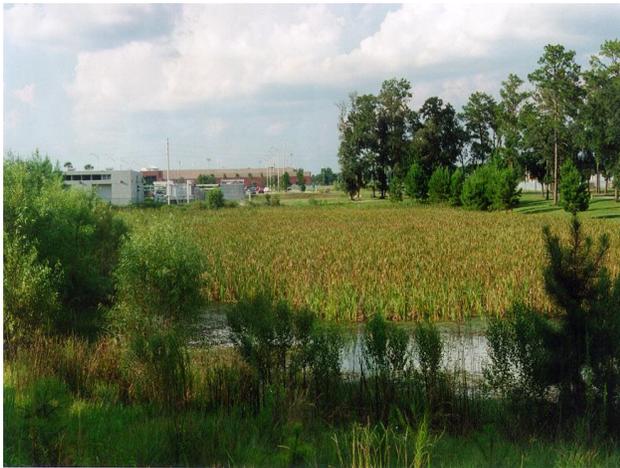
Pre-SEEP (looking north) – Cattail dominated

Another approach that uses the traditional stormwater pond design with an ecological design twist is a large scale bio-retention area, which is a BMP that should be considered in developing areas of campus. This approach to stormwater retention can be found currently at the Stormwater Ecological Enhancement Project (SEEP), adjacent to the Performing Arts parking lot and the Natural Areas Teaching Lab (NATL) Conservation Area. The retention pond was originally constructed in 1988 as a typical wet retention pond with a flat bottom and no attention paid to plant species diversity. In 1995, an initiative to redesign the basin into a more ecologically sensitive manor that befitted its placement next to the NATL was initiated. As articulated by its designers, the primary goal of the SEEP was to increase the diversity of flooding depths and frequency of flooding that will occur, since this is the primary factor regulating species composition in a wetland. To do this, two depressions (one 4-feet, the other 5-feet deep), were dug at the southeastern end of the pond providing a deep, open-water habitat. At the north end a low berm was constructed to temporarily impound 80% of the entering stormwater. This forebay provides the first phase of treatment and was planted with species known to take up heavy metals and remove nutrients. Water from the forebay is then slowly released, first flowing through an area planted to resemble a bottom-land hardwood swamp, moving into a shallow freshwater marsh and then entering the deep-water ponds. The basin was planted with species that resemble those found in wetlands of North Central Florida.

The expected benefits of this type of retention are species diversity, wildlife habitat, aesthetics, water quality, and research potential. All of these benefits have been shown to have merit at the SEEP, however one issue remains that has not been adequately studied. This issue is the potential effects that these ponds have on wildlife, and particularly federally listed species. Since stormwater ponds are designed to treat the noxious constituents found in run-off, they are laden with metals, pesticides and fertilizers all of which can prove harmful to wildlife. The main species of concern that use ponds for foraging are wading birds, such as the federally listed Wood Stork. At present little research has been conducted on what the long-term impacts are on these species from utilizing stormwater detention, roadside swales, and ecologically enhanced ponds. Arguments can be made that these species will utilize wet retention ponds regardless of whether they have been ecologically enhanced, however it is equally likely that by enhancing them the probability of more productivity (more food) will encourage increased use. Thus, while it is hoped that these ponds are the panacea that is a win-win, additional research is sorely needed.

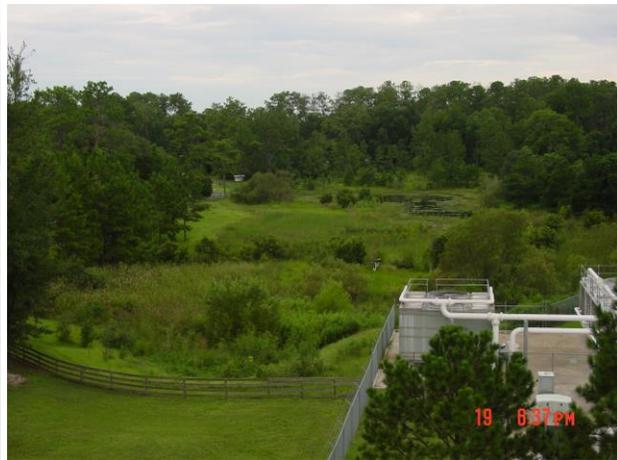
SEEP (looking south) – Variety of plant species

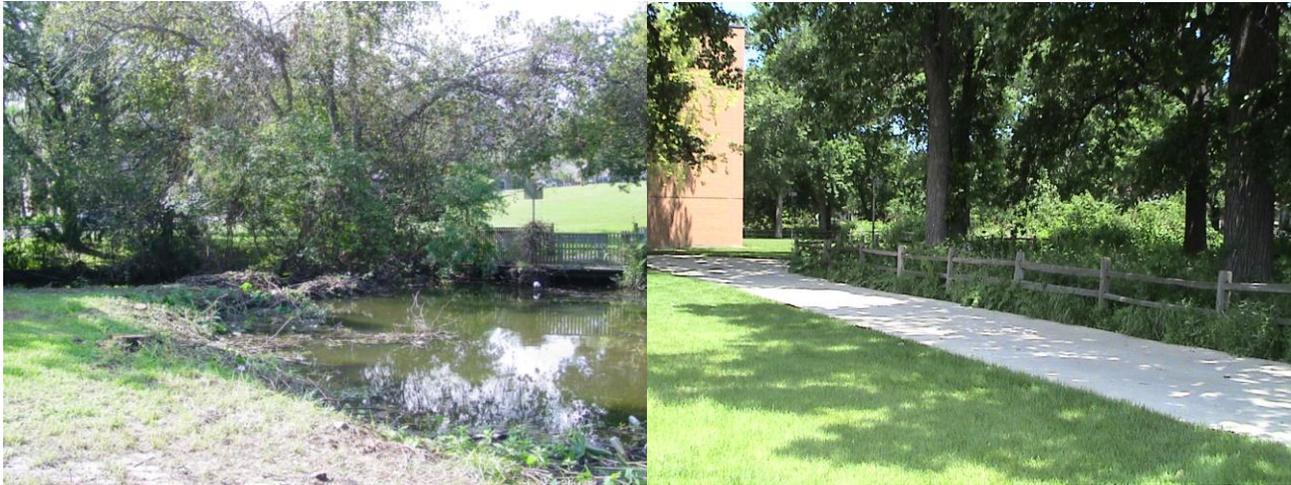
Mowed to the water's edge

Fenced off natural area – no mow area

Throughout campus, many areas have been traditionally mowed to give a neat and orderly appearance. While this has been the traditional approach, there are some areas where mowing is not necessary and by eliminating

some of these areas, the University may save time, money, and energy while enhancing wildlife habitat. In fact, quite often the use of infrequent mowing, decorative fencing and planting of wildflowers can be done in such a way that it both enhances habitat and is aesthetically pleasing. Additionally, in some areas a less frequent mow schedule versus an all-out ban on mowing may be more appropriate. As with all operational decisions there are a number of factors that must be considered, before deciding which areas are appropriate for non-traditional approaches. The balance between aesthetics (form) and function will always have to be determined on a case-by-case basis. Public education can improve the acceptance of strategic no-mow areas by explaining the benefits of this approach and recognizing the areas as wildlife habitats
