University of Florida Conservation Area Land Management Plan Bivens Rim Forest

Introduction

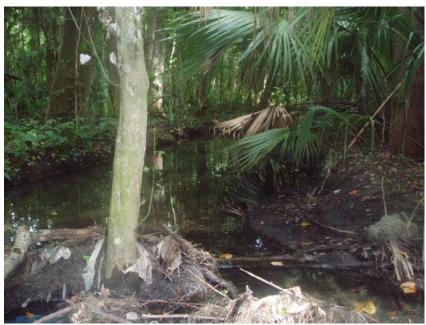
Tumbling Creek flowing through the University's bottomland hardwood forest.

Bivens Arm Lake is the receiving body of Tumbling Creek, which is a creek that runs though the University's laboratory school, P.K. Yonge, and through the eastern boundary of this Conservation Area. Other more intermittent tributaries are present to the north of the lake, adjacent to the College of Veterinary Medicine and to the west by IFAS's facilities, crops and pastures. Most of the University's properties south of Archer Road drain into Bivens Arm from intermittent streams during storm events.

According to data from the Florida Department of Environmental (FDEP) protection, Tumbling Creek's water quality suffers from the following constituents: fecal coliforms, dissolved oxygen, instream erosion and downstream sedimentation. Additionally, the creek is on the FDEP 305 (b) list for not meeting water quality standards, with a water quality rating of poor and on the 303(d) list as impaired waters. Bivens Arm Lake is listed by the FDEP impaired for nutrients and is listed with a poor water quality rating.
