January 9th, 2025

MP09130

MP09130, MP09139, + MP09143
Maguire and University Apartments

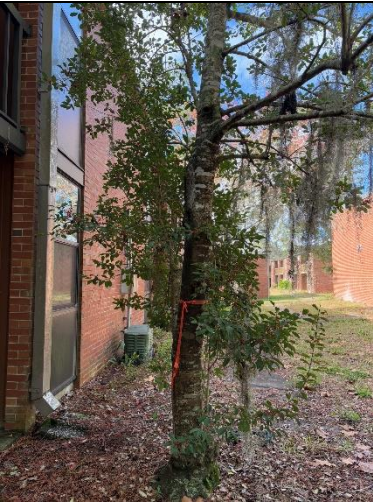
Tag #	Species	DBH	MP#	Arborist Notes/ Recommendation	Photo (if available)
1	American Holly	<5	09139	Below Regulated Size	
2	American Holly	<5	09139	Below Regulated Size	
3	American Holly	<5	09139	Below Regulated Size	
4	American Holly	<5	09139	Below Regulated Size	
5	American Holly	8.5	09139	-Recommended for removal -Tree is in close proximity to building being demolished

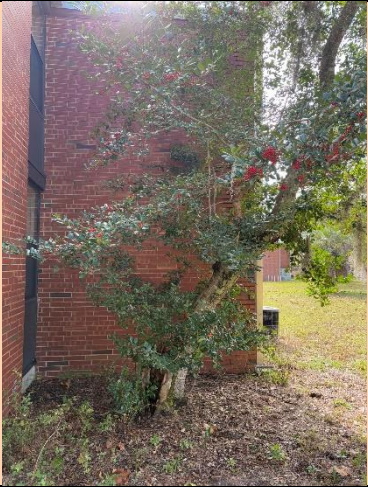
Tag #	Species	DBH	MP#	Arborist Notes/ Recommendation	Photo (if available)
6	American Holly	8.8	09143	-Recommended for removal -Tree is in close proximity to building to be removed

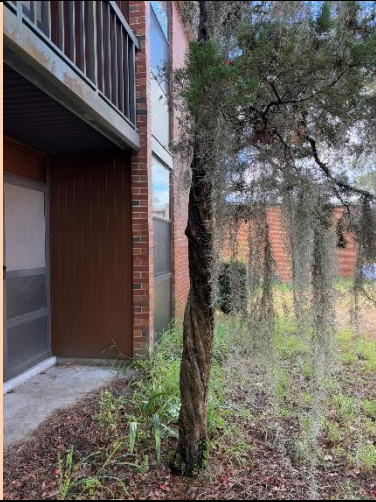
Tag #	Species	DBH	MP#	Arborist Notes/ Recommendation	Photo (if available)
47	Red Cedar	7.3	09139	-Recommended for removal -Tree is in close proximity to building being demolished

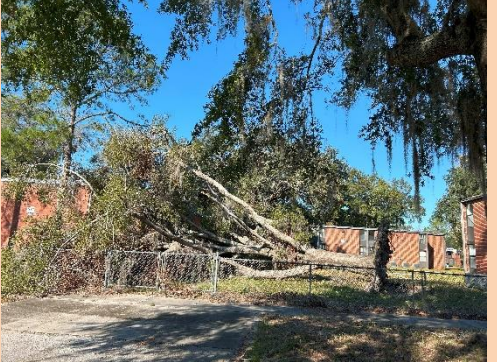
87	Chinese Elm	22	09130		
88	Laurel Oak	45	09143	-Tree is downed

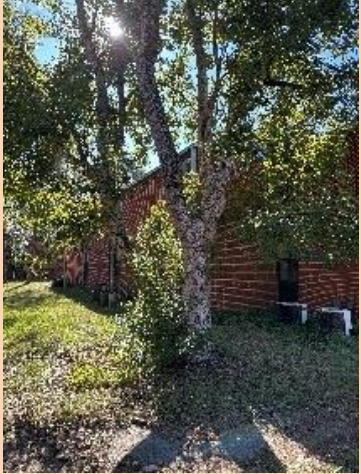
Tag #	Species	DBH	MP#	Arborist Notes/ Recommendation	Photo (if available)
89	Camphor	34.5	09130	-Invasive Species to be removed -Tree is in close proximity to building to be demolished

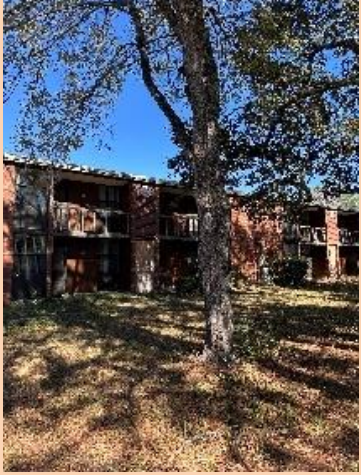
91	Elm	18.5	09139	-Recommended for removal -Co-dominant trunks above DBH

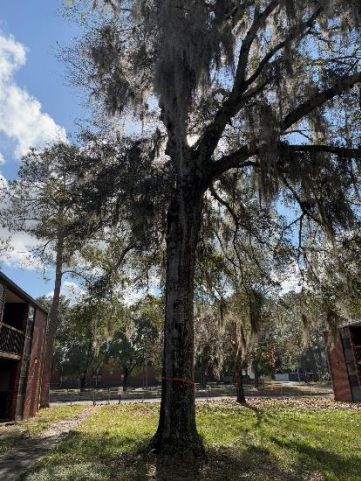
Tag #	Species	DBH	MP#	Arborist Notes/ Recommendation	Photo (if available)
92	Laurel Oak	31.7	09143	<p>-Recommended for removal -Tree is in poor condition</p>

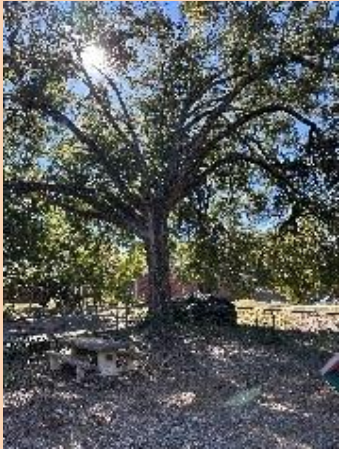
93	Laurel Oak	31.8	09139	<p>-Recommended for removal -Tree is in poor condition with obvious signs of decay and canopy dieback</p>

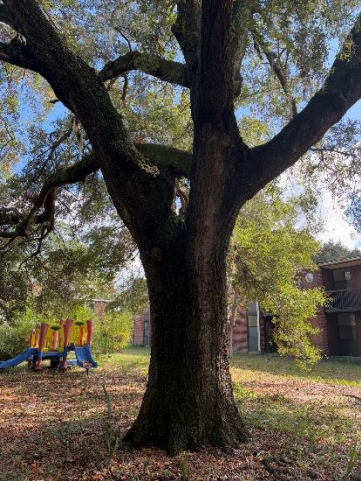
Tag #	Species	DBH	MP#	Arborist Notes/ Recommendation	Photo (if available)
94	Laurel Oak	38.5	09130	<p>-Recommended for removal - Tree is in poor condition</p>

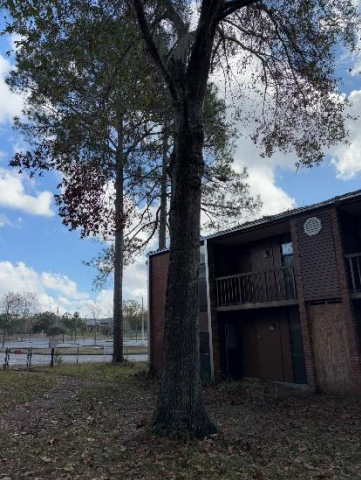
Tag #	Species	DBH	MP#	Arborist Notes/ Recommendation	Photo (if available)
96	Laurel Oak	31	09143	<ul style="list-style-type: none"> -Recommended for removal -Tree is in close proximity to building being demolished -Tree is in poor condition

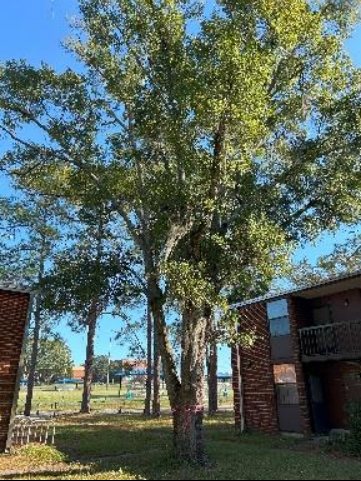
97	Laurel Oak	33.1	09130	<ul style="list-style-type: none"> -Tree is in poor condition -Co-Dominant stems above DBH

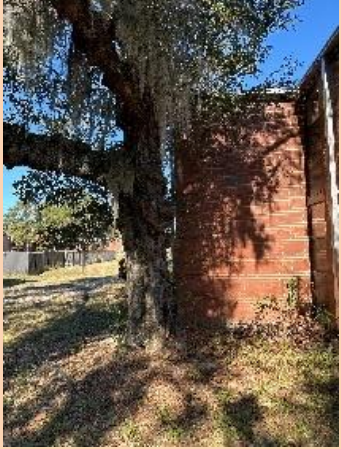
98	Laurel Oak	34.6	09143	<ul style="list-style-type: none"> -Tree is in poor condition -Tree is <6' from existing building to be demolished

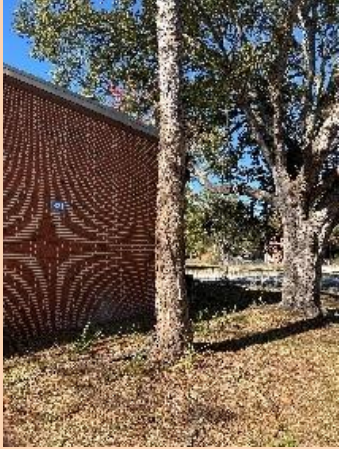
103	Loblolly Pine	26	09130	<p>-Recommended for removal -Tree is in close proximity to building to be demolished</p>

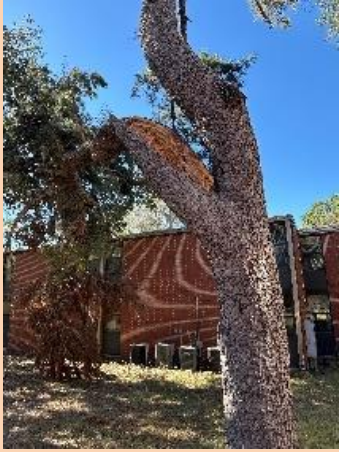
104	Short Leaf Pine	26.5	09143	<p>-Recommended for removal -Tree has failure at major stem above DBH</p>

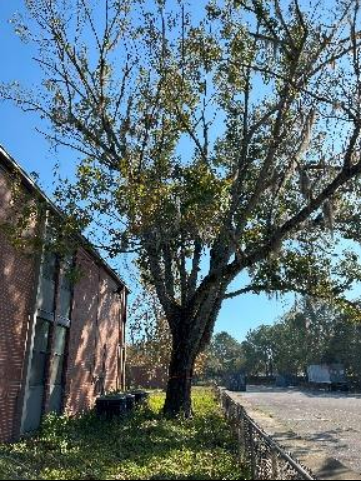
Tag #	Species	DBH	MP#	Arborist Notes/ Recommendation	Photo (if available)
110	Shumard Oak	37.6	09139	<ul style="list-style-type: none"> - Recommended for removal - Tree is in poor condition with significant canopy dieback and signs of decay - Tree is <6' from building to be demolished

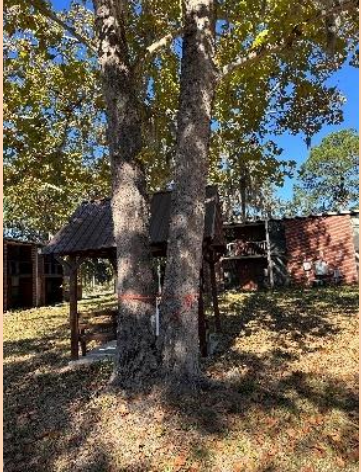
111	Sycamore	40.6	09139	<ul style="list-style-type: none"> - Recommended for removal - Co-Dominant trunks above DBH - At risk for failure

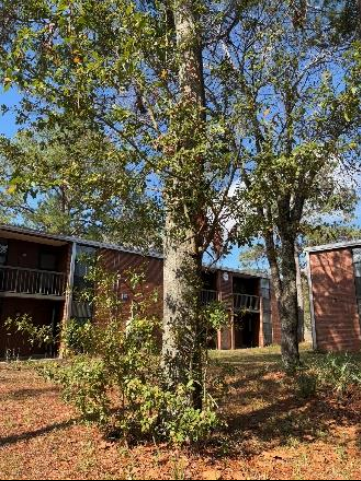
112	Laurel Oak	17.4	09139	<ul style="list-style-type: none"> - Recommended for removal - Tree is in poor condition

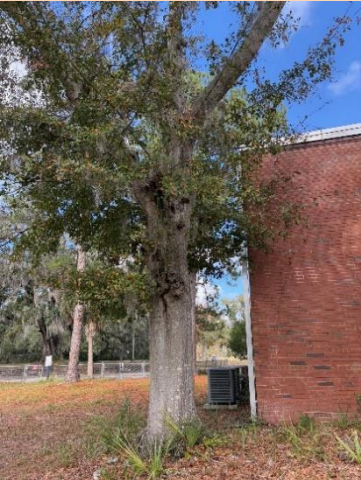
Tag #	Species	DBH	MP#	Arborist Notes/ Recommendation	Photo (if available)
113	Water Oak	23.5	09139	<ul style="list-style-type: none"> - Recommended for removal -Tree is in poor condition and in close proximity to building being demolished

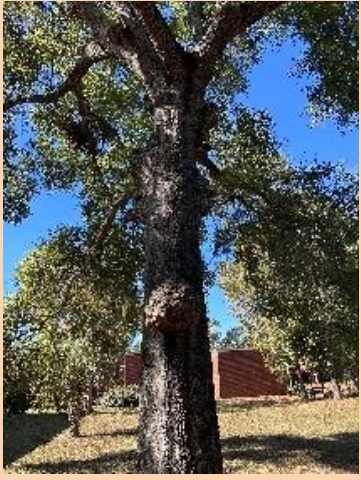
114	Water Oak	34.3	09139	<ul style="list-style-type: none"> - Recommended for removal -Tree is in poor condition with obvious signs of decay

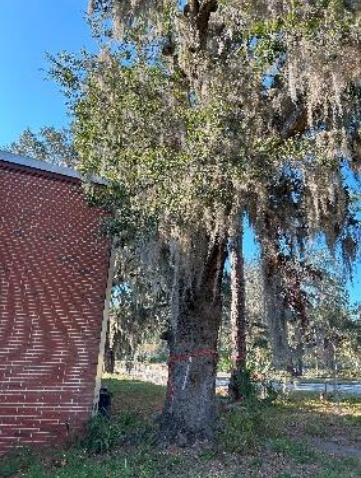
115	Laurel Oak	37.5	09139	<ul style="list-style-type: none"> - Recommended for removal - Tree is in poor condition - Tree is <6' from the building to be demolished

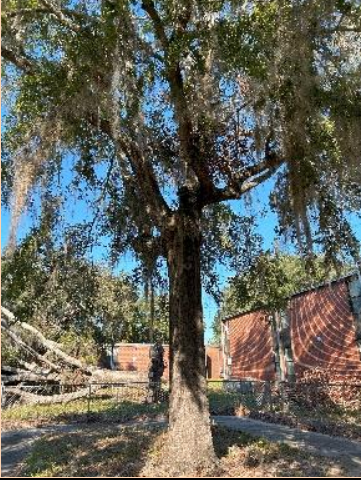
116	Laurel Oak	28	09143	<ul style="list-style-type: none"> - Recommended for removal -Tree is in poor condition -Tree has canopy dieback and signs of rot along trunk

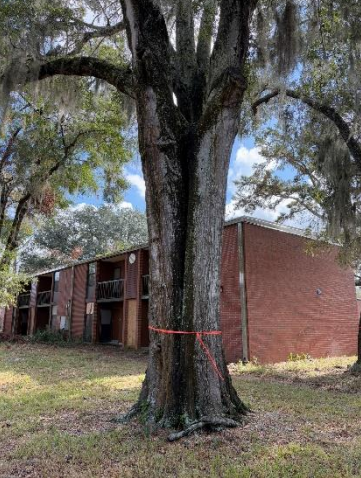
117	Laurel Oak	50.5	09143	<ul style="list-style-type: none"> - Recommended for removal -Tree is in poor condition -Co-dominant stem above DBH

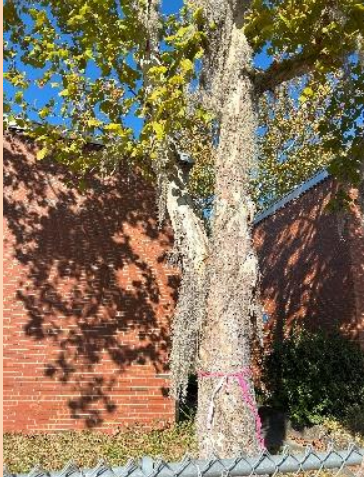
Tag #	Species	DBH	MP#	Arborist Notes/ Recommendation	Photo (if available)
120	Sycamore	17	09143	-Recommended for removal -Co-Dominant branching -Tree is in close proximity to building to be demolished

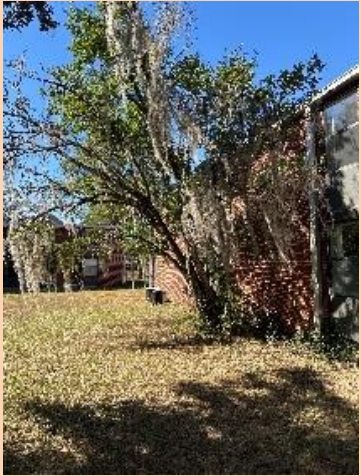
Tag #	Species	DBH	MP#	Arborist Notes/ Recommendation	Photo (if available)
125	Cherry Laurel	11.5	09143	-Recommended for removal -Multi-trunk -Tree is in close proximity to building to be demolished

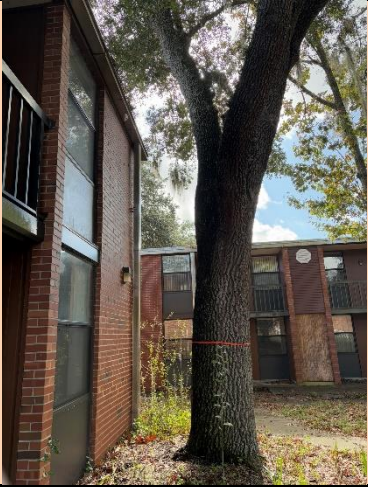
Tag #	Species	DBH	MP#	Arborist Notes/ Recommendation	Photo (if available)
147	Live Oak	25	09130		
148	Live Oak	27	09130		
149	Live Oak	29.1	09139		
150	Live Oak	29.5	09139		
151	Live Oak	29.5	09130		
152	Live Oak	29.8	09130		
153	Live Oak	30	09143	- Recommended for removal -Tree is in close proximity to building to be removed

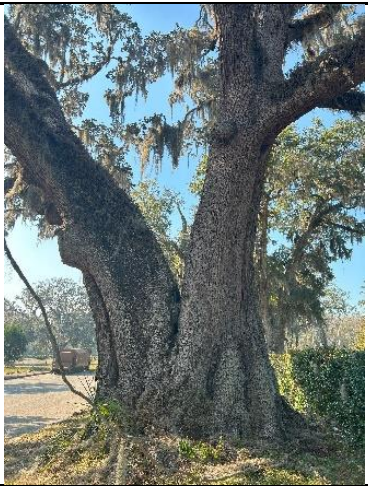
174	Live Oak	62.2	09139		
175	Live Oak	84.6	09139	<ul style="list-style-type: none"> - Codominant trunk with 2 large, similarly sized stems - Should be considered for preservation with future project(s)

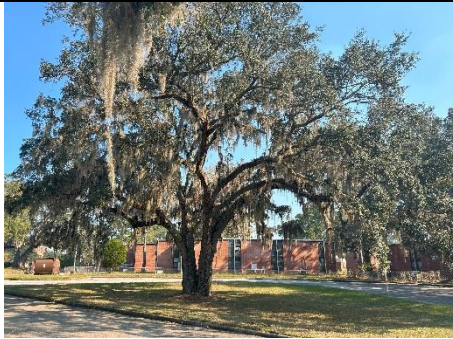
176	Live Oak	35 & 35.2	09139	<ul style="list-style-type: none"> - Co-dominant trunks - Should be considered for preservation with future project(s)

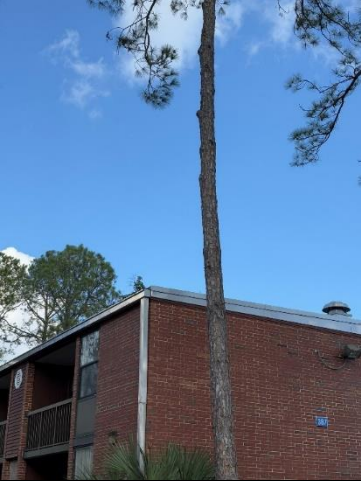
Tag #	Species	DBH	MP#	Arborist Notes/ Recommendation	Photo (if available)
251	Loblolly Pine	27	09130		
252	Loblolly Pine	29.1	09139		
253	Loblolly Pine	15.4	09143	-Recommended for removal -Tree is in close proximity to building being demolished, ~7' off

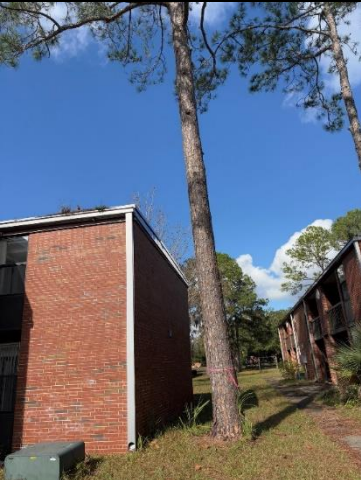
254	Loblolly Pine	21.5	09143	-Recommended for removal -Tree is in close proximity to building being demolished, ~7' off

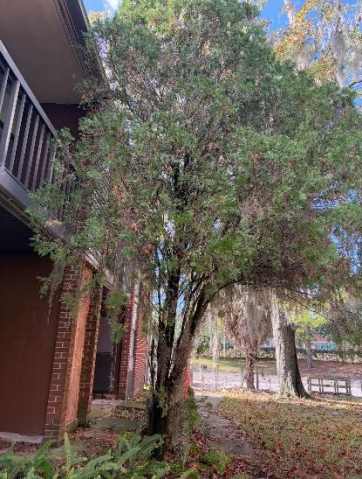
Tag #	Species	DBH	MP#	Arborist Notes/ Recommendation	Photo (if available)
265	Magnolia	15	09130		
266	Red Cedar	41	09143		
267	Red Cedar	<5	09130		
268	Chinese Elm	6	09143		
269	Red Cedar	<5	09130	-Recommended for removal -Tree is in close proximity to building to be removed

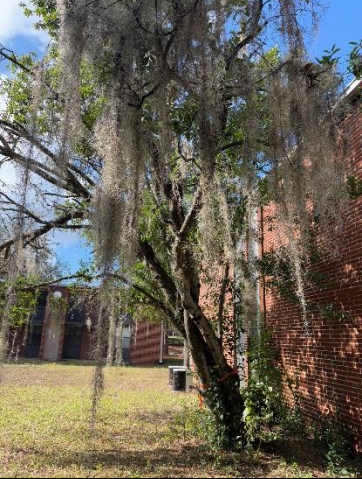
270	Cherry Laurel	>5	09130	-Recommended for removal -Tree is in close proximity to building to be removed
