University of Florida Conservation Area Land Management Plan
Reitz Ravine Woods

Introduction

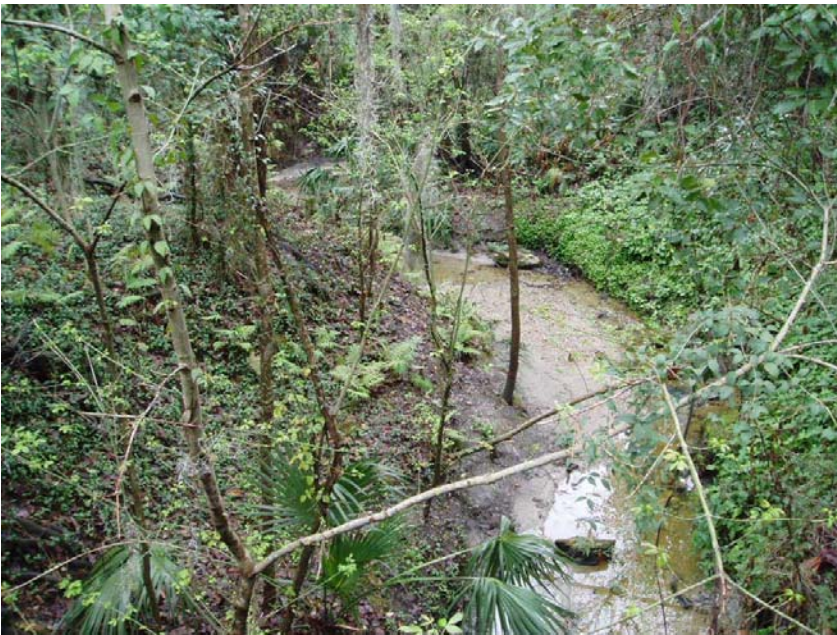
Reitz Ravines Woods contains a permanent stream that run southwesterly towards Hume Pond and ultimately into Lake Alice. The banks of the creek are deeply incised by years of down-cutting from run-off of impervious surfaces and stormwater that drains directly into the ravine and creates much of its base flow. Like most other creek systems on campus, the Ravine's creek is a mix of both stormwater runoff and natural surficial aquifer seepage.

This creek shows some evidence of side bank erosion as evidenced elsewhere on campus. As with most of the watersheds on campus, the solution to these problems will be primarily found in picking up stormwater before it enters the stream with small retention / detention basins throughout campus in both existing green space and in future building sites. Specific to this site, measures should be taken to treat water before it leaves adjacent parking lots with retention / detention put in place of current hardscaped swales. Additionally, some riprap or alternative stabilization counter-measure may be needed in order to reduce in-stream erosion.

Unnamed creek

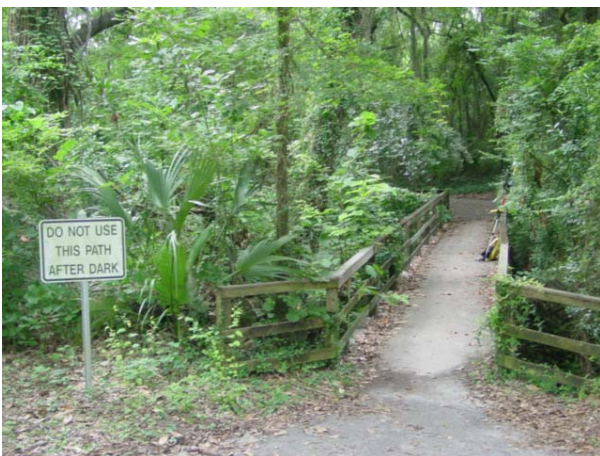
Bridge over Ravine's Creek
