Conservation Area Land Management

November 2004

Facilities, Planning &
Construction Division

UNIVERSITY OF
FLORIDA

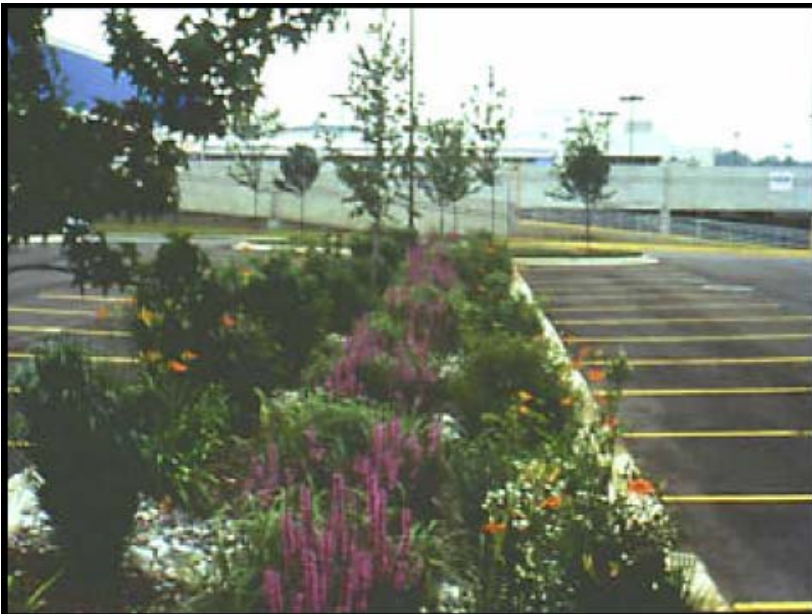
This example illustrates a bio-retention (rain garden) stormwater treatment in a parking lot.

Another approach that uses the traditional stormwater pond design with an ecological design twist is a large scale bio-retention area, which is a BMP that should be considered in developing areas of campus. This approach to stormwater retention can be found currently at the Stormwater Ecological Enhancement Project (SEEP), adjacent to the Performing Arts parking lot and the Natural Areas Teaching Lab (NATL) Conservation Area. The retention pond was originally constructed in 1988 as a typical wet retention pond with a flat bottom and no attention paid to plant species diversity. In 1995, an initiative to redesign the basin into a more ecologically sensitive manor that befitted its placement next to the NATL was initiated. This redesign's primary goal, as articulated by its designers, was to increase the diversity of flooding depths and frequency of flooding that will occur, since this is the primary factor regulating species composition in a wetland. To do this, two depressions (one 4-feet, the other 5-feet deep), were dug at the southeastern end of the pond providing a deep, open-water habitat. At the north end a low berm was constructed to temporarily impound 80% of the entering stormwater. This forebay provides the first phase of treatment and was planted with species known to take up heavy metals and remove nutrients. Water from the forebay is then slowly released, first flowing through an area planted to resemble a bottom-land hardwood swamp, moving into a shallow freshwater marsh and then entering the deep-water ponds. The basin was planted with species that resemble those found in wetlands of North Central Florida.

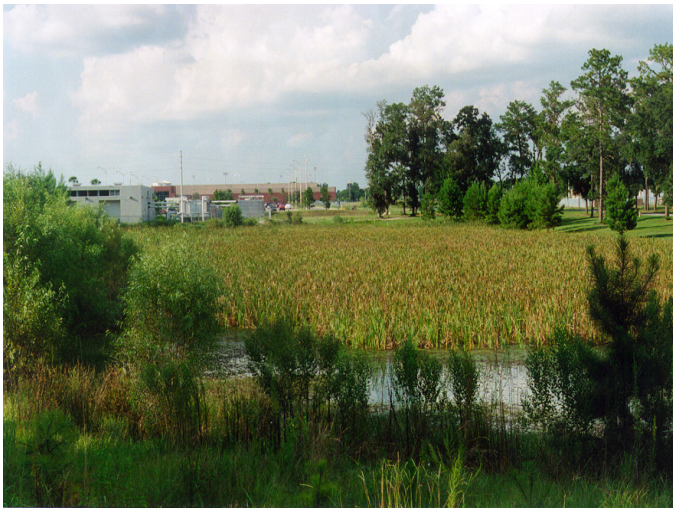
Pre-SEEP (looking north) – Cattail dominated

The expected benefits of this type of retention are species diversity, wildlife habitat, aesthetics, water quality, and research potential. All of these benefits have been proven to be correct at the SEEP, however one issue remains that has not been adequately studied. This issue is the potential effects that these ponds have on wildlife, and particularly federally listed species. Since stormwater ponds are designed to treat the noxious constituents found in run-off, they are laden with metals, pesticides and fertilizers all of which can prove harmful to wildlife. The main species of concern that use ponds for foraging are wading birds, such as the federally listed Wood Stork. At present little research has been conducted on what the long-term impacts are on these species from utilizing stormwater detention, roadside swales, and ecologically enhanced ponds. Arguments can be made that these species will utilize wet retention ponds regardless of whether they have been ecologically enhanced, however it is equally likely that by enhancing them the probability of more productivity (more food) will encourage increased use. Thus, while it is hoped that these ponds are the panacea that is a win-win, additional research is sorely needed.

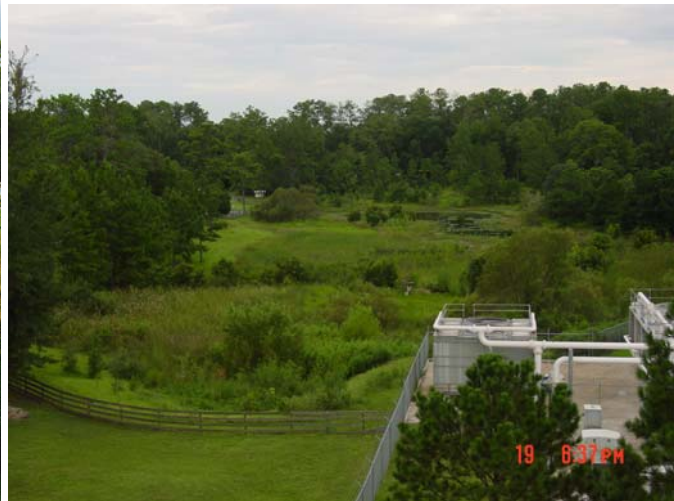
SEEP (looking south) – Variety of plant species

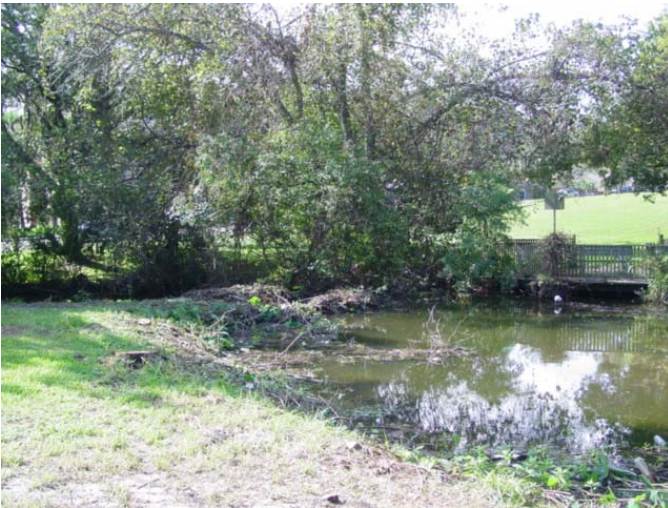
Mowed to the water's edge

Throughout campus, many areas have been traditionally mowed to give a neat and orderly appearance. While this has been the traditional approach, there are some areas where mowing is not necessary and by eliminating some of these areas, the University may save time, money, and energy while enhancing wildlife habitat. In fact, quite often the use of infrequent mowing, decorative fencing and planting of wildflowers can be done in such a way that it both enhances habitat and is aesthetically pleasing. Additionally, in some areas a less frequent mow schedule versus an all out ban on mowing may be more appropriate. As with all operational decisions there are a number of factors that must be considered, before deciding which areas are appropriate for non-traditional approaches. The balance between aesthetics (form) and function will always have to be determined on a case-by-case basis. Public education can improve the acceptance of strategic no-mow areas by explaining the benefits of this approach and recognizing the areas as wildlife habitats

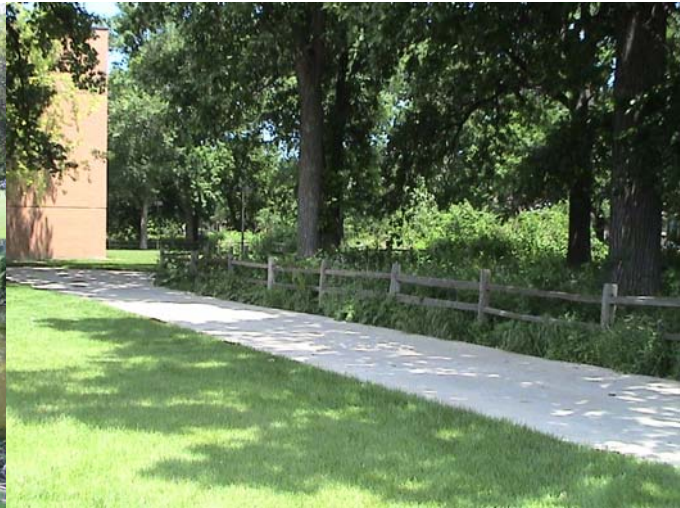
Fenced off natural area – no mow area
